Revised January 2019

Dealer Service Instructions for:

## Safety Recall T80 / NHTSA 17V-820 Heated Seats

**2005 (ND) Dodge Dakota**

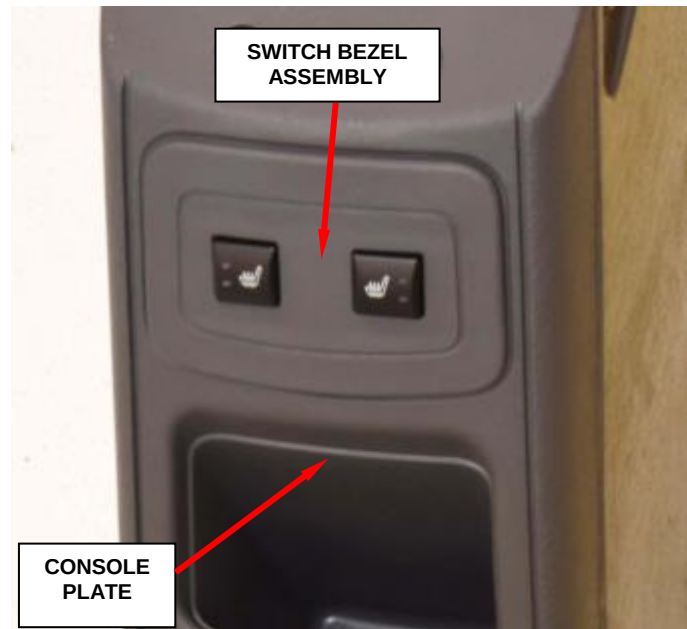
Figure 9 – Switch Bezel to Console Plate

14. Install the **NEW** switch bezel assembly with **NEW** switches in the **NEW** floor console plate (Figure 9).
15. Connect the **NEW** heated seat electrical connectors to the heated seat switches and 12-volt outlet.
16. Position the **NEW** the floor console plate to the floor console (Figure 10).
17. Install the six lower (underside) console plate screws.
18. Position the floor console to the vehicle.
19. Connect the **NEW** the console switch harness to the body harness.
20. Install the four floor console fasteners and tighten securely.
21. Install the floor console plate fasteners and tighten securely.
22. Install the cup holder and all console mats.
23. Install the arm rest lid.
24. Continue with **Section C. Install Heated Seat Pads.**

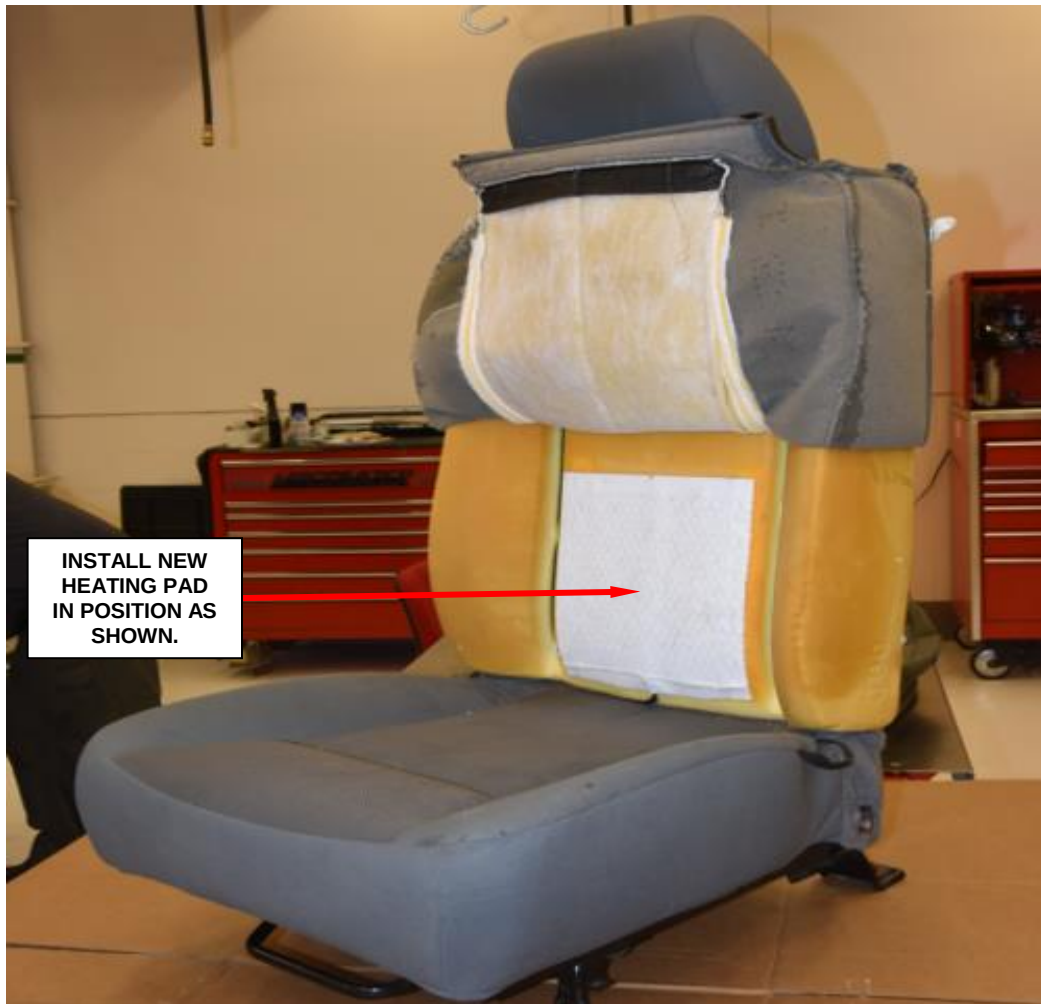
**Figure 13 – Heating Pad Location**

**CAUTION:** During the installation of the replacement heating pad, be careful not to fold or crease the element assembly. Folds or creases will cause premature failure.

8. Peel off the adhesive backing of the replacement heating pads and stick on foam pad directly where the original pad was placed (there will be adhesive marks on the foam outlining the original installed heating element) (Figure 13).

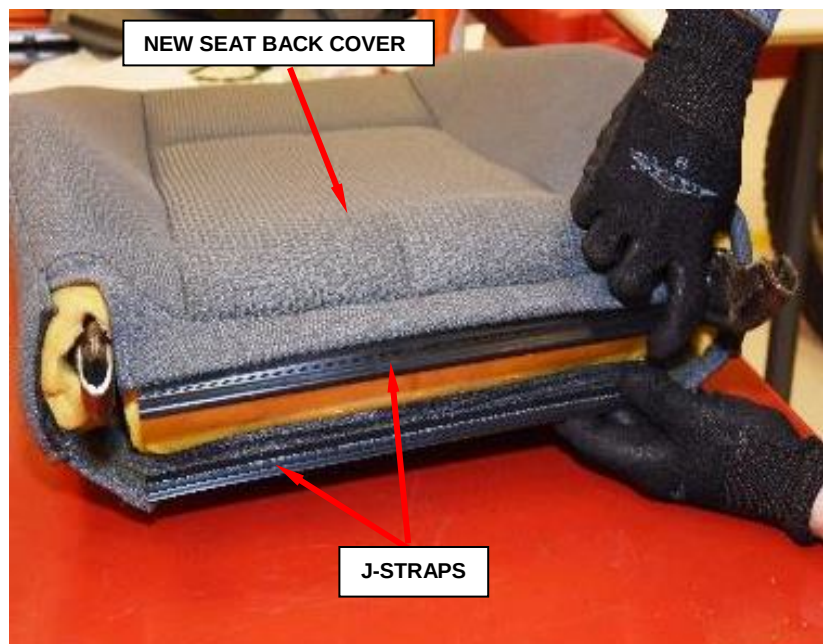
**Figure 14 – Seat Back Cover J-Straps  
(Seat Back Removed for Photographic Purposes)**

9. Position the seat back cover over the cushion.
10. Connect the J-straps. **Listen for audible clicks** to assure the J-straps are fully seated (Figure 14).
11. Disconnect the seat cushion electrical connector from the seat frame assembly.
12. Separate the seat cushion cover J-straps.
13. Remove and save the seat cushion cover.
14. Remove the seat cushion heating pad by peeling it off the foam pad, being careful not to remove excessive foam in the process (Figure 15).

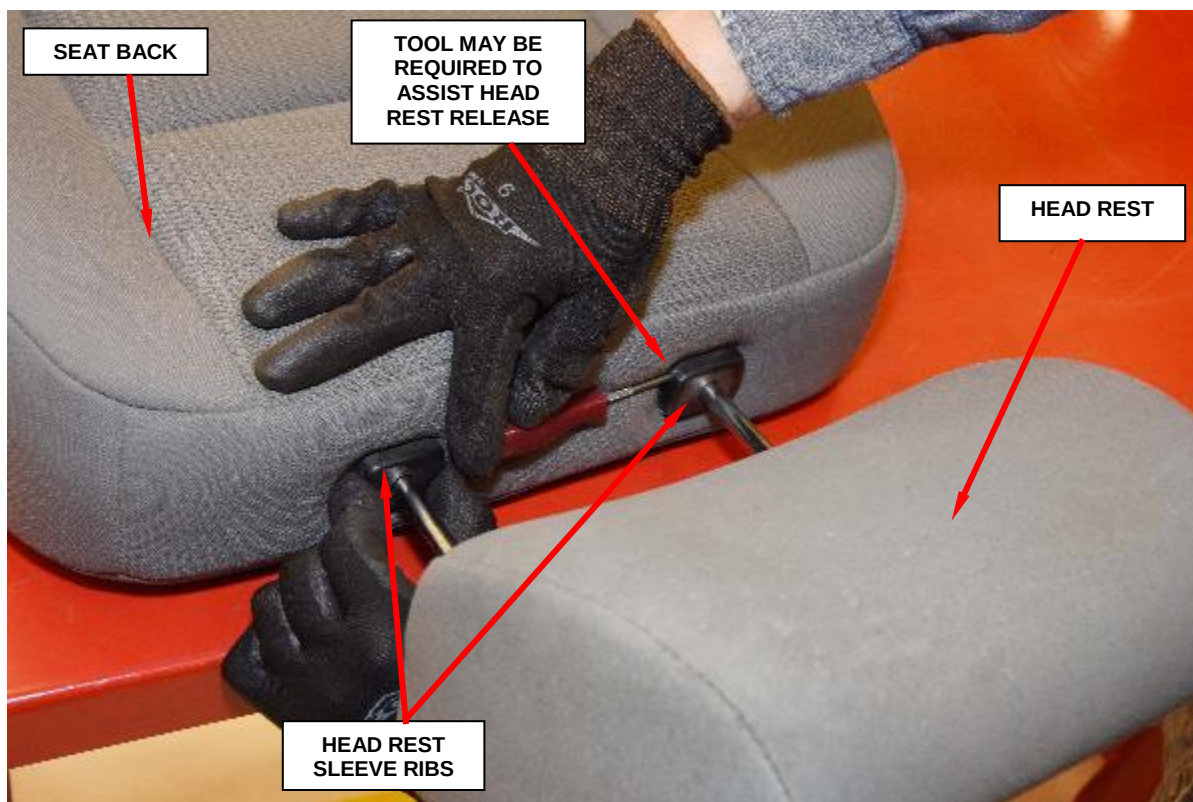
**Figure 18 – Head Rest Removal**

27. Remove the front seat belt buckle.
28. Separate the seat back J-straps and pull the cover up over the frame.
29. Release both headrest tabs and remove the headrest (Figure 18).
30. Pinch both headrest sleeve ribs from inside the seat back frame with pliers or equivalent.
31. Carefully strike the bottom of the headrest sleeves with a rubber mallet or equivalent to remove the headrest sleeves.
32. Remove and **DISCARD** the seat back cover and cushion.

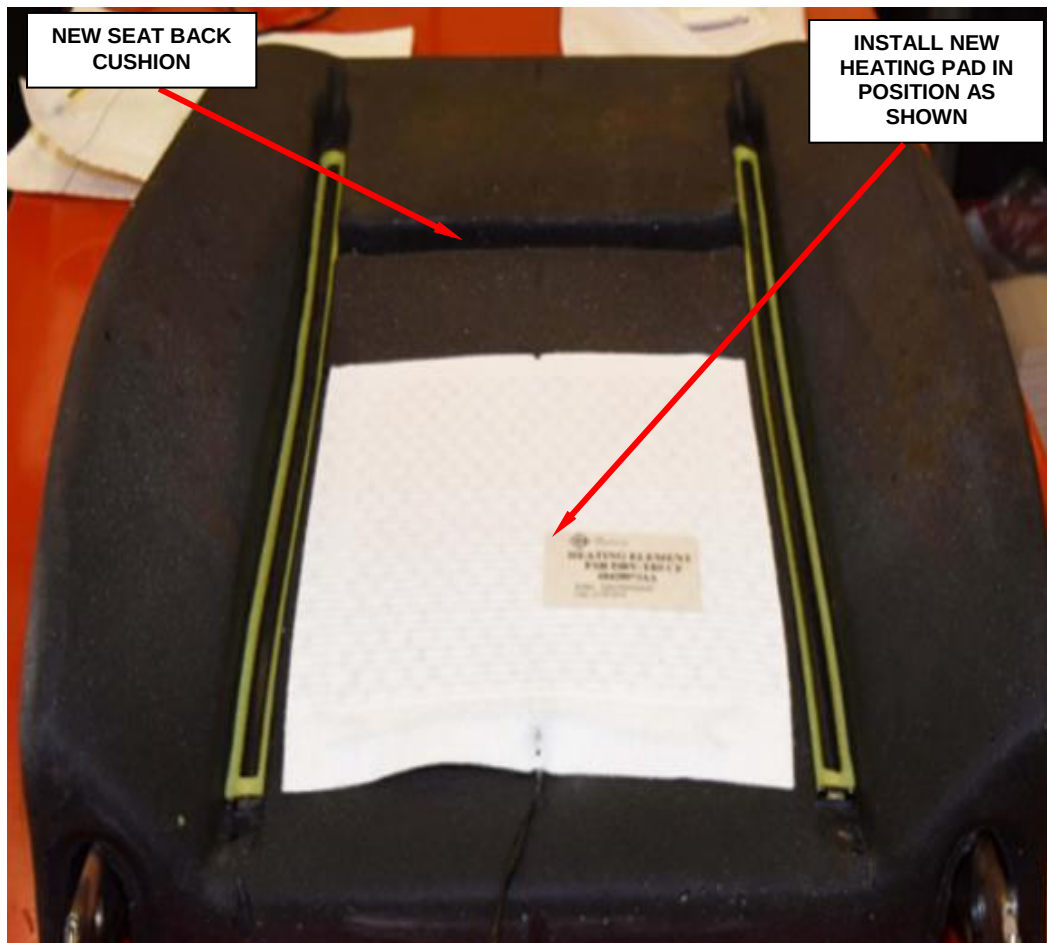
**Figure 19 – Seat Back Cushion and Heating Pad Location**

**CAUTION:** During the installation of the replacement heating pad, be careful not to fold or crease the element assembly. Folds or creases will cause premature failure.

33. Install the **NEW** seat back cushion to the frame.
34. Peel off the adhesive backing of the **NEW** replacement heating pad and stick on the seat back cushion directly where the original pad was placed, as shown (Figure 19).

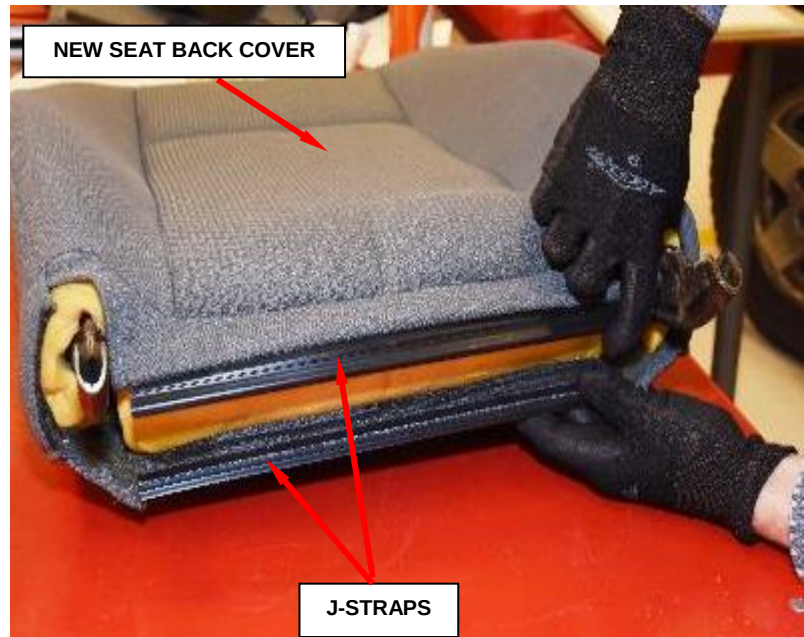
**Figure 20 – Seat Back J-Straps**

35. Position the **NEW** seat back cover over the cushion.
36. Connect the J-straps. **Listen for audible clicks** to assure the J-straps are fully seated (Figure 20).
37. Install the headrest sleeve ribs and headrest.
38. Separate the seat cushion cover J-straps.
39. Remove and **DISCARD** the seat cushion cover and seat cushion.
40. Install the **NEW** seat cushion to the seat frame (Figure 21).

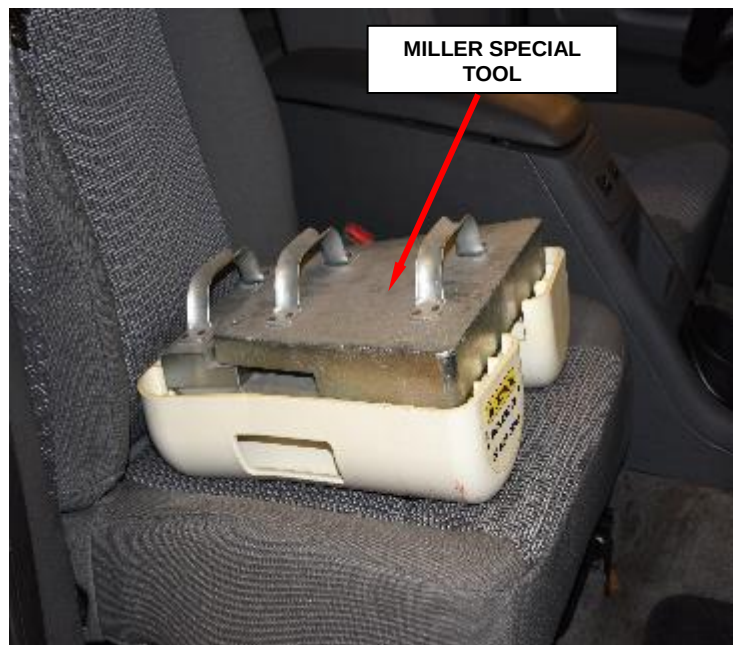
**Figure 23 – Miller Special Tool**

12. From the “**Action Items**” screen, click on the “**OCM**” Module icon then “**Miscellaneous Functions**” tab.
13. Select “**OCM system verification test**”; follow screen prompts using **Miller Special Tool** weighted ballasts (Figure 23).
