## **Safety Recall T80 / NHTSA 17V-820 Heated Seats**

**2005 (ND) Dodge Dakota**

The driver or passenger seat cushion or seat back on about 16,800 of the above vehicles may experience overheating due to fatigue failures in the heater pad. Fatigue failures of the heater pad can cause hot spots to develop which can propagate into burn holes in the seat cushion or open flames in the interior of the vehicle. The heated seat control system used in these vehicles cannot detect these hot spots that cause thermal damage to the seat and will not shut down automatically. Any of these consequences may increase the risk of occupant injury or cause a fire in the vehicle.

Replace the seat heating system to include updated control features and replace any damaged seat components.

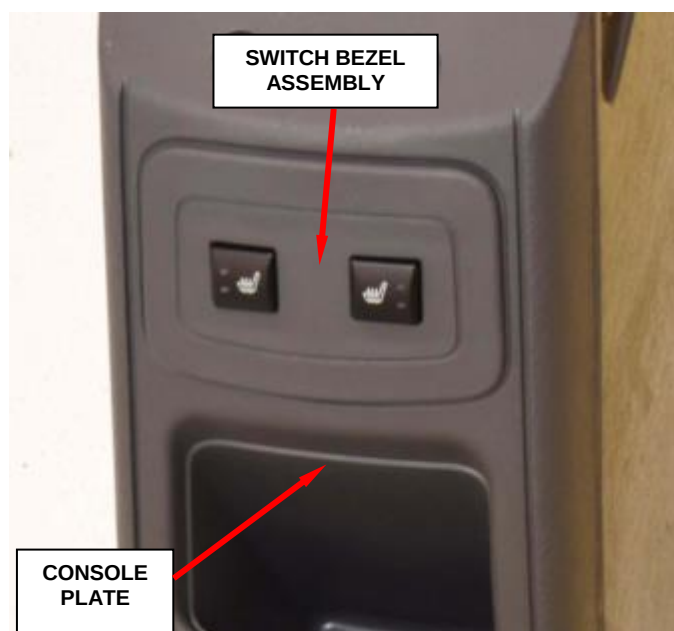
Figure 9 – Switch Bezel to Console Plate

14. Install the **NEW** switch bezel assembly with **NEW** switches in the **NEW** floor console plate (Figure 9).
15. Connect the **NEW** heated seat electrical connectors to the heated seat switches and 12-volt outlet.
16. Position the **NEW** the floor console plate to the floor console (Figure 10).
17. Install the six lower (underside) console plate screws.
18. Position the floor console to the vehicle.
19. Connect the **NEW** the console switch harness to the body harness.
20. Install the four floor console fasteners and tighten securely.
21. Install the floor console plate fasteners and tighten securely.
22. Install the cup holder and all console mats.
23. Install the arm rest lid.
24. Continue with **Section C. Install Heated Seat Pads.**

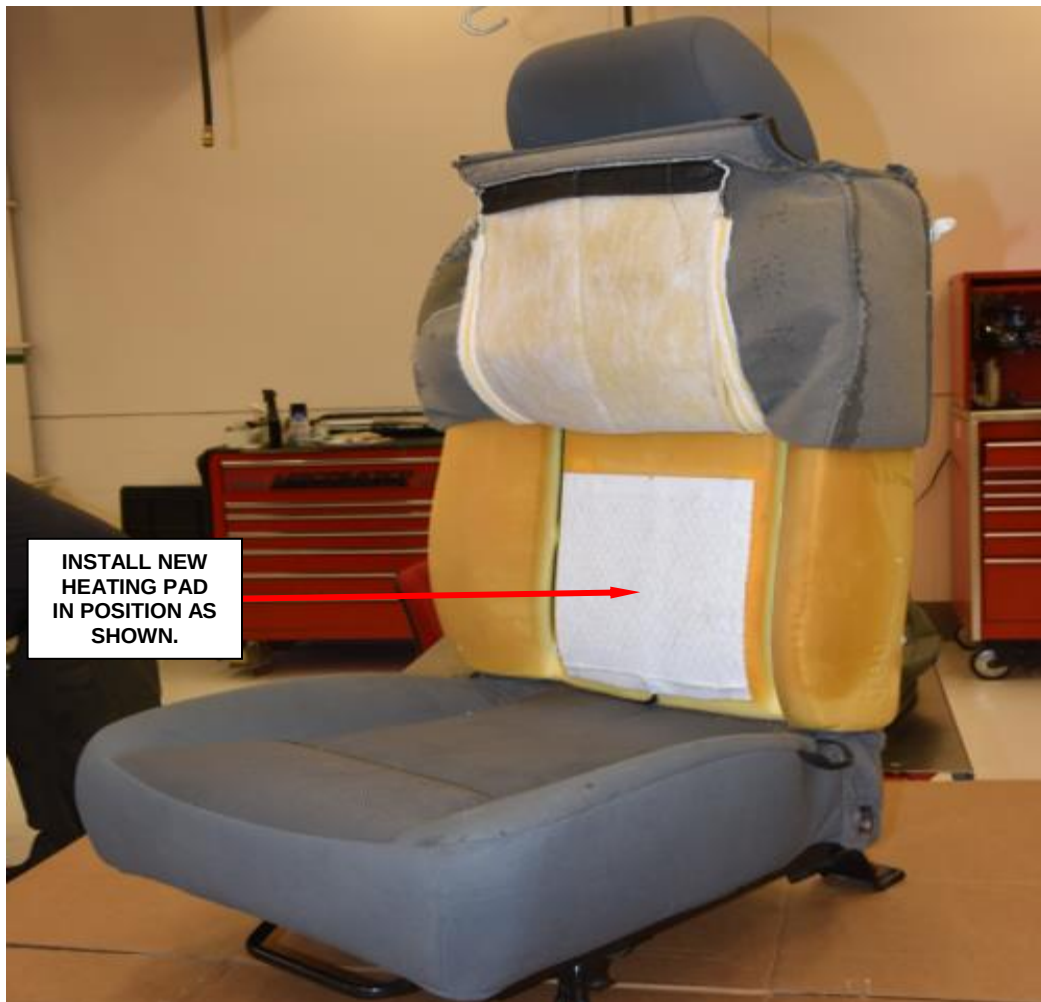
**Figure 13 – Heating Pad Location**

**CAUTION:** During the installation of the replacement heating pad, be careful not to fold or crease the element assembly. Folds or creases will cause premature failure.

8. Peel off the adhesive backing of the replacement heating pads and stick on foam pad directly where the original pad was placed (there will be adhesive marks on the foam outlining the original installed heating element) (Figure 13).

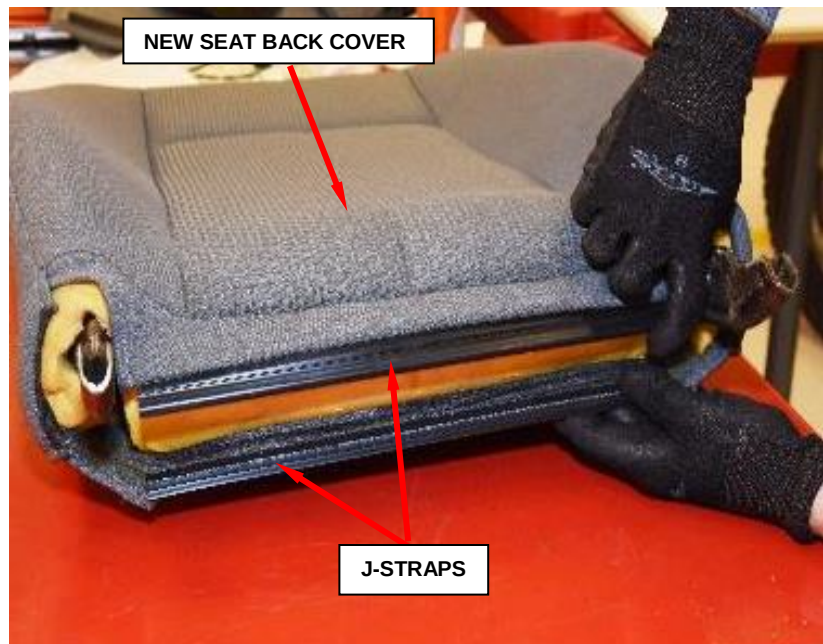
**Figure 14 – Seat Back Cover J-Straps  
(Seat Back Removed for Photographic Purposes)**

9. Position the seat back cover over the cushion.
10. Connect the J-straps. **Listen for audible clicks** to assure the J-straps are fully seated (Figure 14).
11. Disconnect the seat cushion electrical connector from the seat frame assembly.
12. Separate the seat cushion cover J-straps.
13. Remove and save the seat cushion cover.
14. Remove the seat cushion heating pad by peeling it off the foam pad, being careful not to remove excessive foam in the process (Figure 15).

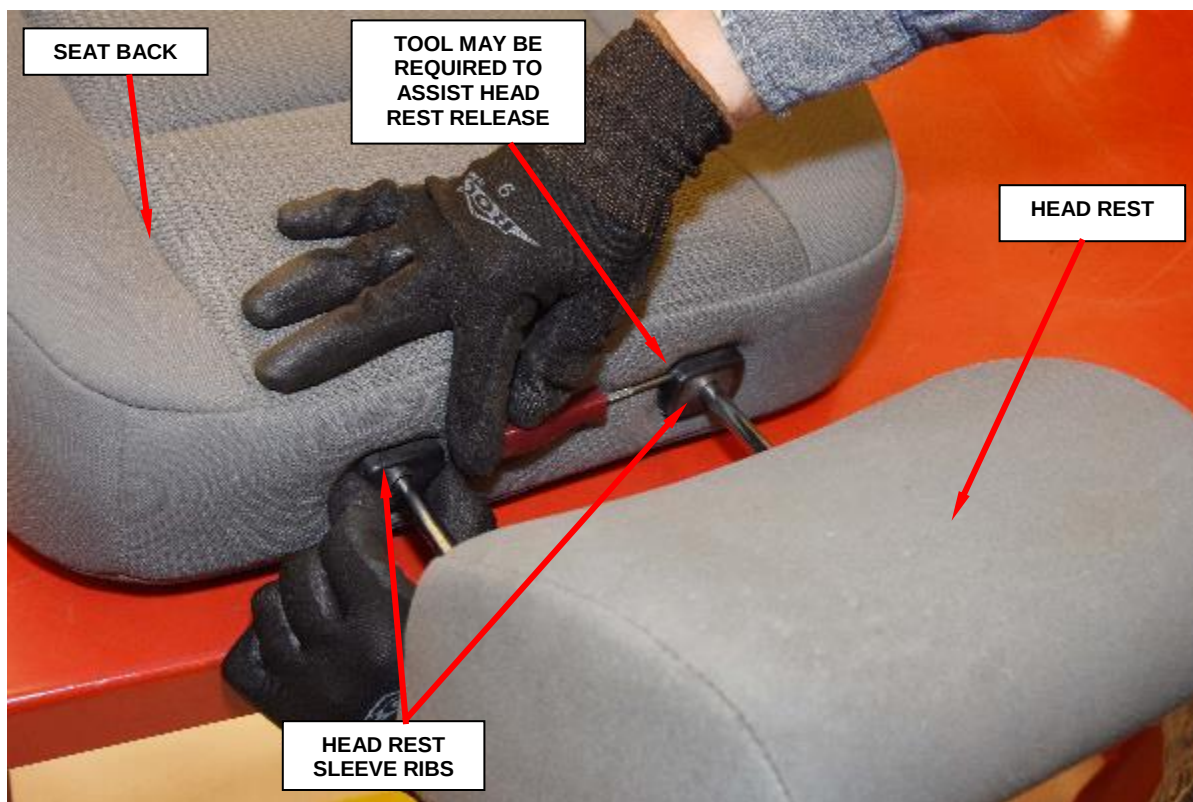
**Figure 18 – Head Rest Removal**

27. Remove the front seat belt buckle.
28. Separate the seat back J-straps and pull the cover up over the frame.
29. Release both headrest tabs and remove the headrest (Figure 18).
30. Pinch both headrest sleeve ribs from inside the seat back frame with pliers or equivalent.
31. Carefully strike the bottom of the headrest sleeves with a rubber mallet or equivalent to remove the headrest sleeves.
32. Remove and **DISCARD** the seat back cover and cushion.

**NOTE: If present, loose plastic material used from manufacturing process should be removed from seat back frame and discarded.**

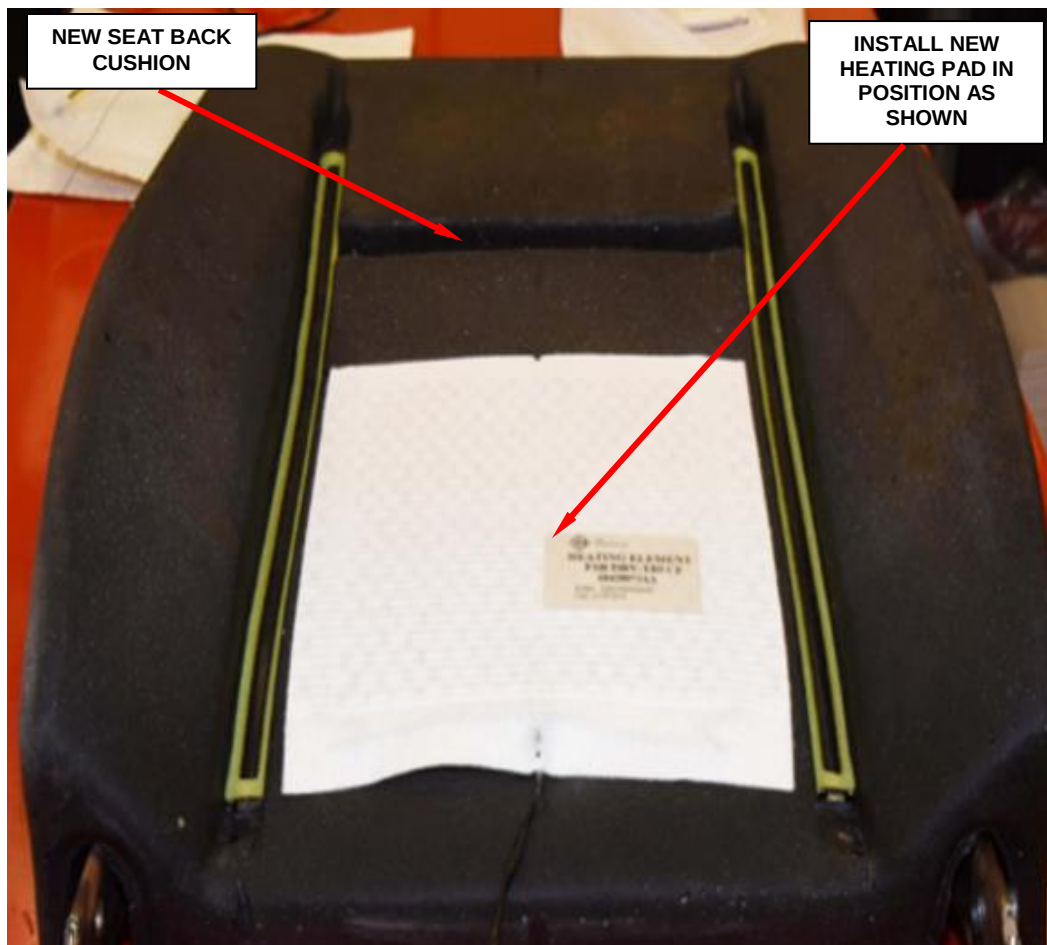
**Figure 19 – Seat Back Cushion and Heating Pad Location**

**CAUTION:** During the installation of the replacement heating pad, be careful not to fold or crease the element assembly. Folds or creases will cause premature failure.

33. Install the **NEW** seat back cushion to the frame.
34. Peel off the adhesive backing of the **NEW** replacement heating pad and stick on the seat back cushion directly where the original pad was placed, as shown (Figure 19).

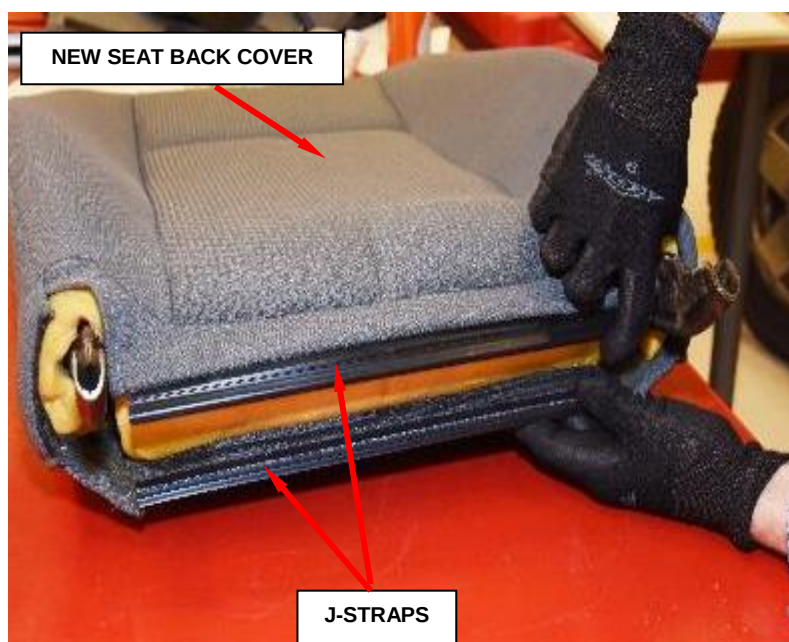
**Figure 20 – Seat Back J-Straps**

35. Position the **NEW** seat back cover over the cushion.
36. Connect the J-straps. **Listen for audible clicks** to assure the J-straps are fully seated (Figure 20).
37. Install the headrest sleeve ribs and headrest.
38. Separate the seat cushion cover J-straps.
39. Remove and **DISCARD** the seat cushion cover and seat cushion.
40. Install the **NEW** seat cushion to the seat frame (Figure 21).

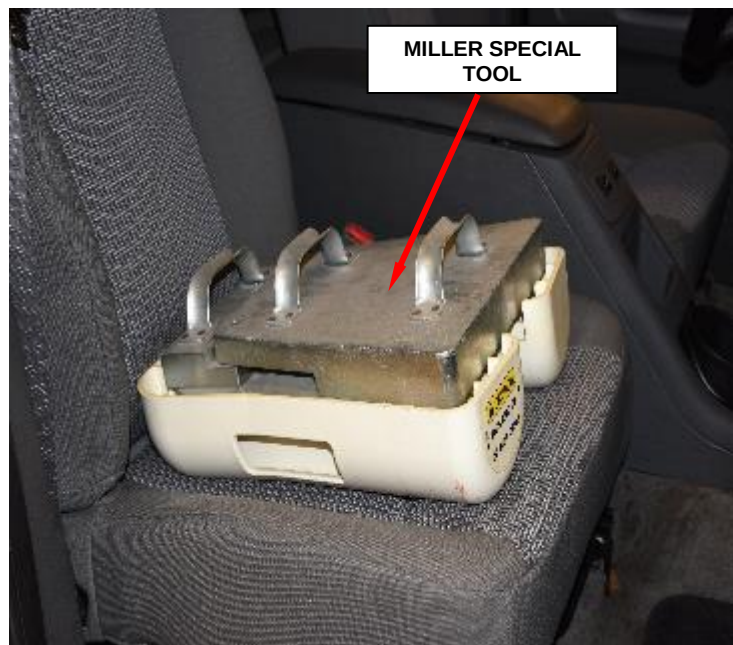
**Figure 23 – Miller Special Tool**

12. From the “**Action Items**” screen, click on the “**OCM**” Module icon then “**Miscellaneous Functions**” tab.
13. Select “**OCM system verification test**”; follow screen prompts using **Miller Special Tool** weighted ballasts (Figure 23).
