## Maserati Technical Bulletin

Date: December 20th, 2017  
Bulletin No. MAS001416 - Fuel Delivery Line  
Replacement - U.S.  
Safety Recall Campaign - 363  
Supersedes: N/A  
Section: Compliance

**Model: Quattroporte (M156) and Ghibli (M157)**

**Subject: Vehicle Safety Recall Campaign 363 – Fuel Delivery Line Replacement**

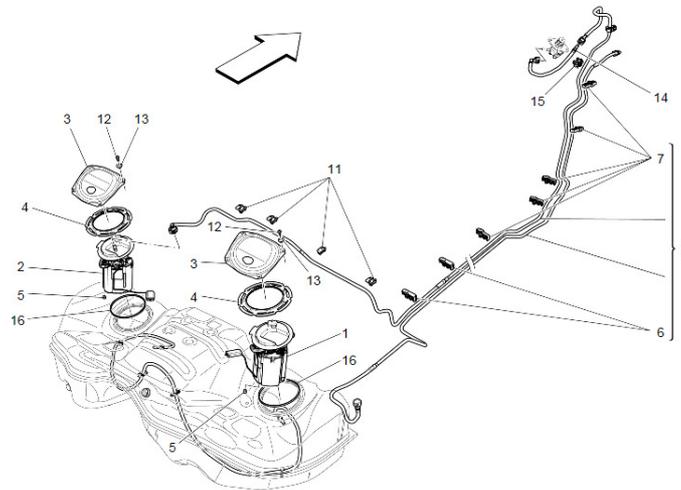
Fig.1

Maserati S.p.A. and MNA have determined that the above described vehicles were manufactured with fuel lines (Num. 9 in Fig.1) that may weep or leak fuel as a result of an assembly process used by a supplier during fuel line production. Potential fuel leaks may occur at any location along the fuel line due to the introduction of foreign particles between the metal fuel line and plastic fuel line during the connection process (due to the supplier's insufficient cleaning process of the fuel line), causing scratches on the plastic fuel line portion. A weeping or leaking fuel line, over time, and in the worst case scenario, can lead to a fire in the engine compartment or underneath the vehicle.

The original 1 piece fuel delivery line will now be replaced by the above kits which contain 3 lines. The engine connection line (1), the body line (2), and the fuel tank connection line (3).

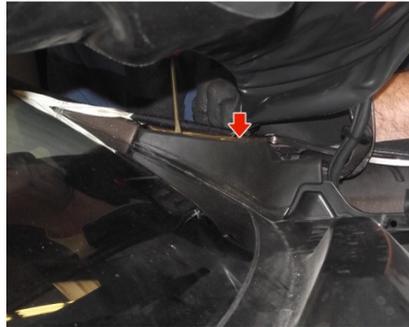
Fig.2

b. Using a Teflon wedge, remove the l/s and r/s windshield trim. (Fig.2)

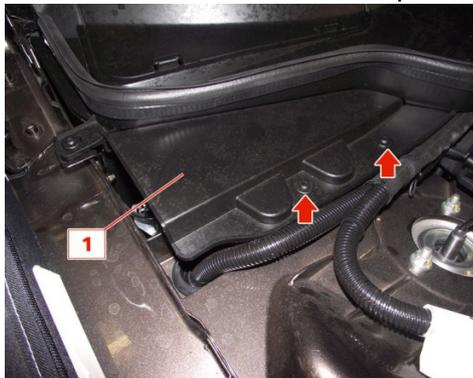
Fig.3

c. Remove the l/s and r/s inspection covers. (Fig.3)

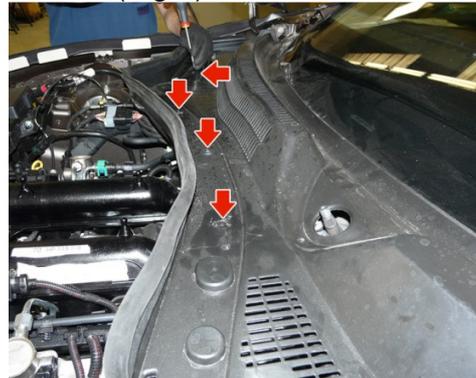
Fig.4

d. Remove the exterior lower windshield trim. (Fig.4)

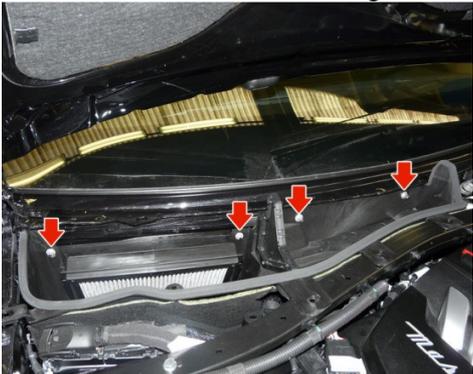
Fig.5

e. Remove the nuts holding the water containment tray. (Fig.5)

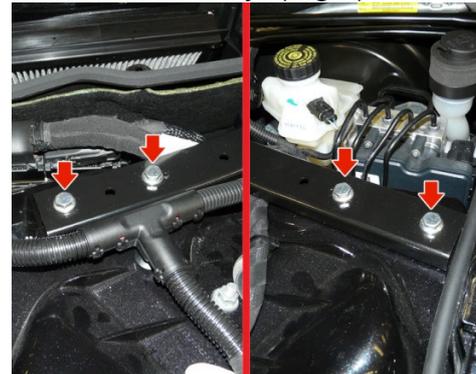
Fig.6

f. Remove the bolts on the engine compartment front cross member. (Fig.6)

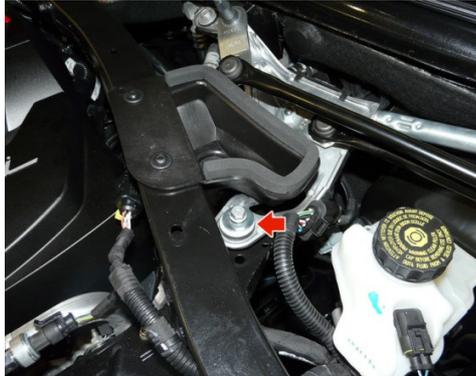
Fig.7

g. Remove the bolt between wiper linkage and the front cross member. (Fig.7)

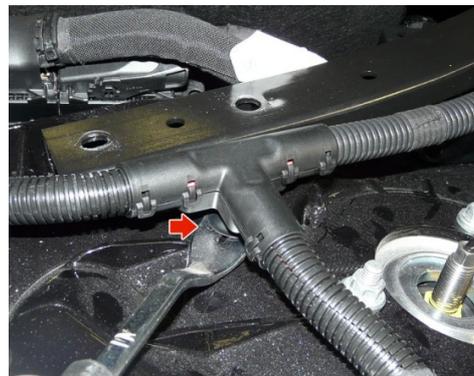
Fig.8

h. Unsnap the wire harness support clip and move the front cross member to the side. (Fig.8)

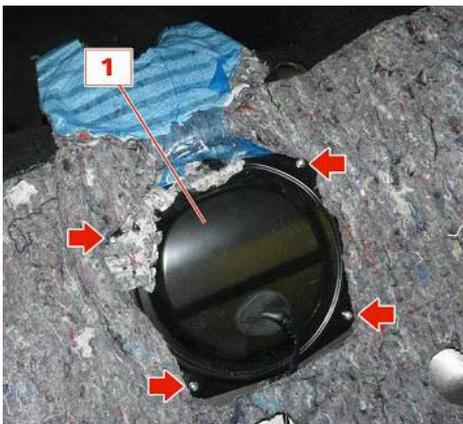
Fig.9

6. Remove the 4 screws and then the l/s fuel pump inspection cover (Fig.9).

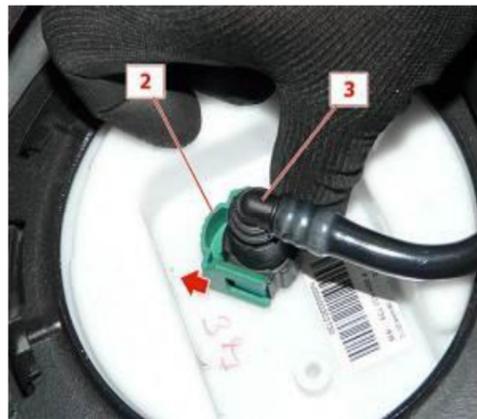
Fig.10

6. Release the safety (2) and unsnap the quick release fuel delivery line (3) as shown in Fig.10.

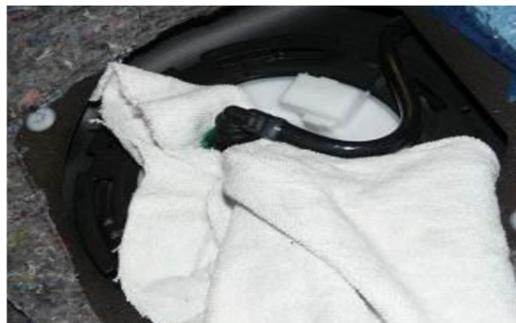
Fig.11

**NOTE: Use an absorbent cloth to wipe off any residual fuel when disconnecting the delivery line from the pump as shown in Fig.11.**

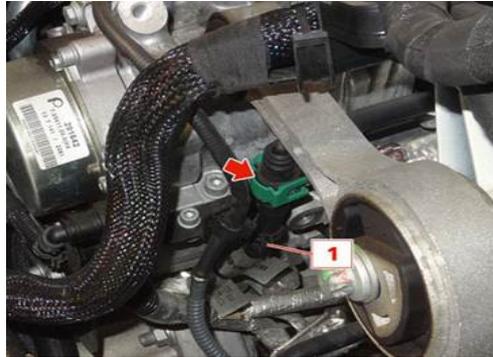
Fig.12

7. In the engine compartment, remove the engine cover, release the safety and disconnect the fuel delivery line, then unclip the fastening clamp. (1 in Fig.12)

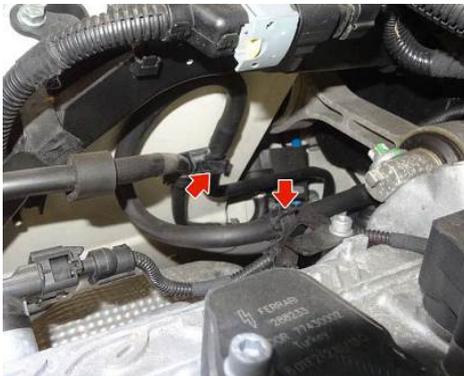
Fig.13

8. Unclip the delivery line from the 2 fastening clamps. (Fig.13)

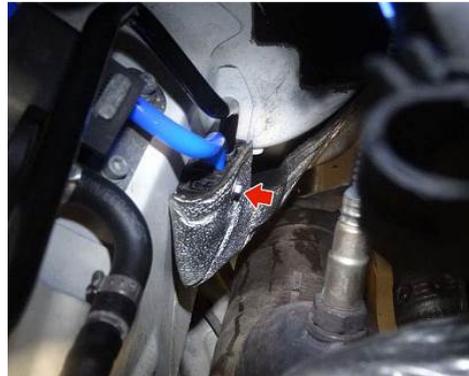
Fig.14

9. Remove the screw on the heat shield between the engine and the r/s dome. (Fig.14)

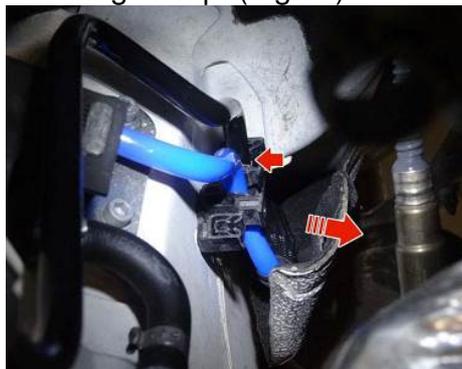
Fig.15

10. Pull the heat shield back and then unclip the fuel delivery line from the securing clamp. (Fig.15)

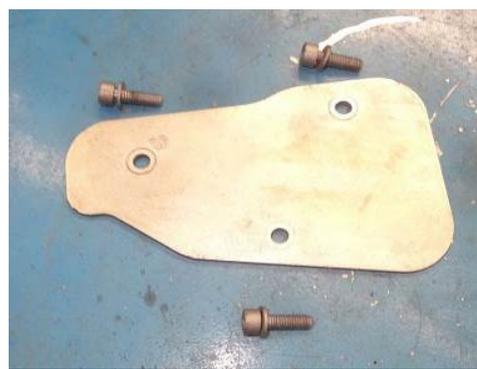
Fig.16

11. Only on the Ghibli AWD, remove the 3 bolts and the metal plate behind the r/s cylinder head. (Fig.16)

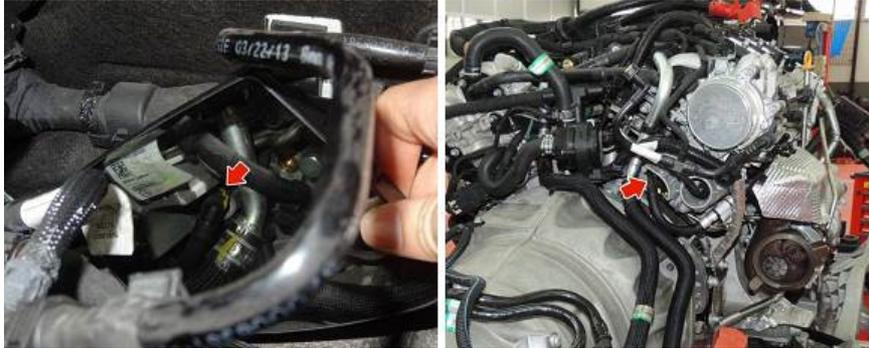
Fig.17

12. Release the safety and unhook the quick release on the fuel delivery line located behind the r/s cylinder head. (Fig.17)

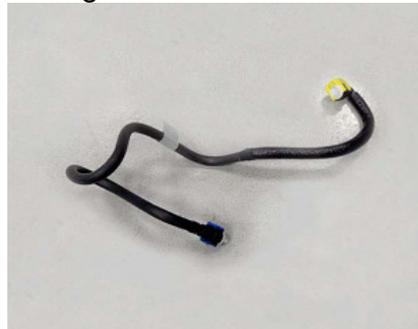
Fig.18

13. Replace the old fuel delivery line on the engine with the new fuel delivery line from the kit as shown in Fig.18.

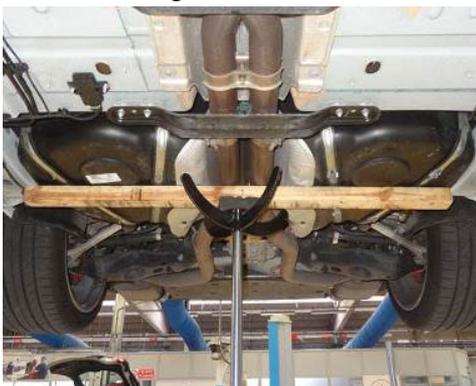
15. Position a hydraulic lift with a brace to support the fuel tank as shown in Fig.19

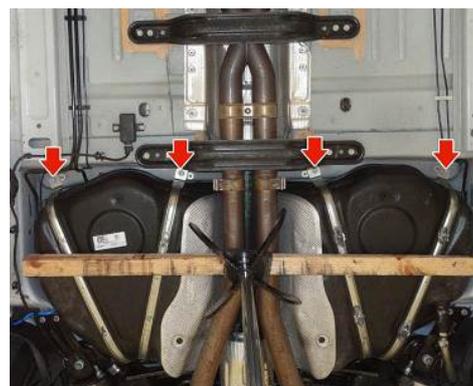
Fig.20

16. Remove the bolts on the fuel tank support straps. (Fig.20)

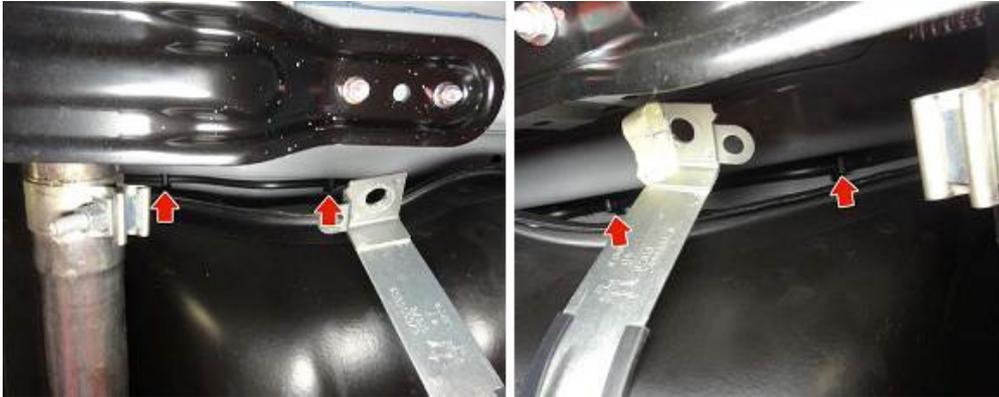
Fig.21

17. Lower the fuel tank just enough to unsnap the fuel delivery line from the 4 clamps located between the fuel tank and the chassis. (Fig.21)

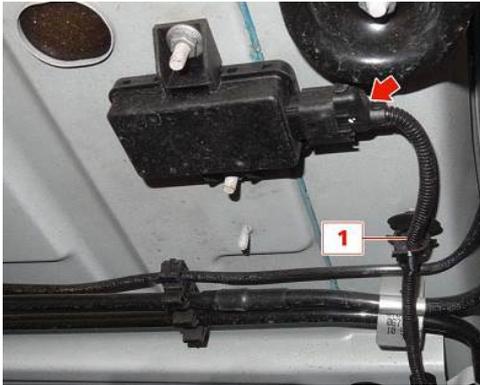
Fig.22

18. On the TPMS sensor, unlock the safety tab and disconnect the wire connector, then release the harness fastener. (1 in Fig.22)

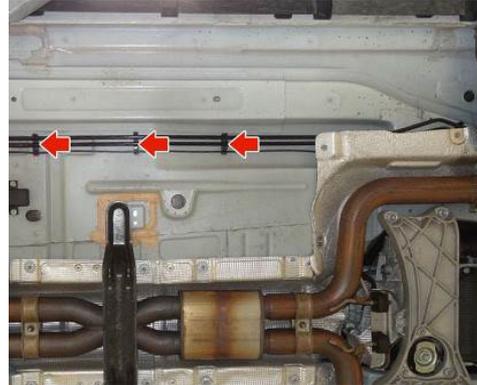
Fig.23

19. Unclip the fuel delivery line from the 3 fastening clamps. (Fig.23)  
 20. Remove the heat shield screws and the fasteners (1) then remove the 2 heat shields as shown in Fig.24 and Fig.25.

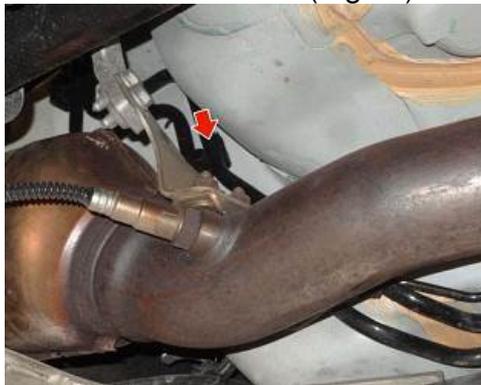
Fig.26

21. Unclip the fuel delivery line from the clamps located between the engine and the r/s dome. (Fig.26)

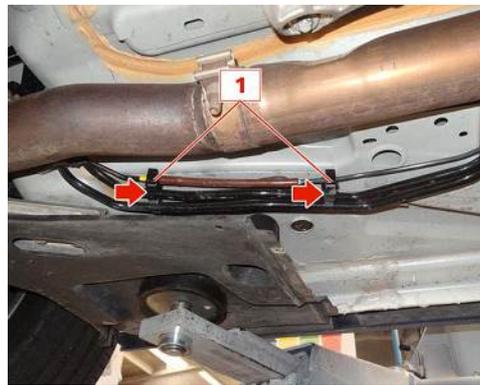
Fig.27

22. Unclip the fuel delivery line from the lower 2 clamps. (1 in Fig.27)

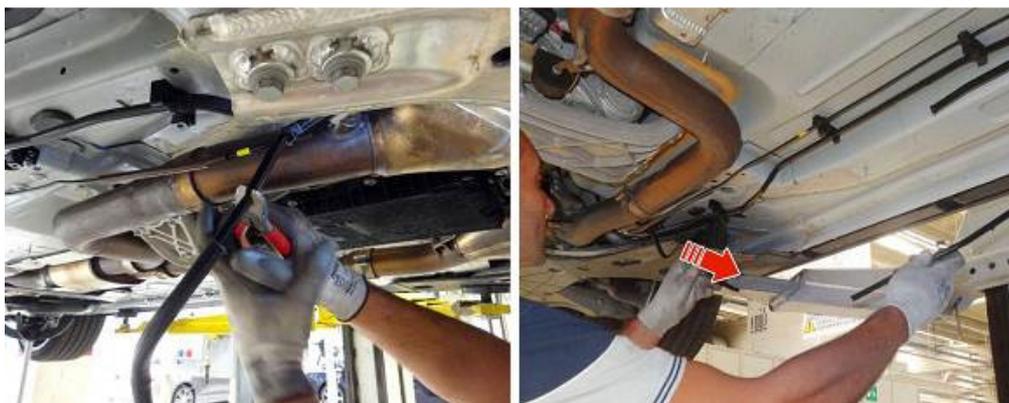
Fig.28

23. Cut the old fuel delivery line (Fig.28) to facilitate the next several steps.

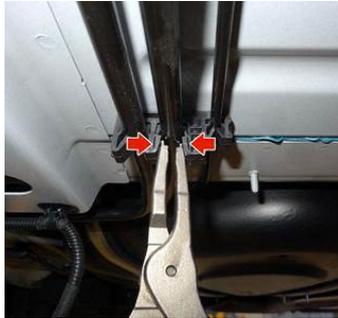
Fig.29

24. With snap ring pliers, loosen the clamps and remove the remaining sections of the fuel delivery line. (Fig.29)

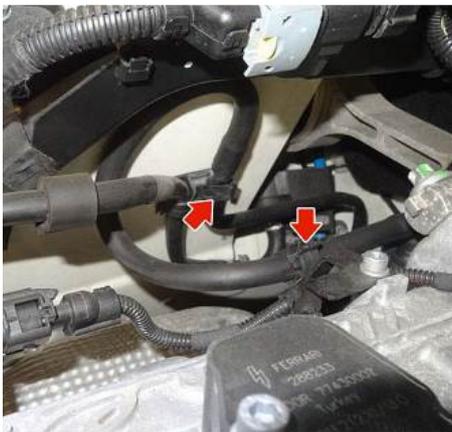
Fig.30

26. Secure the new engine line into the engine compartment clamps. (Fig.30)

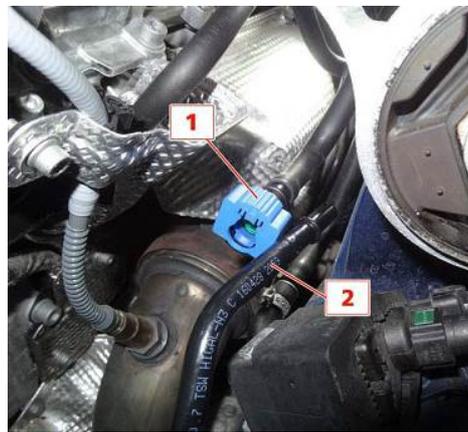
Fig.31

27. Attach the new body delivery line to the engine delivery line and snap the lock closed. (Fig.31)

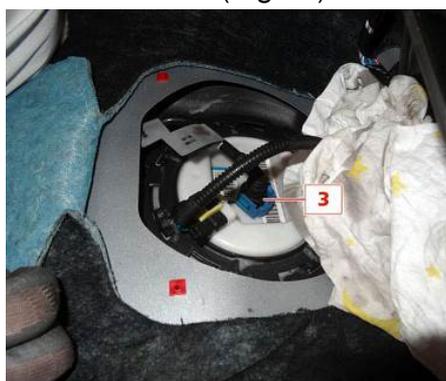
Fig.32

28. Attach the new tank delivery line to the fuel pump. (3 in Fig.32)

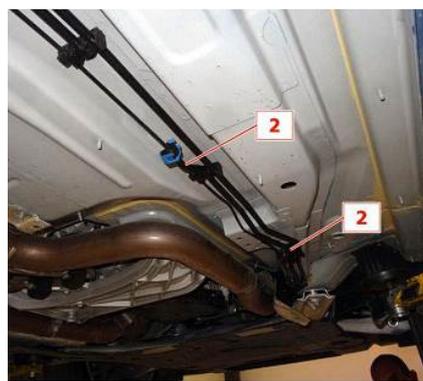
Fig.33

29. Snap the new delivery line into the securing clamps. (2 in Fig.33)

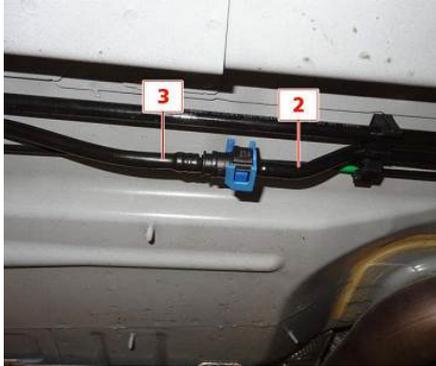
Fig.34

30. Attach the new tank delivery line (3) to the new body delivery line (2) and snap the lock closed. (Fig.34)

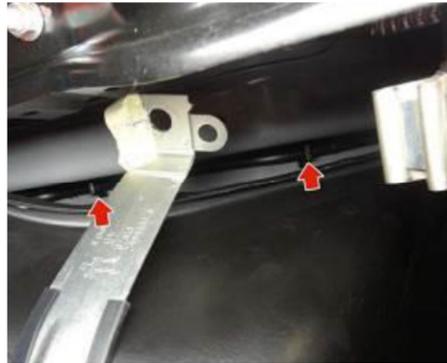
Fig.35

31. Snap the new tank delivery line into the securing clamps above the fuel tank. (Fig.35)
32. Tighten the fuel tank strap bolts to 35Nm. (Fig.36) and remove the lift.

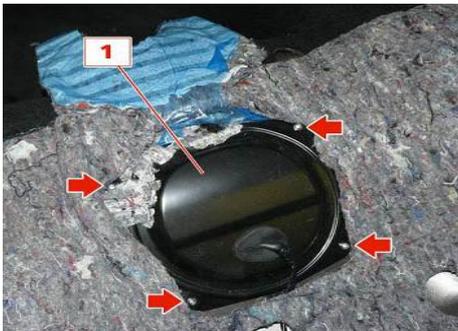
Fig.1

3. Remove the rear seat cushion as shown in Section 9.42.006 – 02 of the Workshop Manual.
4. Remove the 4 screws and then the l/s fuel pump inspection cover. (Fig.1)

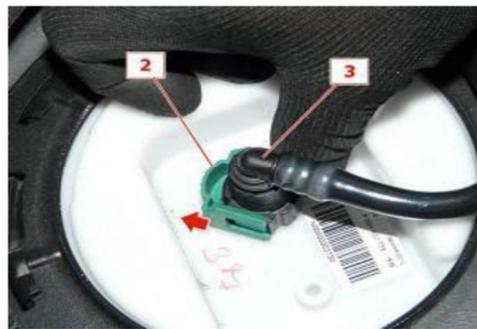
Fig.2

5. Release the safety (2) and unsnap the quick release on the fuel delivery line (3) as shown in Fig.2.

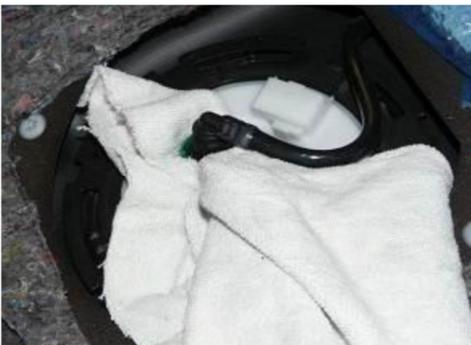
Fig.3

**NOTE:** Use an absorbent cloth to wipe off any residual fuel when disconnecting the delivery line from the pump as shown in Fig.3.

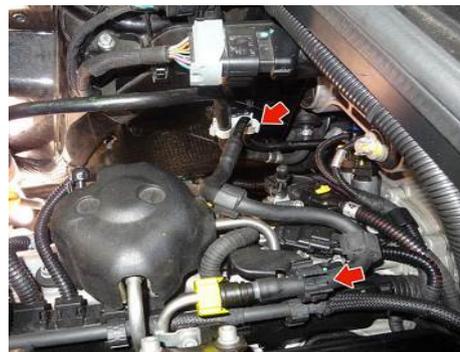
Fig.4

6. In the engine compartment, remove the engine cover then release the engine fuel delivery line from the securing clamps. (Fig.4)

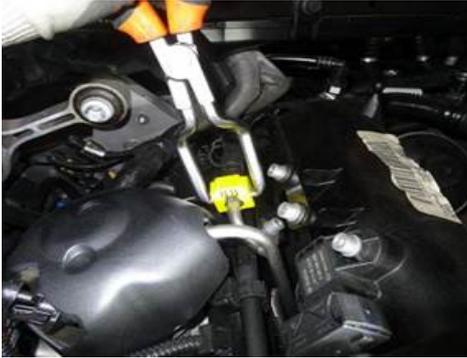
Fig.5

7. Disconnect the engine fuel delivery line from the body fuel delivery line with pinch pliers (e.g. Mac Tools P11LRGLA, 11" pliers) as shown in Fig. 5.
8. Remove the engine fuel delivery line. (Fig.6)
9. Remove the l/s and r/s central underbody panels as shown in sections 9.14.043 – 00 and 9.14.044 – 00 of the Workshop Manual.
10. Position a hydraulic lift with a brace to support the fuel tank as shown in Fig.7.

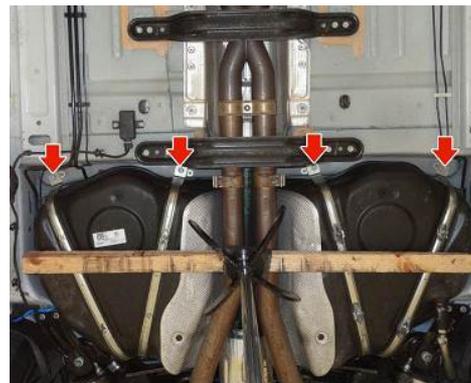
Fig.8

11. Remove the bolts on the fuel tank support straps. (Fig.8)
12. Lower the fuel tank just enough to unclip the fuel delivery line from the 4 clamps located between the fuel tank and the chassis. (Fig.9 and Fig.10)

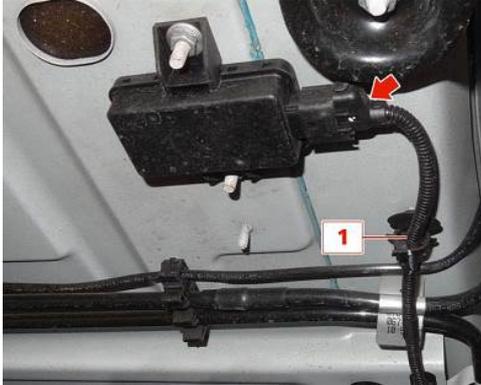
Fig.11

13. On the TPMS sensor, unlock the safety tab and disconnect the wire connector, then release the harness fastener (1 in Fig.11).

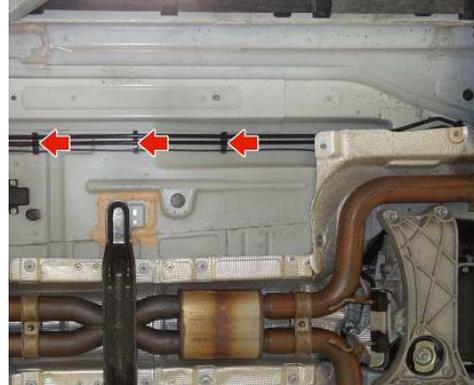
Fig.12

14. Unclip the fuel delivery line from the 3 fastening clamps. (Fig.12)
15. Remove the heat shield screws and the fasteners (1) then remove the 2 heat shields as shown in Fig.13 and Fig.14.

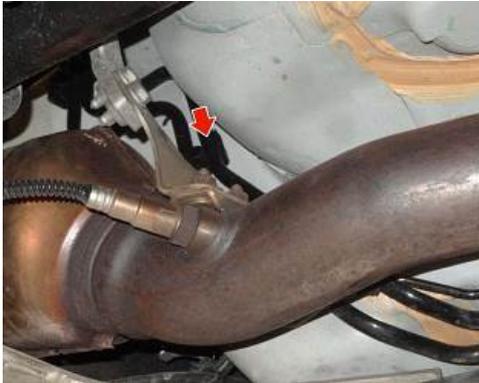
Fig.15

16. Unclip the fuel delivery line from the clamps located between the engine and the r/s dome. (Fig.15)

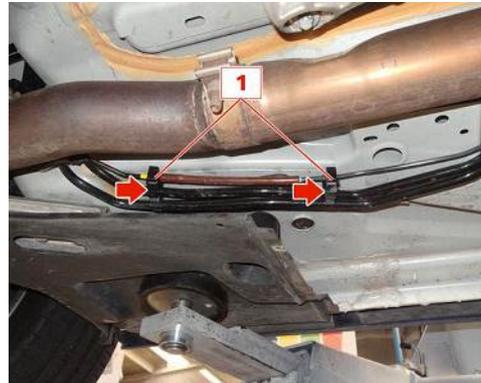
Fig.16

17. Unclip the fuel delivery line from the lower 2 clamps. (1 in Fig.16)

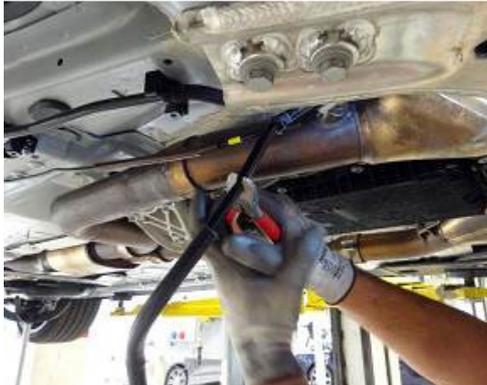
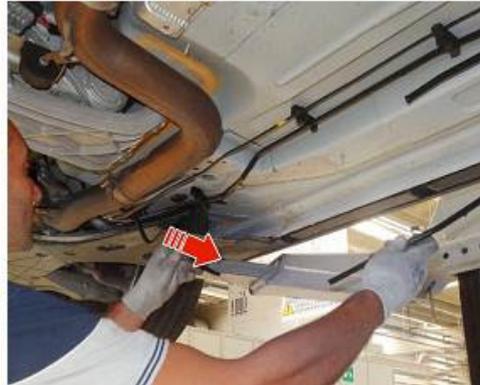
Fig.17

18. Cut the old fuel delivery line (Fig.17) to facilitate the next several steps.

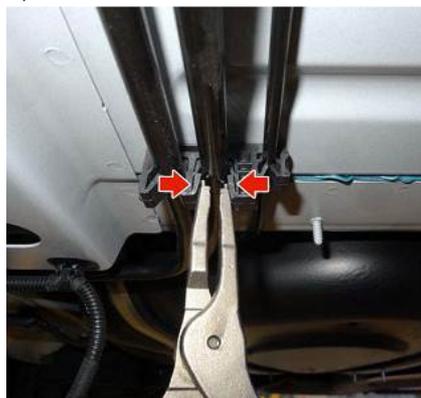
Fig.18

19. With snap ring pliers, loosen the clamps and remove the remaining sections of the fuel delivery line. (Fig.18)

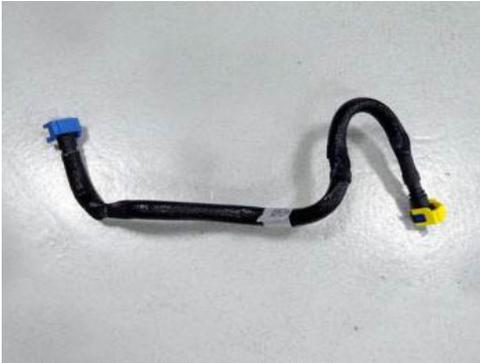
Fig.19

20. Install the new engine delivery line (Fig.19) into the engine compartment clamps. (Fig.20)

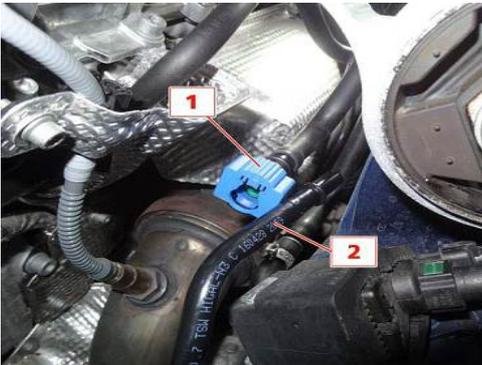
Fig.21

21. Attach the new body delivery line (2) to the engine delivery line (1) and snap the lock closed. (Fig.21)

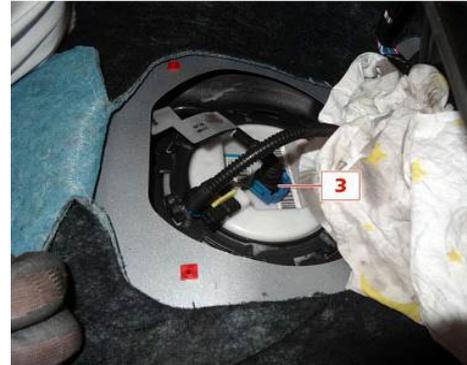
Fig.22

22. Attach the new tank delivery line to the fuel pump. (3 in Fig.22)

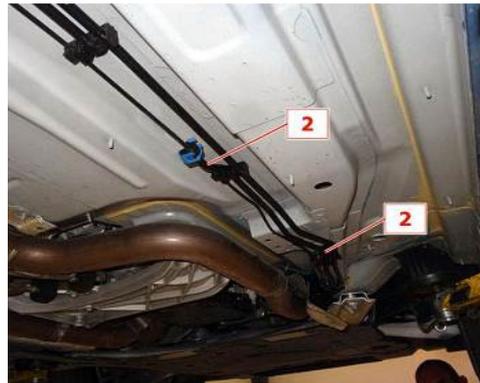
Fig.23

23. Snap the new delivery line into the securing clamps. (2 in Fig.23)

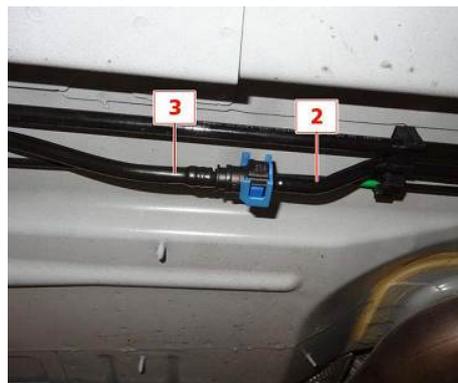
Fig.24

24. Attach the new tank delivery line (3) to the new body delivery line (2) and snap the lock closed. (Fig.24)

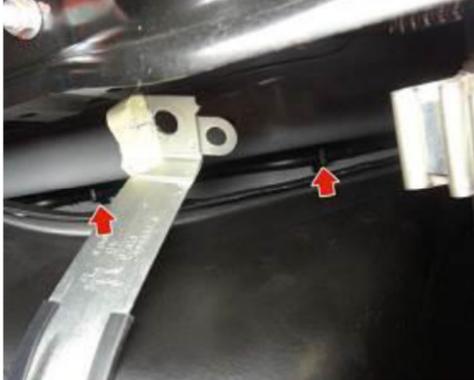
Fig.25

25. Snap the new tank delivery line into the securing clamps above the fuel tank.  
(Fig.25)

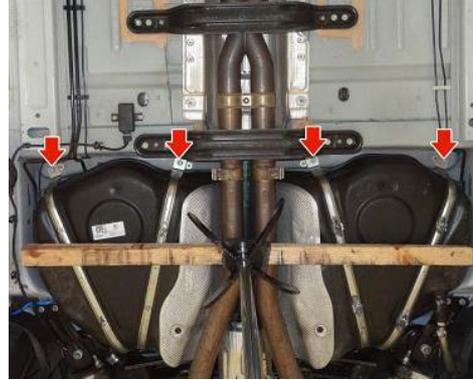
Fig.26

26. Tighten the fuel tank strap bolts to 35Nm. (Fig.26) and remove the lift.
27. With the new fuel delivery lines installed and secured, perform the following function test of the system before re-installing the rear seat cushion.
- Cycle the ignition to the run position and leave on for 30 seconds, during these 30 seconds inspect the connections and tubing for any signs of fuel leakage.
  - Repeat the ignition cycle one additional time prior to cranking engine. Verify that there are no leaks in the system.
28. Re-install the remaining components.
