**DATE:** August 9, 2022  
**TO:** Blue Bird Owners  
**SUBJECT:** Recall R17YY, Vision Chassis Mounted Battery Box Supports

**Subject: RECALL R17YY, Vision Chassis Mounted Battery Box Supports**

# VISION CHASSIS MOUNTED BATTERY BOX SUPPORT

The chassis mounted battery box support brackets may develop cracks or fracture and could allow the battery box to separate from the chassis and fall.

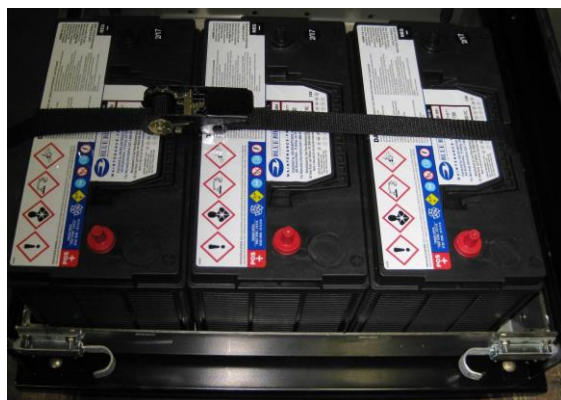
THREE GROUP 31 BATTERIES

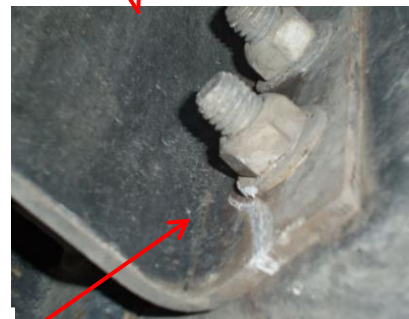
Crack may be in vertical bend.

Example shown of vertical crack at lower hole. Cracks may be vertical or horizontal to one or more holes.

| | | <u>Choose Bus Battery Option</u> | |
|---|---|---|---|
| | <b>Front battery box frame mounting bracket CRACKS-</b> at <u>one</u> bolt hole or in the bends of bracket | Repair C | Repair C |
| | <b>Front and Rear battery box frame mounting bracket CRACKS-</b> at <u>more than one</u> bolt hole or bend of either bracket | Repair D | Repair D |

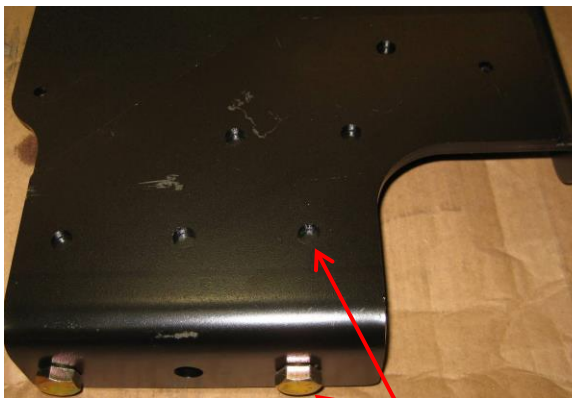
Temporary install two 1/2 inch capscrews with standard nuts and tighten. Drill six 3/8 inch diameter holes using the reinforcement as guide.

2. On the bench, assembly install new high strength steel front frame battery bracket 10049663 and front (LH) reinforcement bracket 10054519 together with two (2) 1/2 inch capscrews 00803239 and standard nuts (not included in kit) and tighten nuts.

3. Using the front (LH) reinforcement bracket 10054519 as a guide, drill six (6) 3/8 inch diameter holes.
4. Install six (6) 3/8 inch capscrews 00559195, flat washers 01107085, and flange locknuts 00543934. Install one (1) 1/4 inch capscrew 00870477, flat washer 01991108, and locknut 02001345. Leave all fasteners loose; do not torque until assembly has been installed on the chassis.

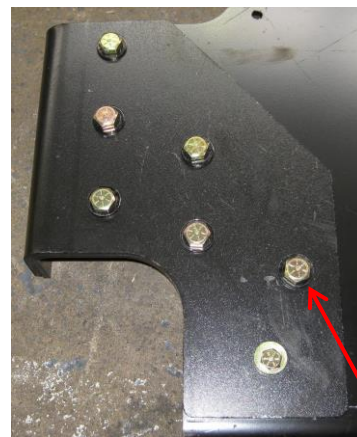
Install all the fasteners attaching the reinforcement to the front frame battery bracket and leave loose until installed onto chassis frame.
