NUMBER: 5.84.17.001.01**DATE: February 2017****MODEL: Model Year 2012 Fisker Karma****TITLE: Remedy - Takata Front Passenger Airbag Inflator Module****PRIORITY:** All Vehicles in Operation**APPLICABILITY:** ALL**MARKET REGIONS:** ALL**PURPOSE:** This document highlights the removal of the recalled Takata Airbag and installation of the new provided part.

Safety Recall Notice (Remedy)
2012 Model Year Fisker Karma – Front Passenger Airbag Inflator Module
Important Information Enclosed

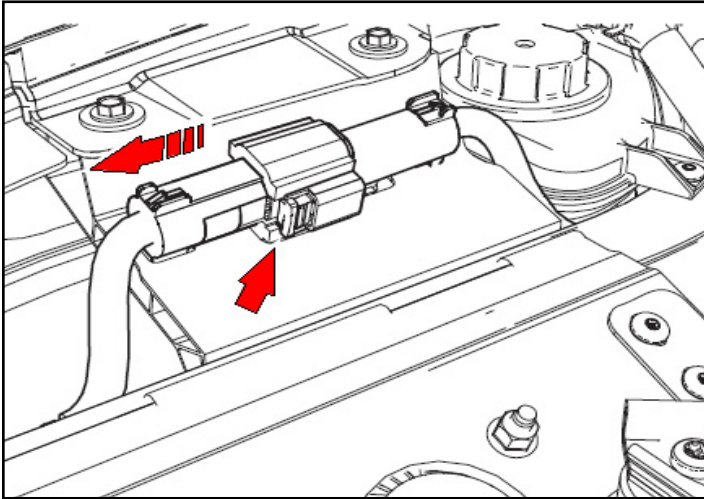
Open hood and both front doors as preparation for the procedure. Disconnect the 12 V battery cable as shown: (located on the passenger hand strut tower).

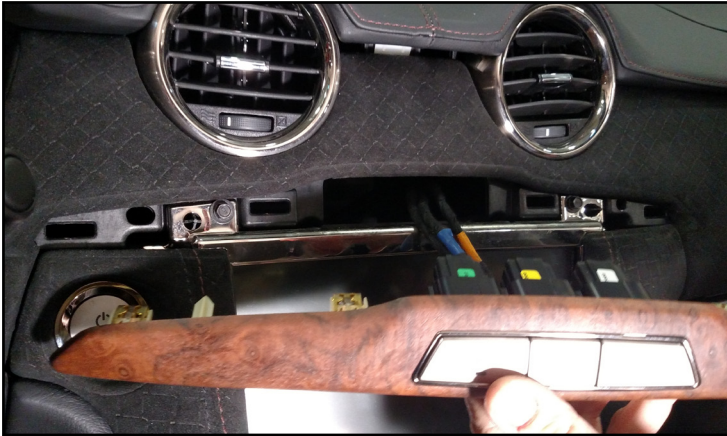
Fig.1

Remove the center console jewel trim piece by pulling forward, unplug the connectors, mark their locations with the switch as the center and one outer plug are interchangeable. (Fig.1)

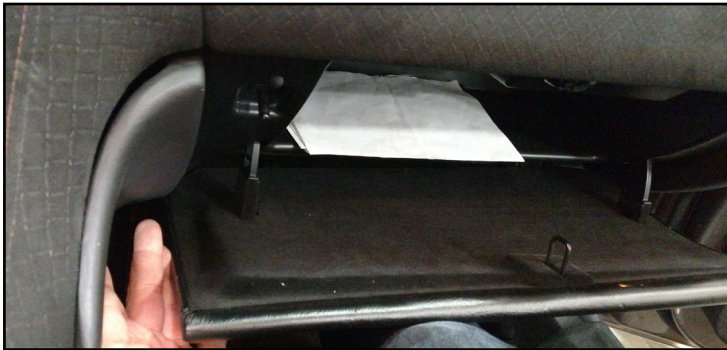
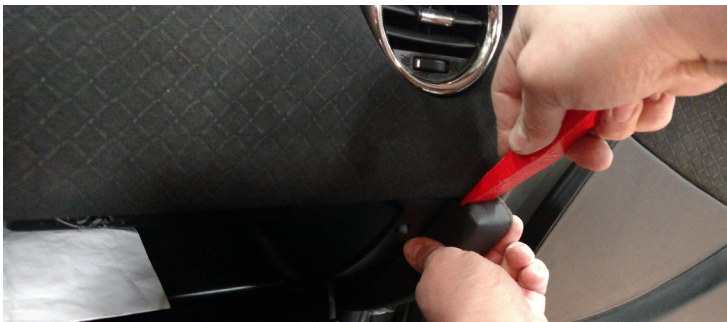
Fig.2a

Open the glove box and Remove side console trim around glove box. Pull firmly towards you to release clips, use the bone tool for assistance. (Fig.2a and b)

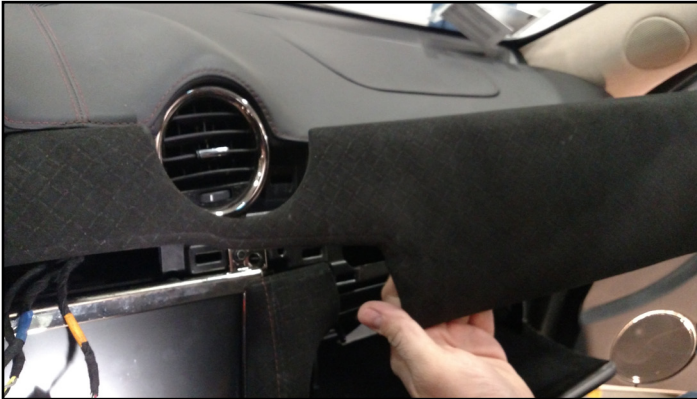
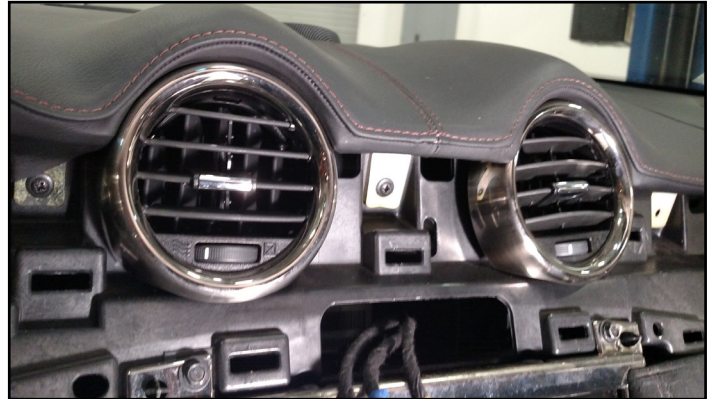
Fig.3a

Remove the dash board cover piece. Pull out from clips firmly, use the bone tool for assistance (Fig 3a and 3b).

Fig. 3b Shown with cover piece removed.

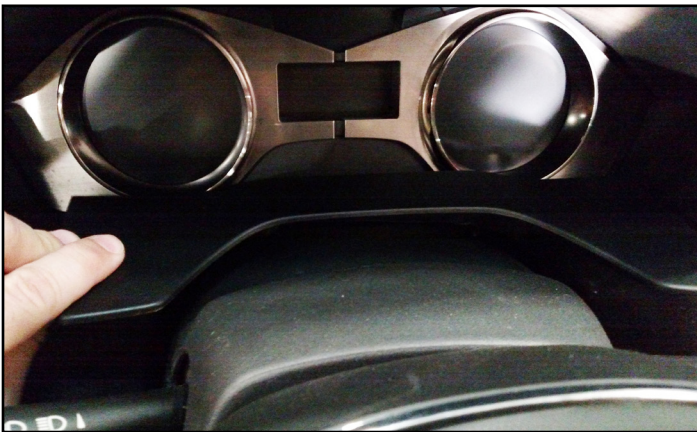
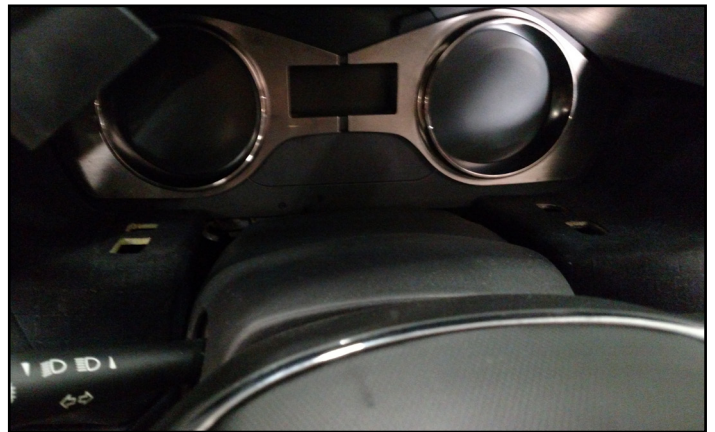
Fig.4a

Remove the gauge cluster cover panels as shown (Fig. 4a and 4b).

Fig.4b Shown with cover panel removed.

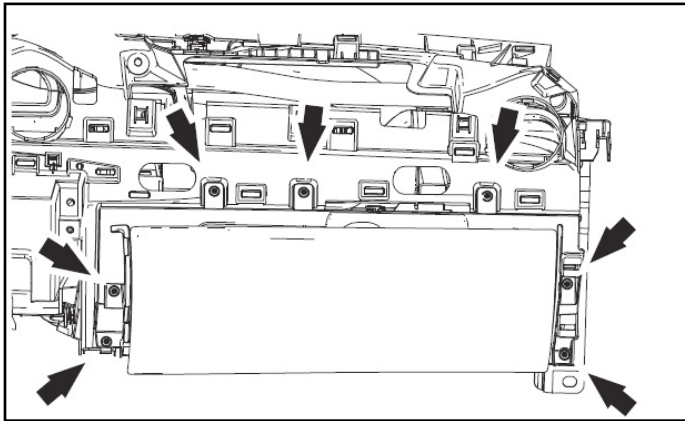
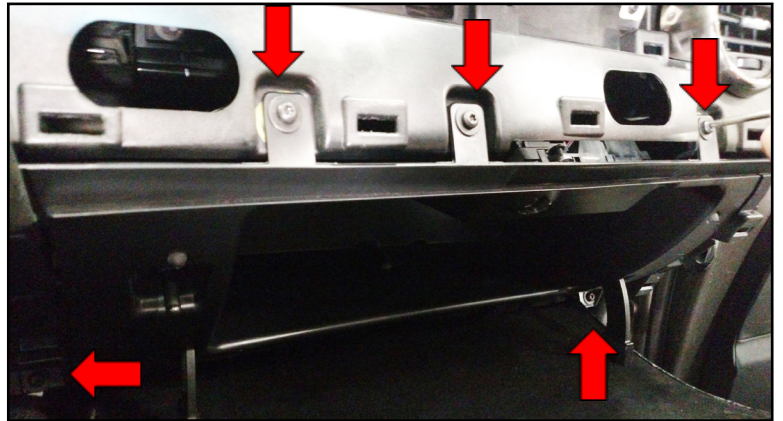
Fig. 5a

With the glove box bolts now exposed, use the T25 torx bit undue the fasteners (7) securing glove box to the dash panel and remove the glove box (10Nm torque) (Fig. 5a and Fig. 5b).

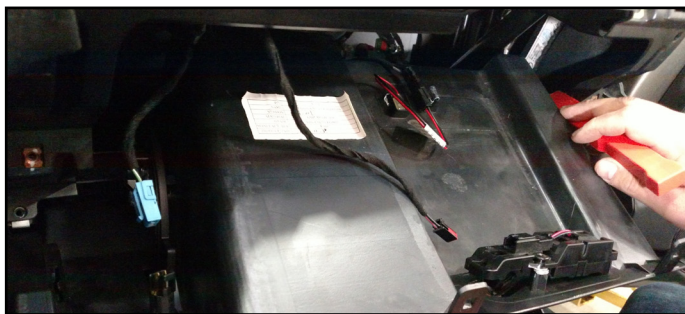
Fig. 6

Unplug glove box connectors (Fig. 6).

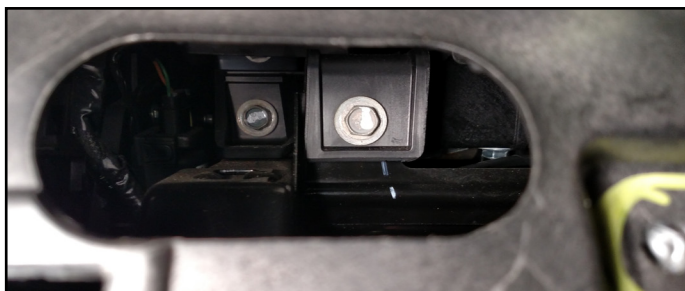
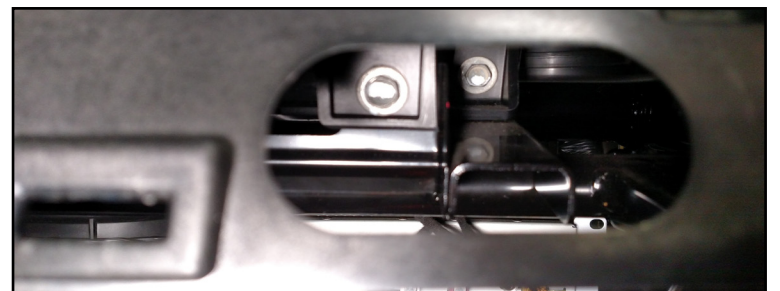
Fig. 7a

The air bag lower bolts are now visible (Fig. 7a and 7b).

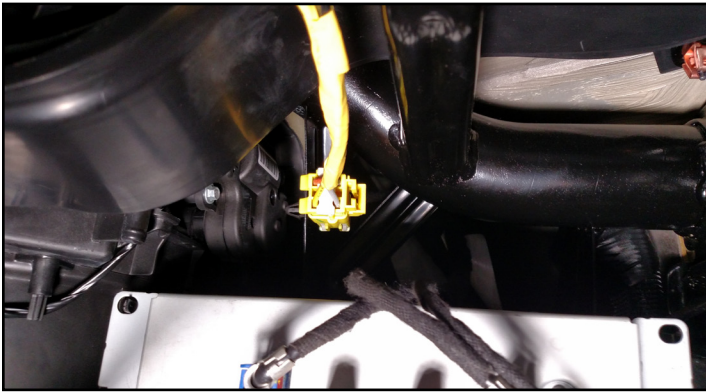
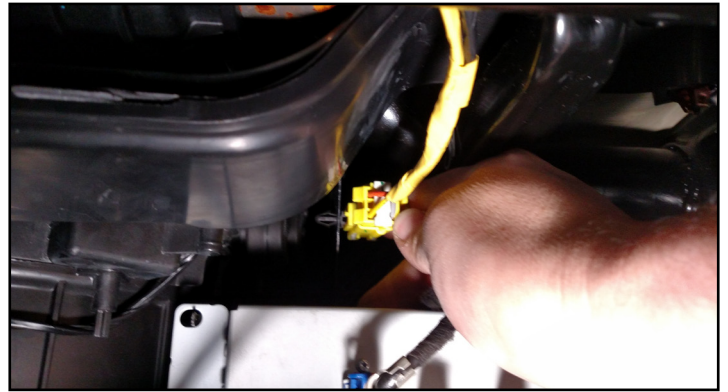
Fig. 8a

Disconnect the airbag harness clip and the airbag connector (Fig 8a and 8b).

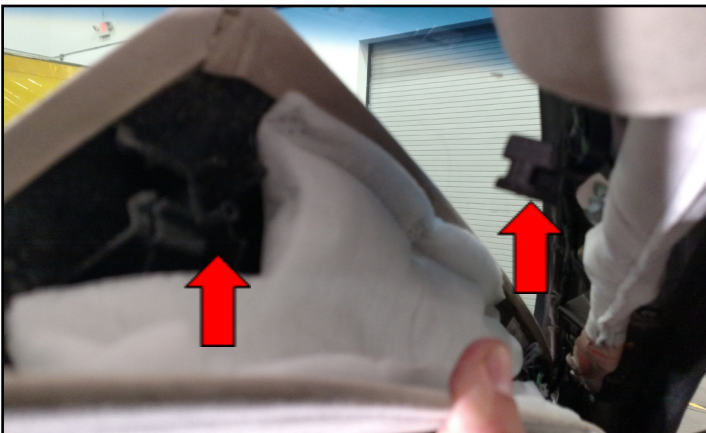
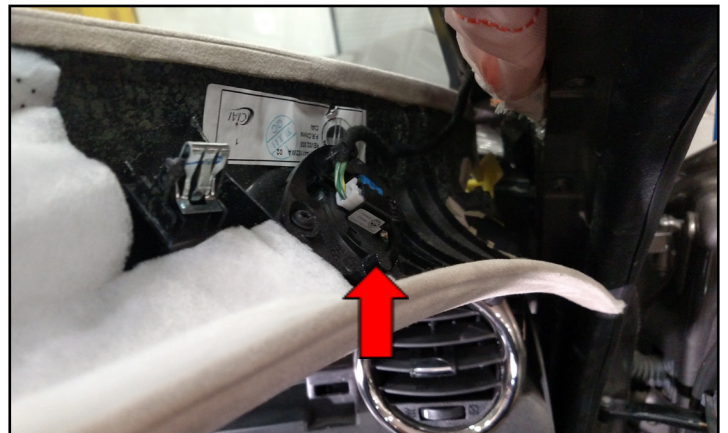
Fig. 9a

Remove the A-pillar. Remember to remove the tether clip from the top portion by sliding it out of the A-pillar (Fig.9a and 9b).

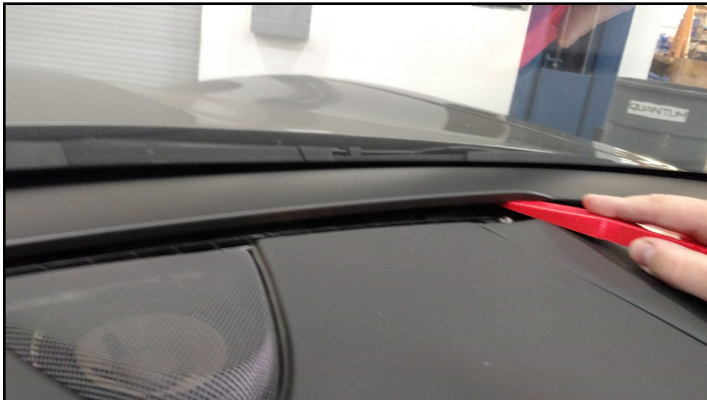
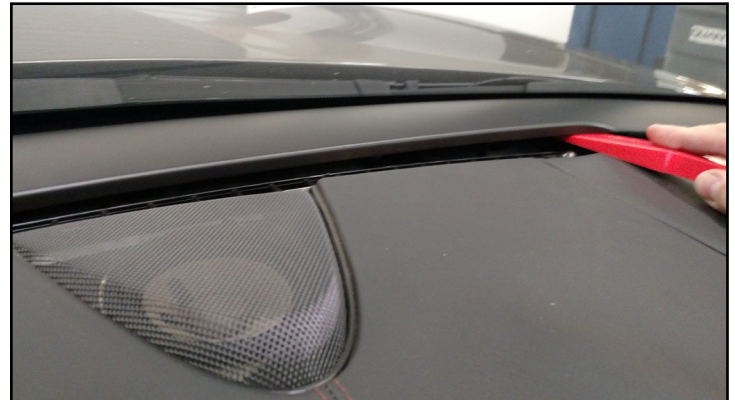
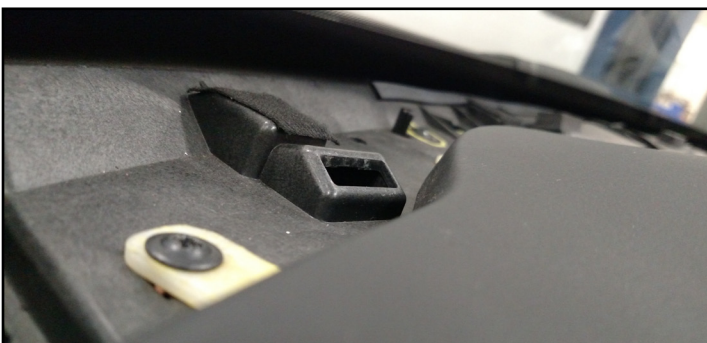
Fig. 11a

Remove the dash pad finisher. Lift up gently using the plastic bone panel tool for assistance (Fig. 11a and 11b) This will expose the dash pad fasteners

(Fig. 11c).

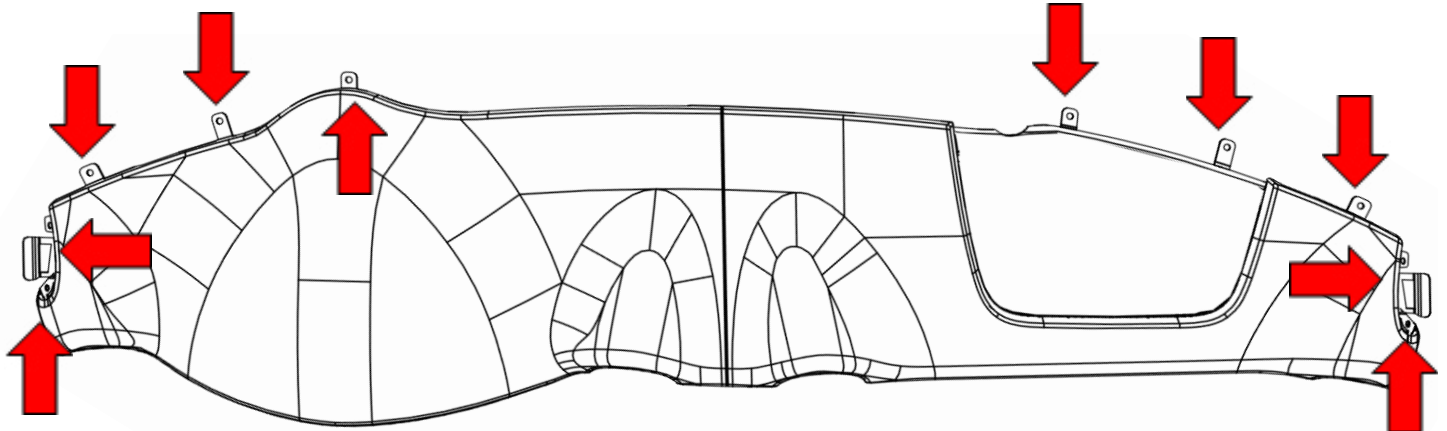
Use the 90 degree bit driver, remove the dash-pad bolts (16). (Indicated by red arrows - Fig. 12a and

12 b). (Install torque 10Nm)

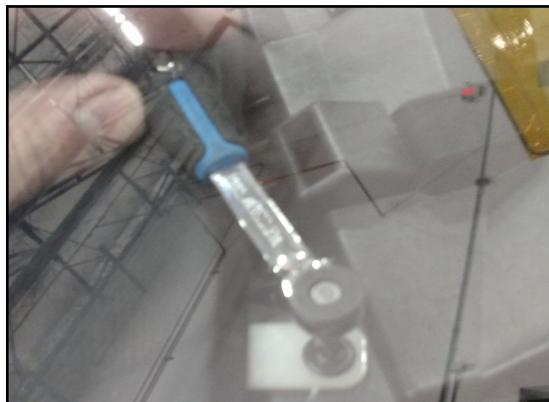
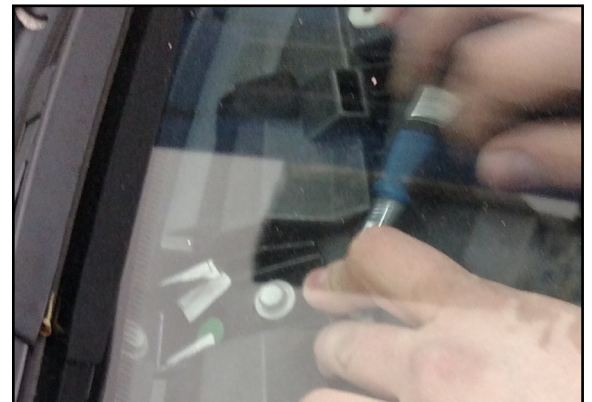
Use of the 90°
bit driver
Fig. 13a and 13b

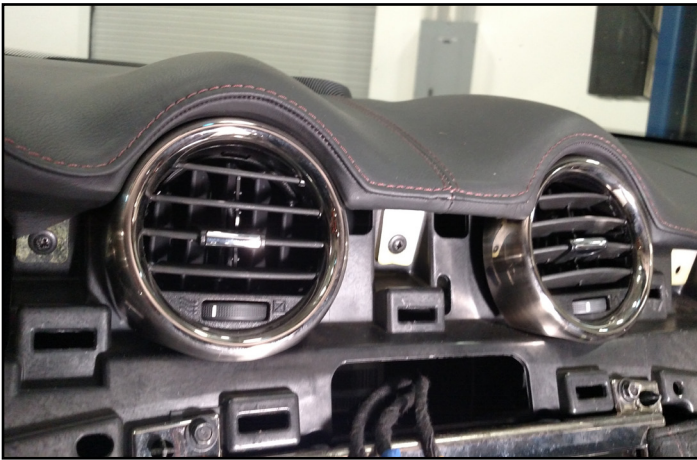
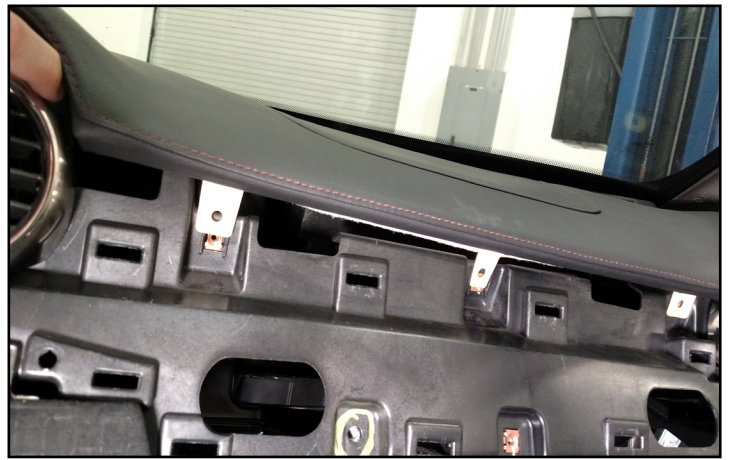
Fig. 14a

Fasteners found on the front face of the dash pad (Fig. 14a and 14b).

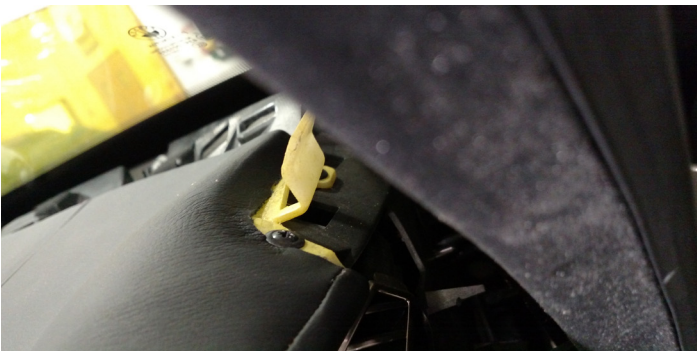
Fig. 15

A “hidden” fastener on the A-Pillar location of the dash panel (Fig. 15).

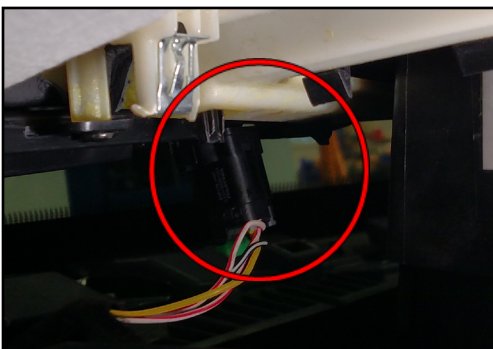
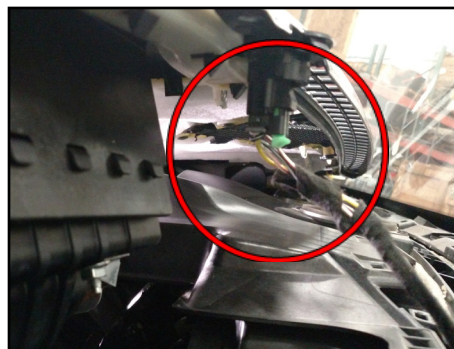
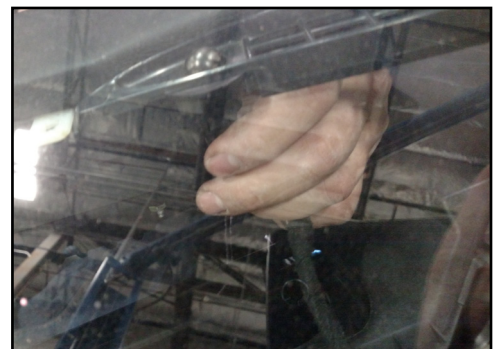
Fig. 16a

The daylight sensor is connected to the center portion of the dash pad base, this can be removed by turning it ninety degrees (90°) in the housing it will slide out without needed to undue the two stage connector on the harness side (Fig. 16a,16b, and 16c).

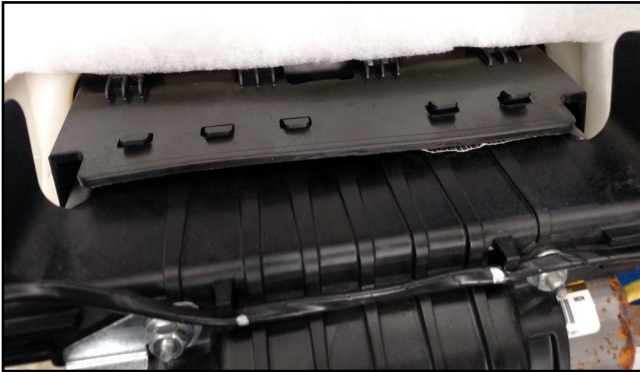
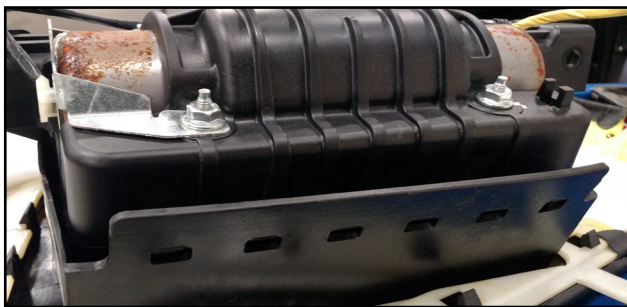
Fig. 17a

Remove the dash pad, and turn over. Place on a safe fabric covered surface to avoid damage to the dash pad surface. (Fig. 17a and 17b)

the airbag is located and secured by clips on the dash pad, release the clips (3) for the harness

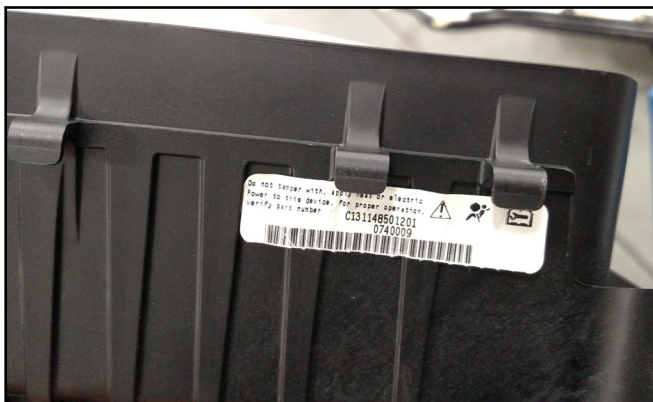
Fig. 18a

Set aside the recalled Takata air bag assembly. (Fig. 18a and 18b)

Part number and serial number visible.

Store the airbag module with the deployment side facing up. This will prevent it from being propelled if accidentally deployed which may cause injury.

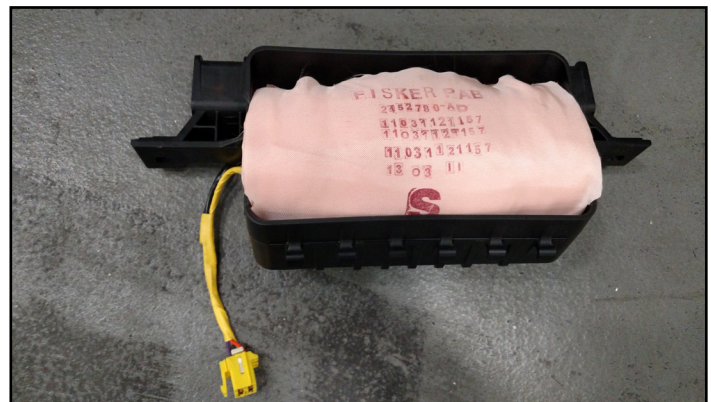
Fig. 18b

The recalled air bag unit when removed, notice the "Fisker PAB" printed label.

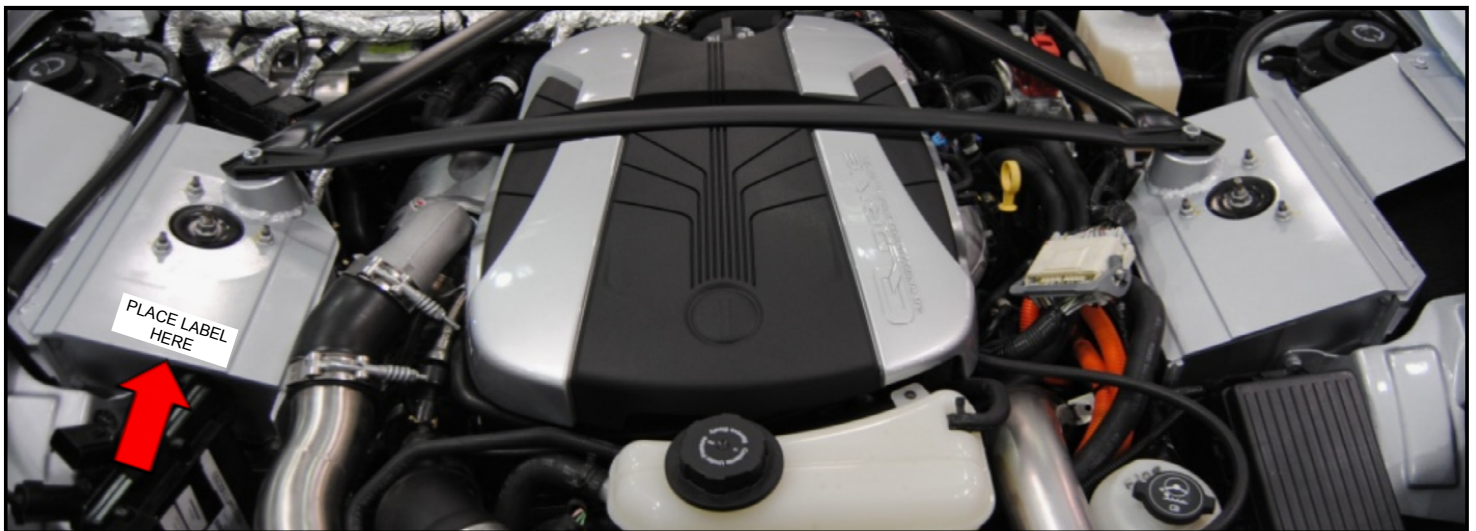
Fig. 20

Please apply label (Fig.19) to the location indicated on the passenger side shock tower (Fig. 20). This will indicate the recall has been performed and is required to ensure compliance with the Takata Airbag recall.
