# Maserati Technical Bulletin

Date: June 26th, 2017  
Bulletin No. – MAS001282 - Front Seat Wiring Harness  
Inspection/Replacement  
Recall Campaign - 342  
Supersedes: N/A

**Subject: Vehicle Safety Recall Campaign 342 – Front Seat Wiring Harness  
Inspection / Replacement**

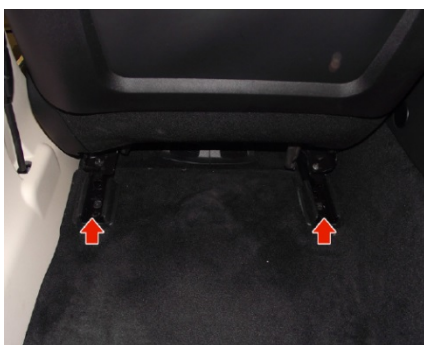
Fig.1

1. Move the L/F seat as forward as possible and then remove the rear mounting bolts. (Fig.1)
2. Move the L/F seat as far back as possible and remove the front mounting bolts. (Fig.2)
3. Disconnect the battery.
4. Carefully tilt the seat back and disconnect the wire connectors. (Fig.3)

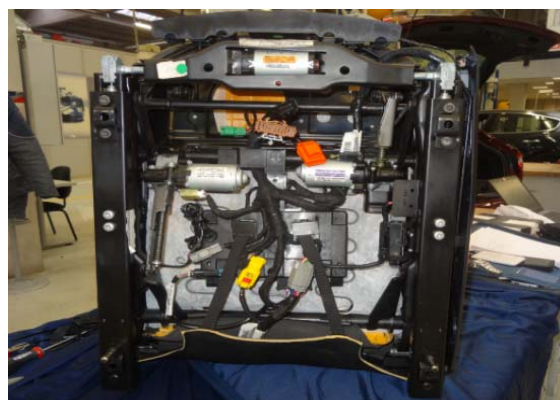
Fig.4

5. Carefully remove the seat from the vehicle and place it on a bench. (Fig.4)

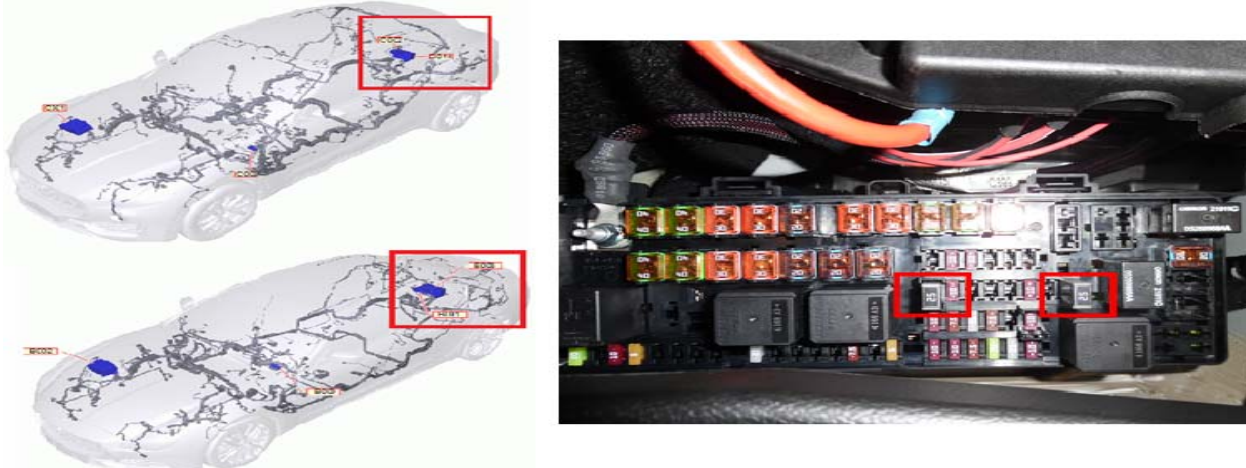
Fig.5

1. With the battery disconnected, remove the 2 circuit breakers (F31 and F38) located in the rear distribution unit (RDU) and install the 2 25A fuses. ( Fig.5.)

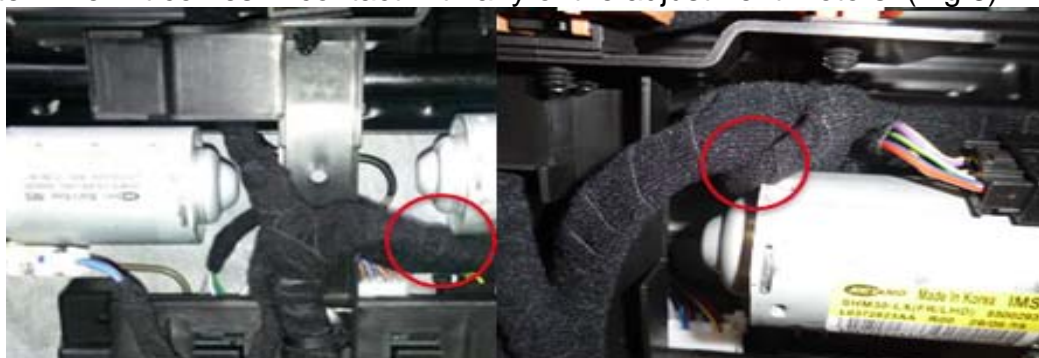
Fig.6

1. With the L/F front seat on the bench, inspect the routing of the wiring harness to determine if it comes in contact with any of the adjustment motors. (Fig.6)

2. If the harness is in contact with the motors (Fig.6), or there are any marks on the harness from contact with the motors (Fig.7), gently bend the harness by hand at the contact point and inspect for any visible signs of copper wiring. (Fig.8)

**NOTE: If the harness is damaged (e.g. copper visible, insulation rubbed through, etc.) the harness must be replaced. Open a BOL and attach pictures of the harness showing the anomaly, then go to Procedure “C” Replacing the Driver Seat Harness.**

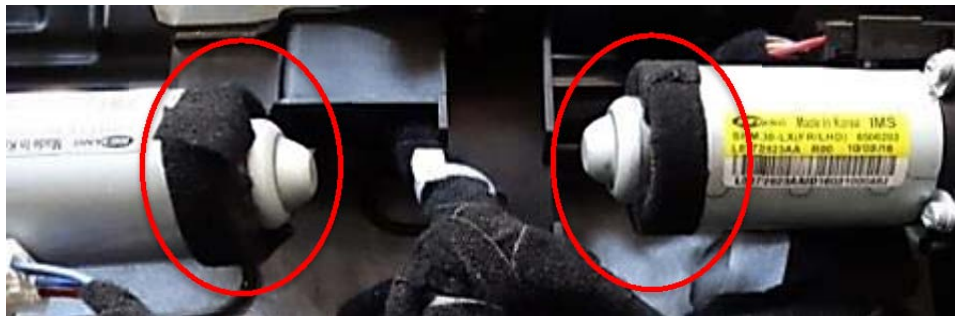
Fig.9

- If the vehicle is equipped with the REAR SEAT ENTERTAINMENT system, the minimum number of tape turns must be 3.
- If the vehicle is not equipped with RSE, the minimum number of tape turns must be 2.
- If necessary, apply the tape to the motors (Fig.9) to meet the above number of turns by following the procedures below.

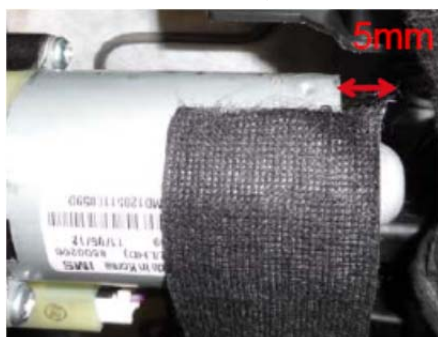
Fig.10

- Apply the tape so that a minimum width of 5mm's (Fig.10) covers the edge of the motor housing as shown in Fig.11.

25. Install the tape on the motors as shown in Fig's 10 and 11 on Page 6.
26. Re-install all of the components removed following the removal instructions in reverse order.
27. Re-connect the battery.
28. Clear any DTC's with the MDEVO.
29. Perform a functional test of the front seat as shown in Fig.15 on Page 7 to be sure it is operating as designed.

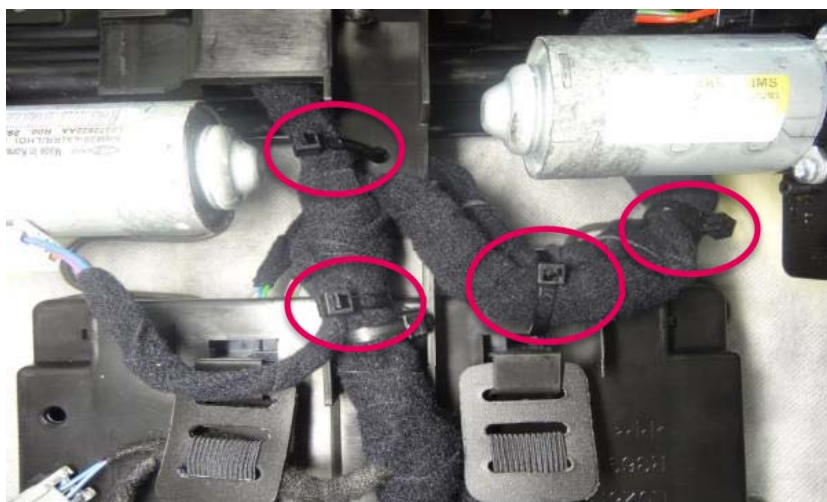
Check the wiring harness routing on the seat. Install the 4 wire ties to the locations circled in Fig.12 to ensure the harness is away from the motor edges.

22. Remove the original wire harness from the carrier. Attach the new wiring harness to the control unit carrier following the layout of the harness as shown in Fig's. 12 and 13 on Page 6.
23. Re-install the harness together with the control unit carrier to the seat.
24. When re-installing the control unit carrier on to the seat springs, make sure the distance between the carrier (Green circles) and the seat motor bracket (Red circles) is between 52 and 53 mm's. (Fig.39 and Fig. 40)

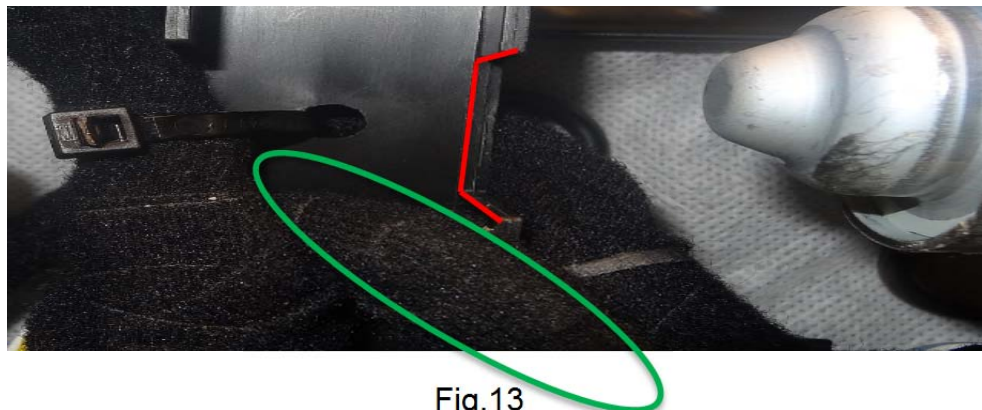
Fig.13

**WARNING:** Pay attention to the routing of the cable circled in green; the cable **MUST NOT** pass through the trimmed portion of the plastic carrier (red line). (Fig.13)

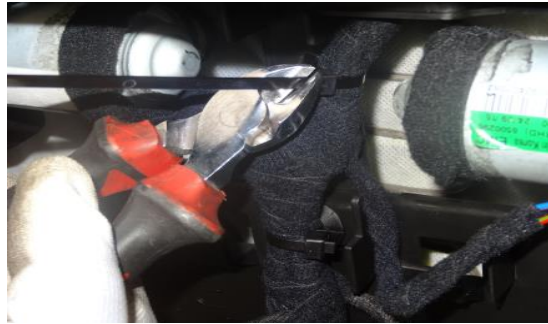
Fig.14

Cut the excess portion of the wire ties as shown below in Fig.14.

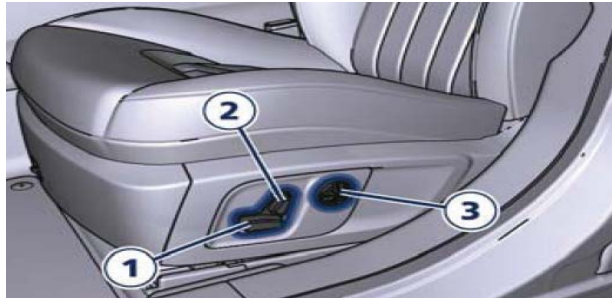
Fig.15

7. Perform a functional test of the front seat. (Fig.15)
8. If the functional test is positive, the procedure is complete.
9. If the functional test is negative, perform a diagnosis on the seat ECU.

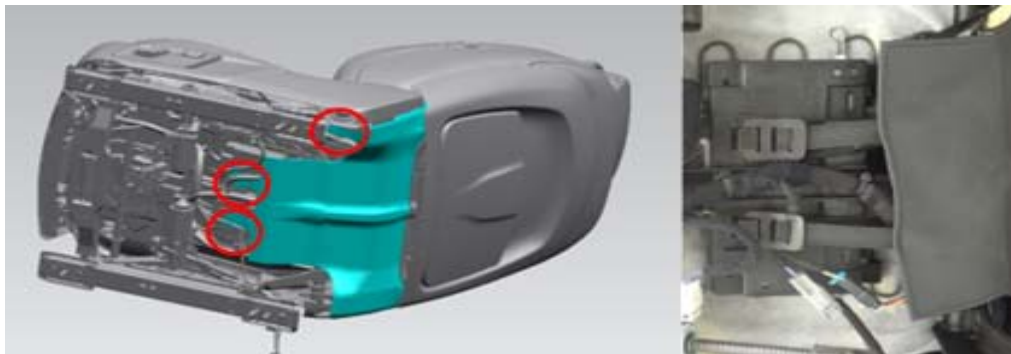
Fig.16

1. Lay the seat on its side and remove the leather wing from the carrier and seat frame.(Fig.16)

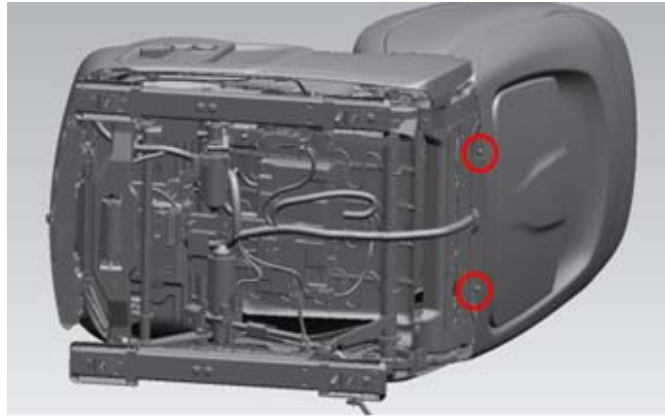
Fig.17

2. Remove the screws from the back panel. (Fig.17)

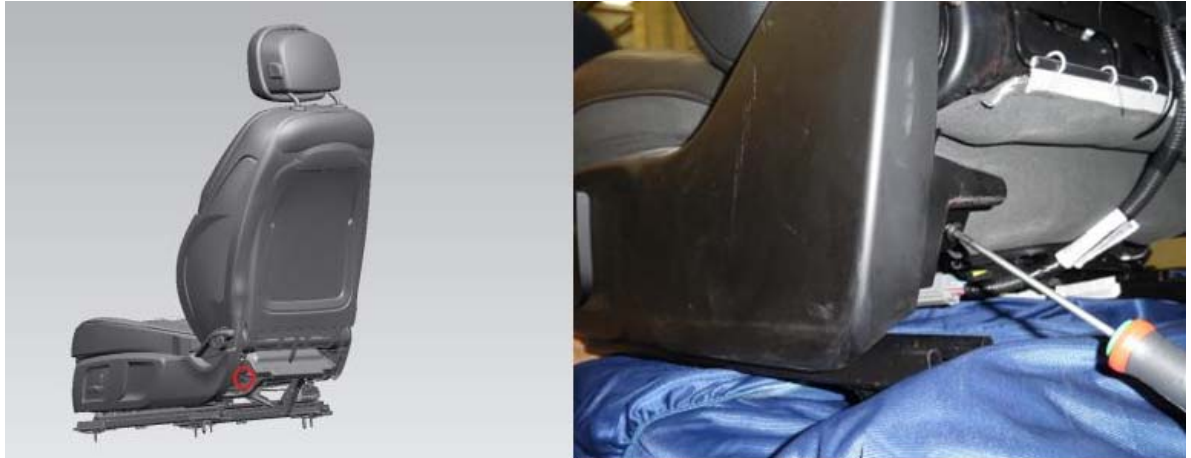
Fig.18

3. Stand the seat up and then remove the side trim screw. (Fig.18)

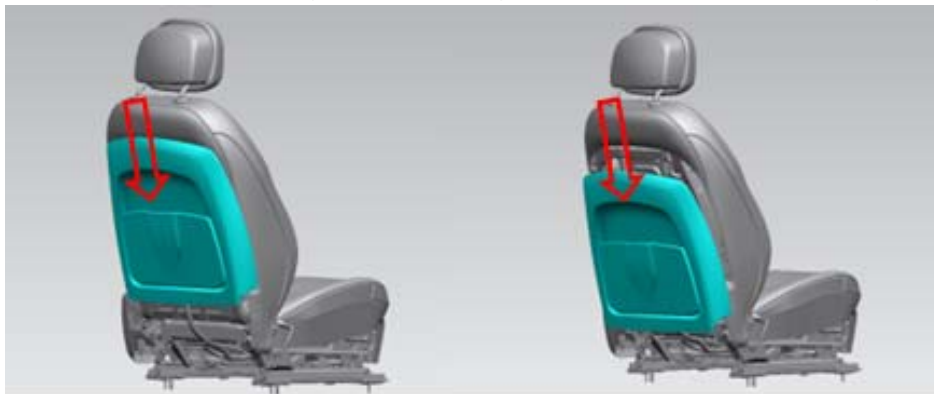
Fig.19

4. Remove the back cover by gently pushing the back cover down. (Fig.19)

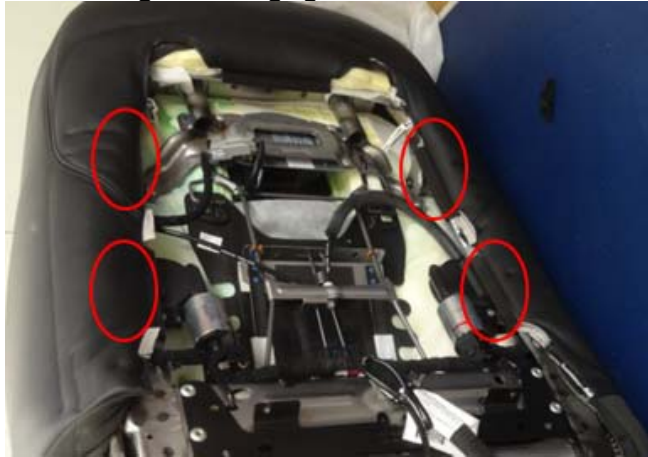
Fig.20

- Using a Teflon wedge, disengage the leather from the frame. (Fig.20)

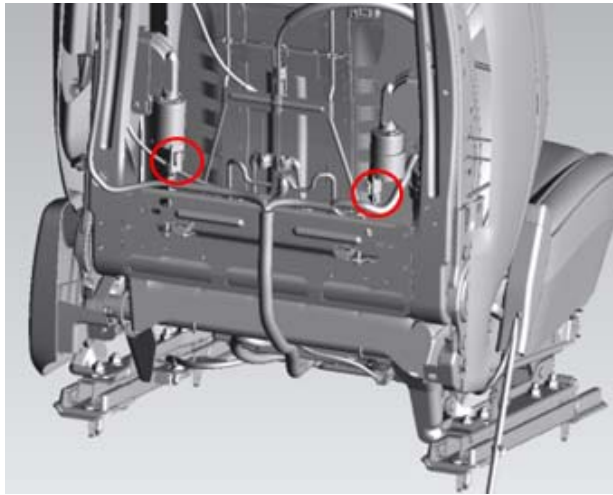
Fig.21

- Disconnect the electrical connectors from the motors. (Fig.21)

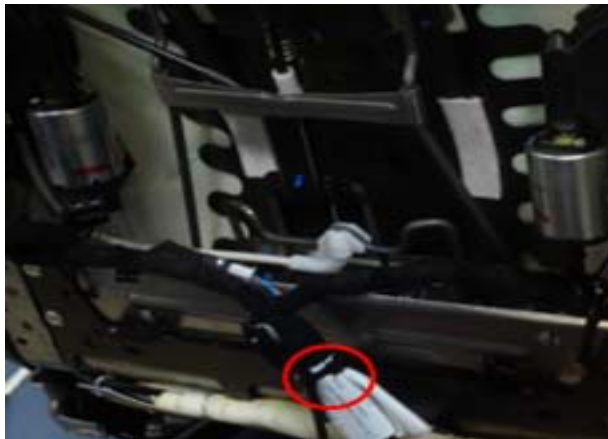
Fig.22

- Remove the wire tie. (Fig.22)

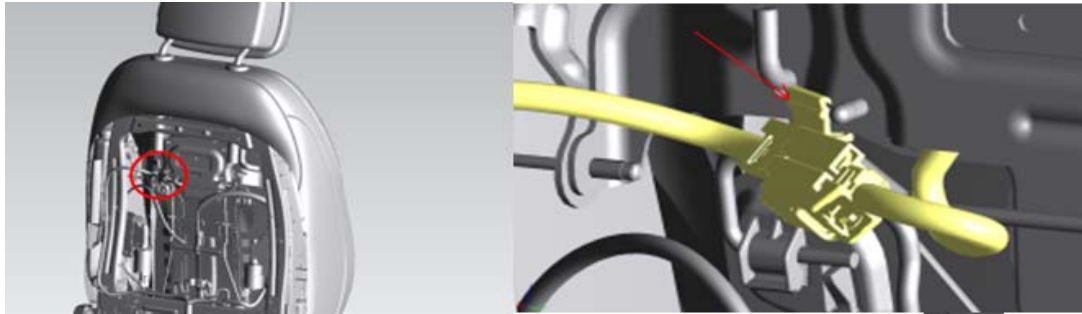
Fig.23

8. Disconnect the circled connector and remove the clip from the seat. (Fig.23)

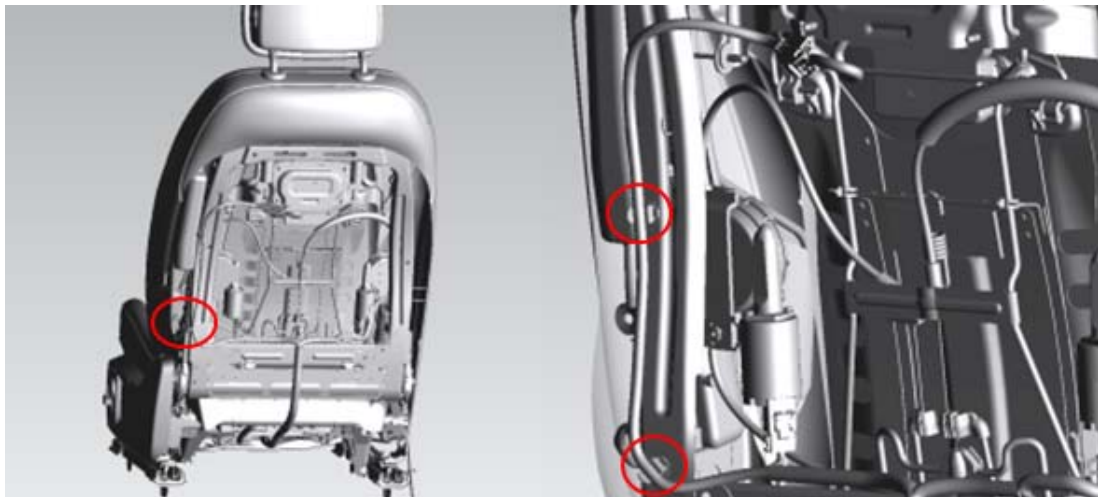
Fig.24

9. Remove the connector and then the wire harness from all of the clips. (Fig.24)

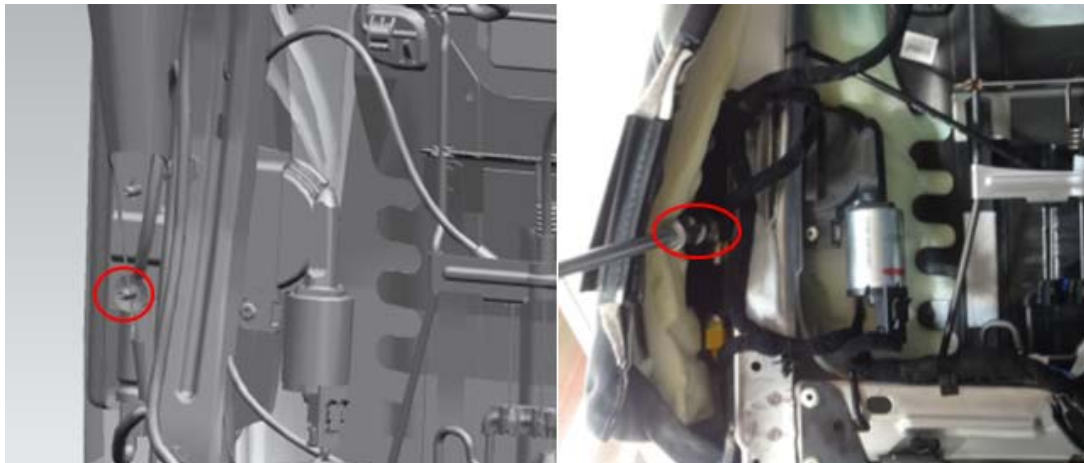
Fig.25

10. Remove the harness fastener and the ground connection. (Fig.25)

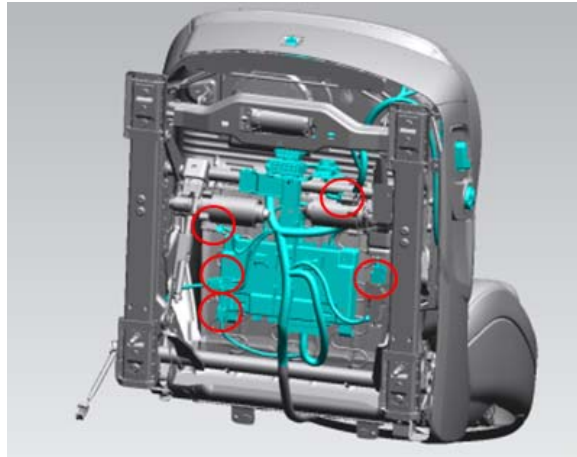
Fig.26

11. Position the seat as shown and disconnect all of the remaining electrical connectors. (Fig.26)

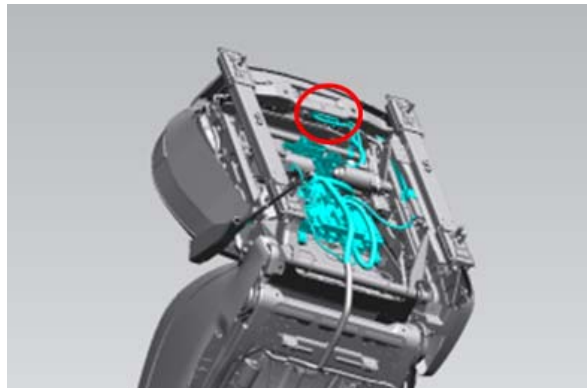
Fig.27

12. Disconnect the front motor connector. (Fig.27)

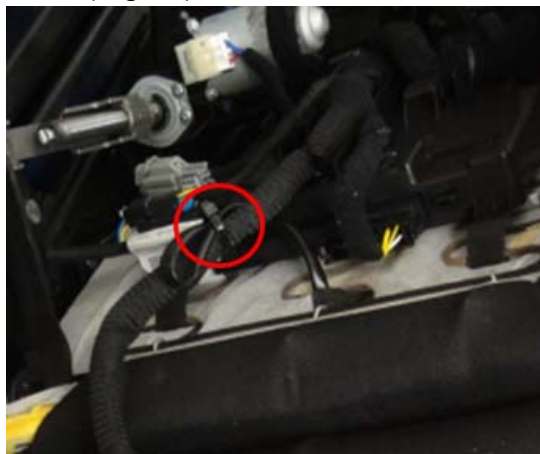
Fig.28

13. Remove the wire tie. (Fig.28)

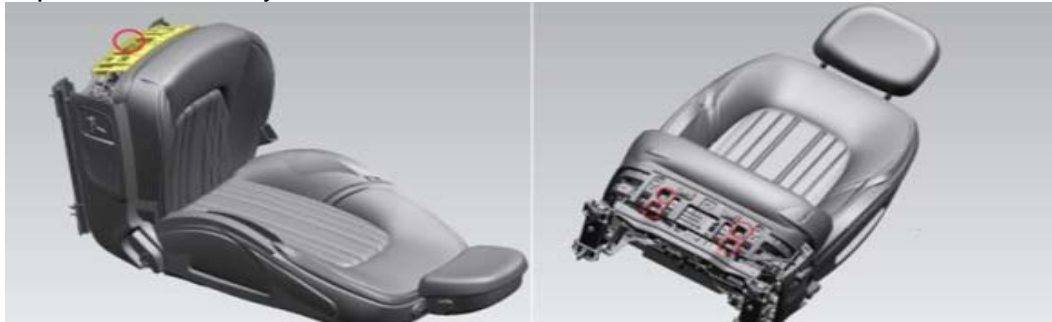
Fig.29

14. If equipped, remove the switch (Fig.29) and the mounting plate (Fig.30) for the pedal control adjustment.

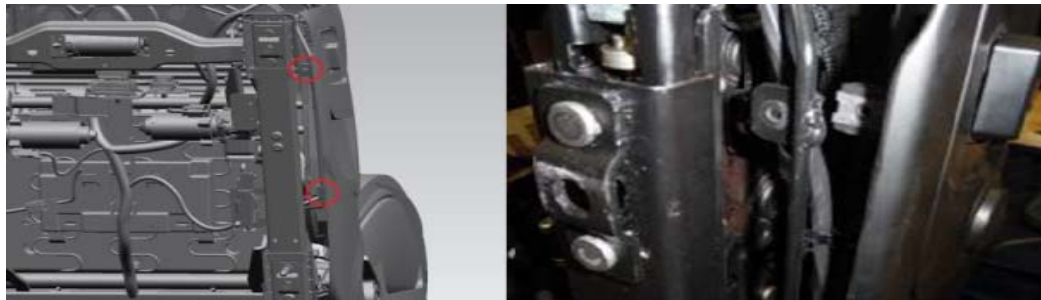
Fig.31

15. Remove the screws (red circles), then gently pull back the trim. (Fig.31)

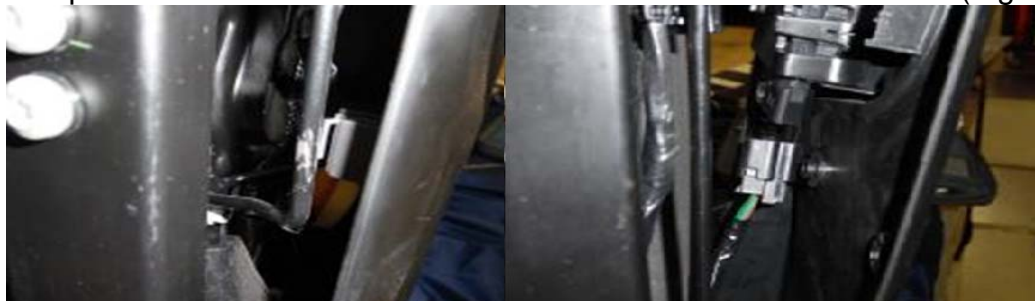
Fig.32

16. Unsnap the trim and remove the electrical connector from the switch. (Fig.32)

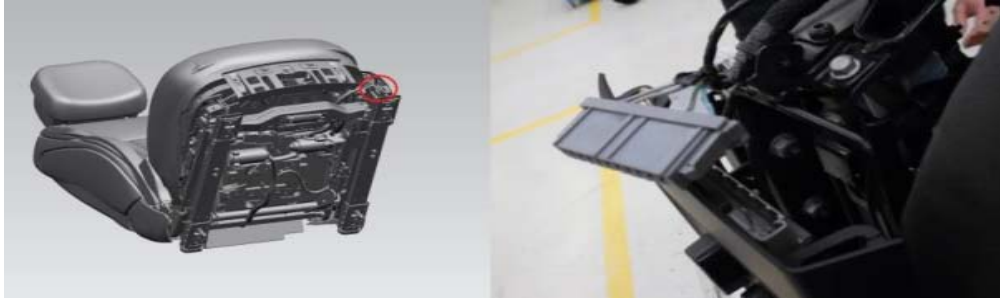
Fig.33

17. Disconnect the lower front electrical connector circled in red. (Fig.33)

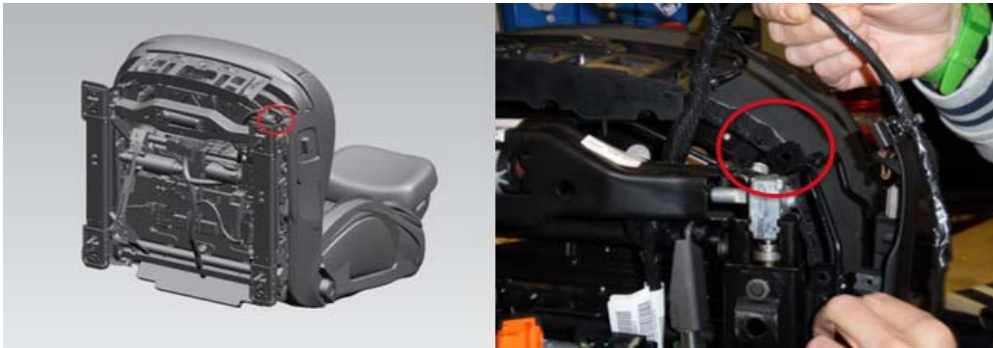
Fig.34

18. Unsnap the cable clip then remove the wire harness. (Fig.34)

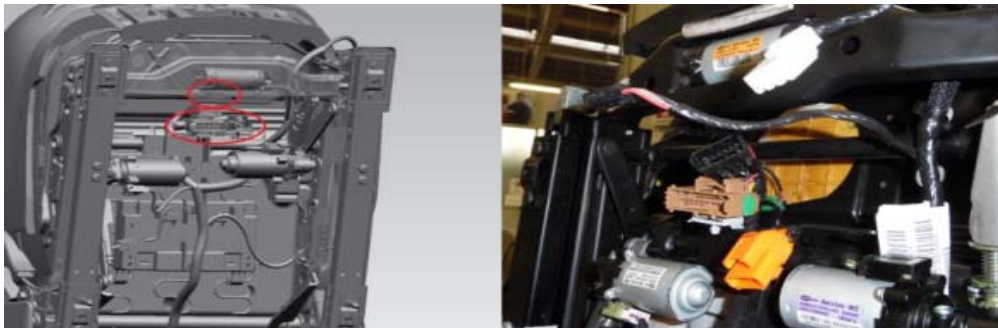
Fig.35

19. Disconnect the upper connector from the frame. (circled in red, Fig.35) then disconnect the wire connectors from the seat motors.

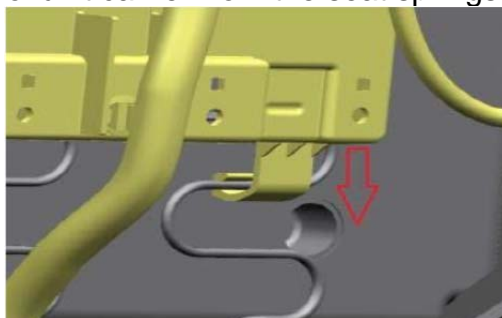
Fig.36

20. Unhook the control unit carrier from the seat springs by pulling down (Fig.36)

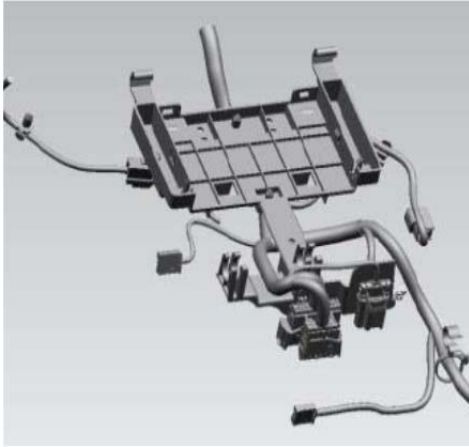
Fig.37

21. Remove the control unit carrier (Fig.37) together with the wire harness and the seat control unit. (Fig.38)
