F/CMVSS Noncompliance Recall

17035 Front Seat Discrepant Welds on Manual Recliner Bracket

Reference Number: N162075000

Revision: 02

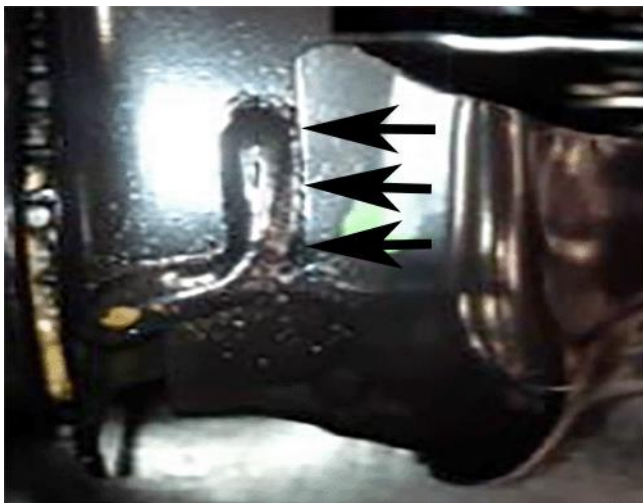
4690696

Bad Weld: weld not contacting the edge of the bracket

This procedure involves seat cushion frame to recliner bracket welds that may be improperly located. The weld may be located next to the joint area instead of joining the two pieces. When inspecting the welds, use the example photos above to determine the proper installation of the weld in relationship to the bracket.

9. If any of the welds or alignment holes are not correctly positioned, replace the seat back cushion frame. Refer to *Driver or Passenger Seat Back Cushion Frame Replacement* in SI.
10. Reinstall all of the seat trim.
11. Perform steps 1-10 on the driver side manual seat if equipped. Do not remove, disassemble or replace the seat frame of a power seat assembly.
12. Reinstall the seat(s). Refer to *Driver or Passenger Seat Removal and Installation* in SI.

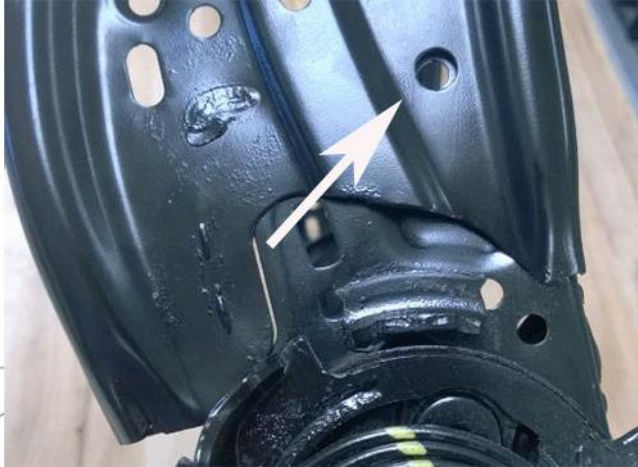
4691254

Alignment Hole Inspection Area

4. Remove the inner recliner finish cover. Refer to *Driver or Passenger Seat Inner Recliner Finish Cover Replacement* in SI.
5. Release the J-channel at the base of the seat cover (seat back cover retainer).
6. Pull the seat back cover up from the bottom, do not remove the cover. Allow enough room to inspect the inner and outer recliner brackets. Lift the foam cushion away from the inspection area. Inspect the welds from the front side of the seat assembly.
7. From the outside of the seat frame assembly, inspect the inner and outer recliner bracket alignment holes. Inspect the holes for proper alignment. Ensure the smaller hole of the recliner bracket is fully visible through the larger hole in the side of the seat frame bracket.

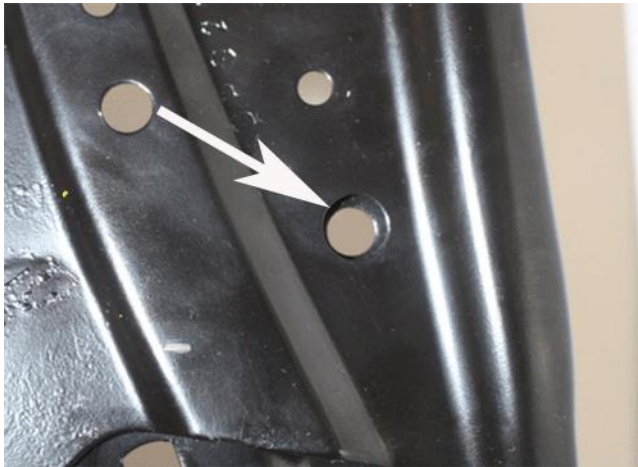
4691232

Acceptable Condition, Holes Aligned

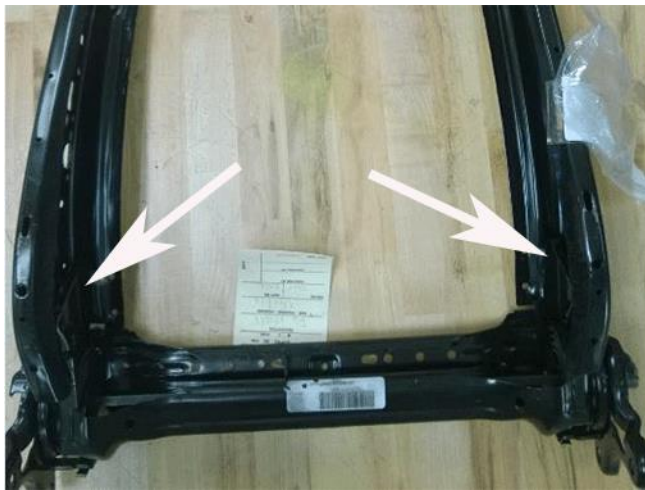
4690698

8. Inspect the inner and outer recliner bracket to seat frame weld locations. There are three welds per side. Ensure the weld is located on the edge of the bracket and connects to the seat frame.
