Fuel Tee Leak

Title	17KWA: Fuel Tee Leak
Search Words	Fuel, tee, leak, recall
Bulletin No.	17KWA
What's New Abstract	Safety Recall - Fuel Tee Leaking on Models K370, T680, and T880 2017 emissions vehicles.
Supplier	VOSS
Description	Fuel Tee Leaking on Models K370, T680, and T880 2017 emissions vehicles
Release Date	03/31/2017
Introduction	Kenworth Truck Company has decided that a defect, which relates to motor vehicle safety, exists in certain model K370, T680, and T880 vehicles manufactured from November 18, 2014 through January 18, 2017.
Situation	The vehicles may have been built with a defective fuel tee fitting that leaks. A manufacturing process control for the fuel tee was out of specification, which may have allowed the part to become porous, allowing a fuel leak during operation.
Resolution	Fuel tees will be replaced on vehicles equipped with suspect fuel tees. Select vehicles require installation of a new bracket. See chassis list below for chassis-specific parts required.

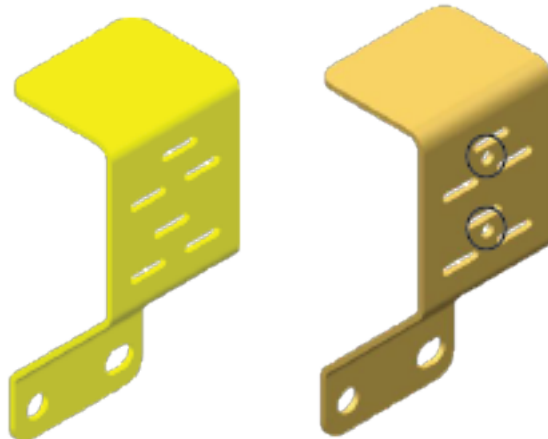
Figure 1 Old bracket on left, new bracket on right

These vehicles require replacement of the mounting bracket, in addition to replacement of the fuel tees. The original bracket does not have holes for the studs on the replacement fuel tees.

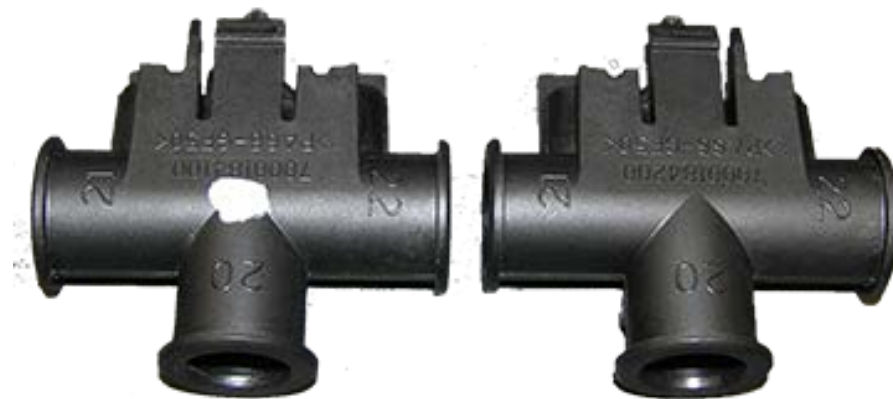
NOTE: New fuel tees have a white dot indicator.

1. Install the new fuel tees on the new bracket by aligning the locking tabs and stud to the corresponding slots and hole in the bracket and then pressing the fuel tee firmly into the bracket until the tabs snap into place.

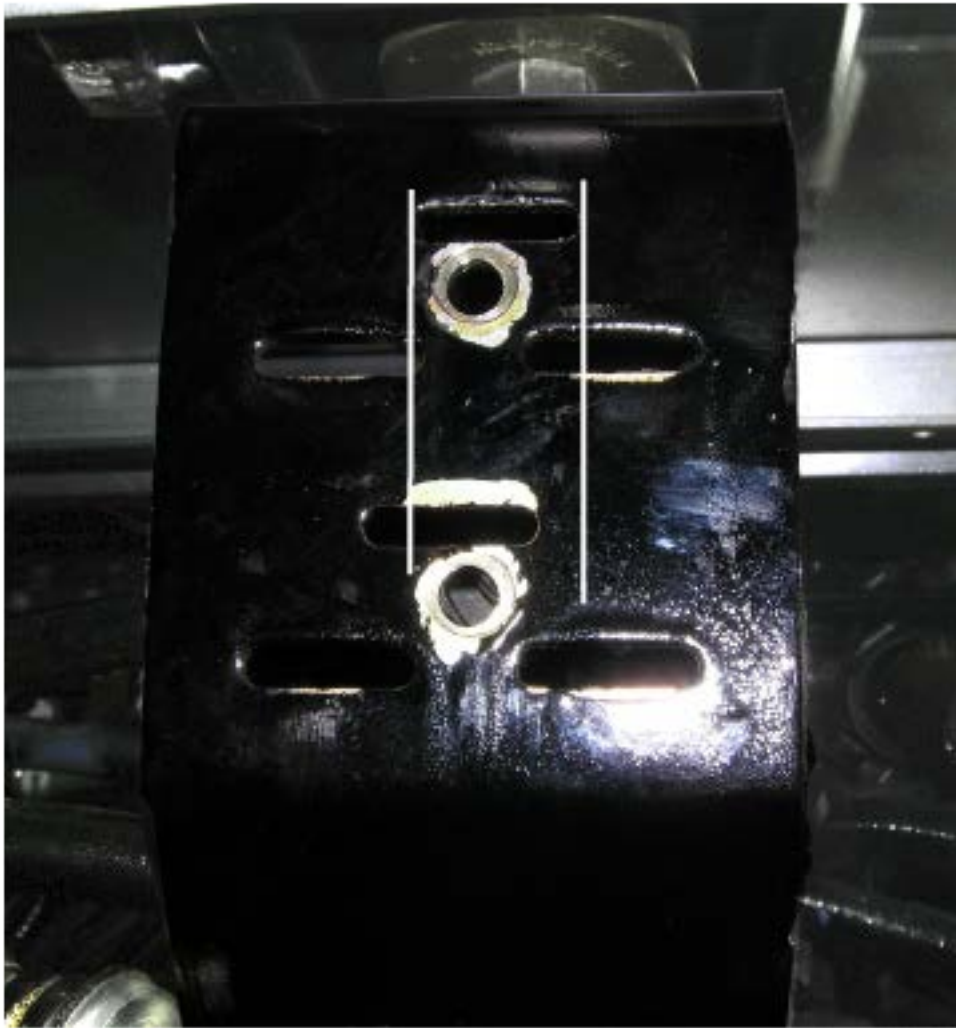
Figure 2 Fuel Tee mounting slots offset

NOTE: Each fuel tee only fits in one set of slots in the bracket.

2. Install new nuts on the studs of the fuel tees. Torque the nuts to 7.9 N-m (70 in-lb.).
3. Depressurize the fuel system.

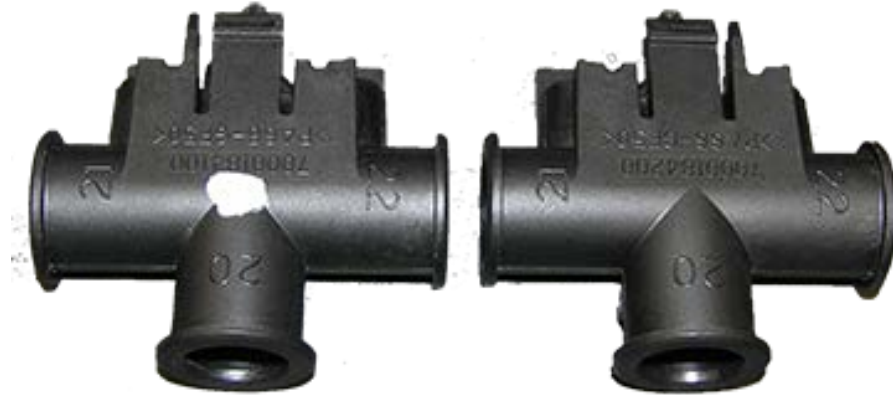
NOTE: New fuel tees have a white dot indicator.

These vehicles require only replacement of the fuel tees.

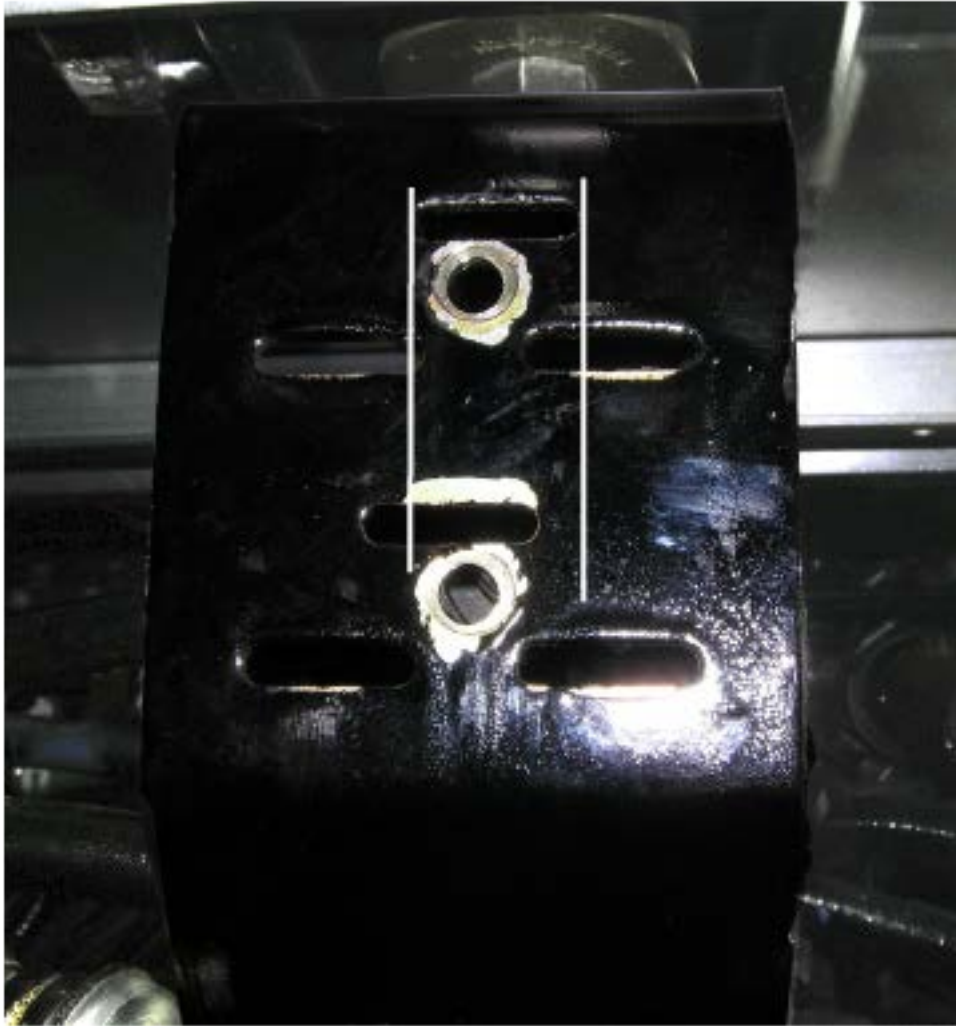
Figure 3 Fuel Tee mounting slots offset

NOTE: Each fuel tee only fits in one set of slots in the bracket. Notice the offset of the mounting slots shown in the figure below.

7. Install new nuts on the studs of the fuel tees. Torque the nuts to 7.9 N-m (70 in-lb.).
8. Install the fuel lines without removing the locking collars. An audible snap is heard/felt when the quick-connect locking collar locks over the retaining rib on the fuel tee.
9. Prime the fuel system. Instructional videos for using the [Davco or Mity-Vac tools](http://www.bca-training.com) are located at: www.bca-training.com, under PACCAR MX ENGINES | Knowledge Minute.
