<b>HYUNDAI</b> <b>Technical Service Bulletin</b>	GROUP	NUMBER
	RECALL	18-01-007-1
	DATE	MODEL(S)
	JUNE, 2018	2013-2014MY SONATA (YF) SANTA FE SPORT (AN)
<b>SUBJECT:</b> SONATA / SANTA FE SPORT GDI ENGINE INSPECTION / REPLACEMENT (RECALL CAMPAIGN 162)

**This TSB supersedes TSB# 18-01-007 and modifies the Parts Information and Warranty Information sections.**

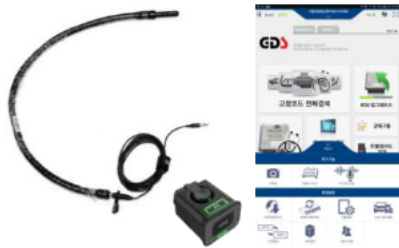
Description	Tool Part #	Image	Comment
Engine Noise Inspection Tool	G1XTD-CP005

**DO NOT** disassemble or modify any components of the engine inspection tool. If any part of the tool is damaged, a new one should be ordered. Individual components of the tool cannot be ordered.

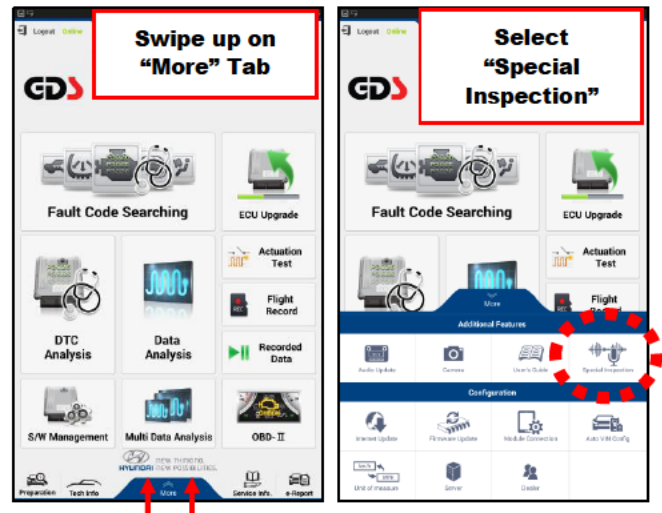
- Obtain the latest GDS Mobile update daily. The GDS Mobile must be connected to the internet via WiFi daily to confirm the latest software update is installed or the application will not function.
- Connect the GDS VCI to vehicle DLC.
- VCI should be updated with latest version and paired with GDS Mobile.
- Open the GDS Mobile App.
- Swipe up on the “More” tab at the bottom of the screen.
- Select the “Special Inspection” function.

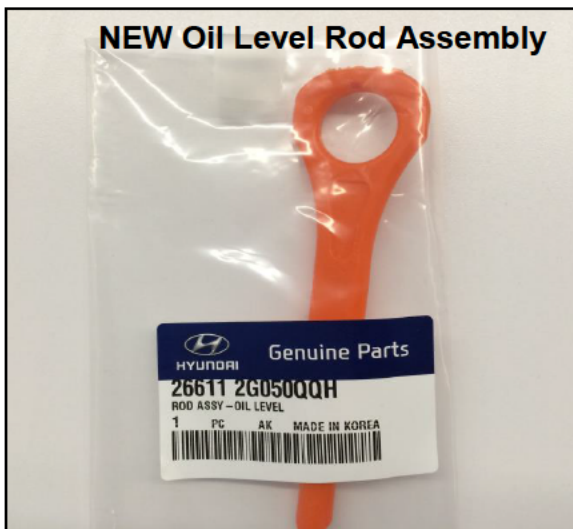
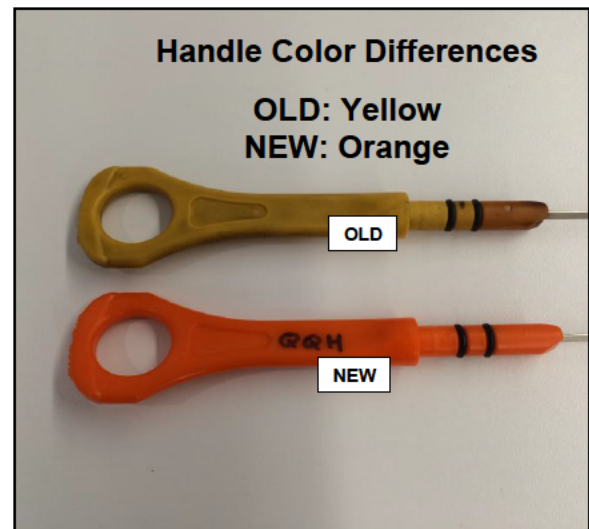
2. Replace the engine oil (4.8 quarts), oil filter, and drain plug gasket.
3. Replace the current Oil Level Rod Assembly with the new campaign part.
  - Remove and discard the existing Oil Level Rod Assembly (engine oil dipstick).
  - Install new ORANGE handle Oil Level Rod Assembly (P/N 26611-2G050QQH)

**Note: Replace the dipstick ONLY if the current dipstick's handle is yellow. Do not replace if it's red.**

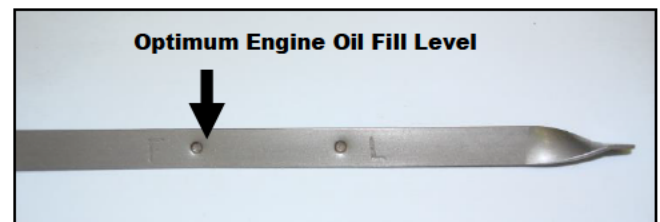
4. Start the engine and allow it to run for 10 seconds. Turn off the engine and after a few minutes adjust the engine oil level to near the "F" mark as shown in the picture.
  - Use Quaker State 5W-30 viscosity engine oil or other brand if not available (conventional type with API SM / ILSAC GF-4 or higher grade).
  - Do not overfill.

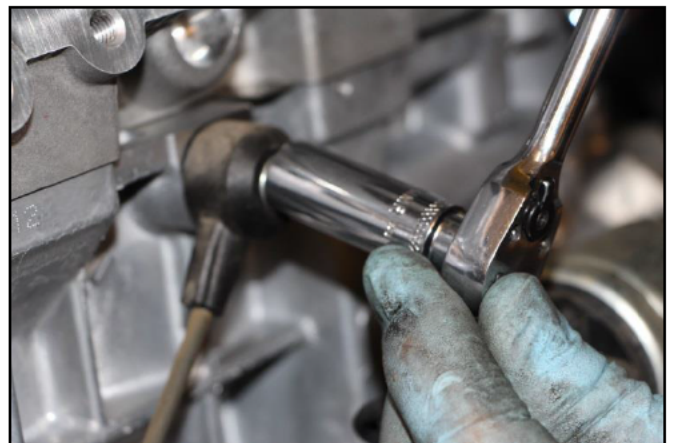
5. Remove and reinstall the engine Knock Sensor from the old engine to the new engine.

**(Knock Sensor Fastener)**  
**Tightening torque: 21Nm (15.5lb-ft)**

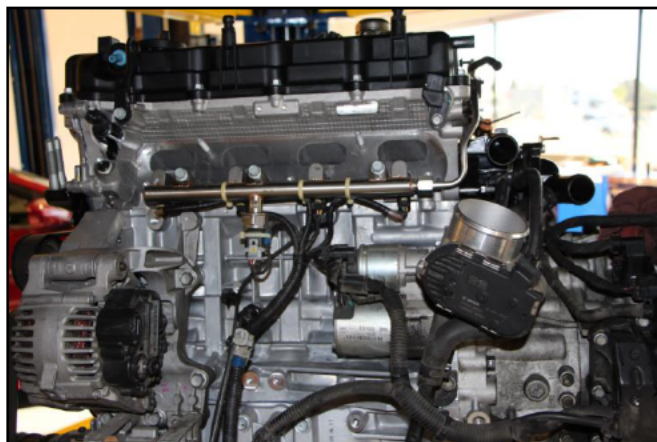
7. Install the new oil cooler hoses.
8. Reconnect and reinstall the engine front harness as shown.
  - Be sure to properly route the opposite end of the harness end down towards the front of the engine.
9. Install newly supplied Oil Level Guide and Oil Level Rod Assemblies to the new engine.
  - Be sure to install the NEW Oil Level Guide (dipstick tube) to the NEW engine.
  - Install the NEW Oil Level Rod Assembly (dipstick) to the NEW engine.

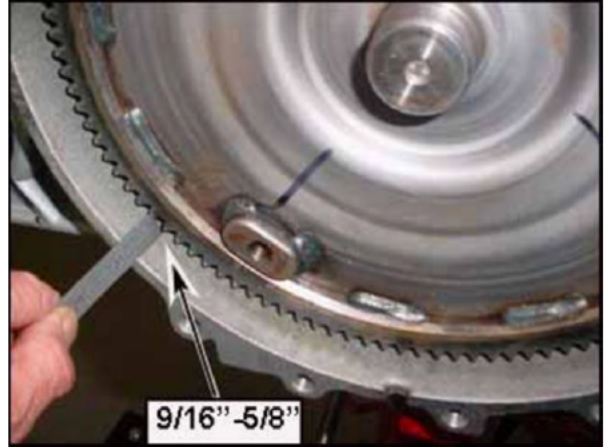
If the torque converter has moved from the fully inserted position, carefully push inward and rotate the torque converter until the converter is recessed approximately 9/16 - 5/8" (14 -16 mm) into the transaxle case when reinstalling the automatic transaxle.

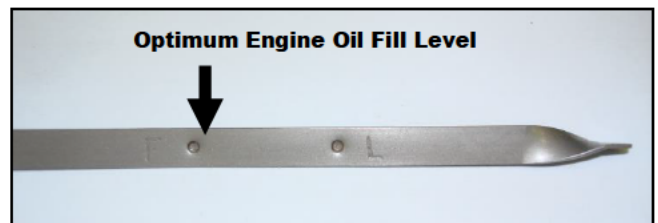
13. Start the engine to warm it up and begin the cooling system air bleeding process.
- During this time, check for any leaks.
  - After the engine has warmed up to normal operating temperature, turn the engine off, wait a few minutes, and then adjust the engine oil level to near the "F" mark as shown in the picture.
