F/CMVSS Noncompliance Recall

17199 Front Passenger Airbag Deployment

Reference Number: N172097790

Release Date: July 2017
Revision: 00

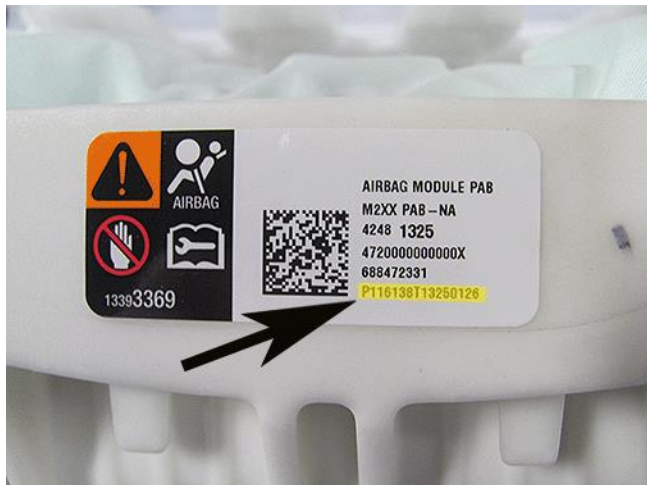
4388784

1. Record the new passenger airbag module serial number on the repair order. This is the last number on the airbag assembly part sticker (highlighted in yellow in the photo above).
2. Replace the instrument panel upper trim panel and airbag instrument panel module. Refer to *Airbag Instrument Panel Module Replacement and Instrument Panel Upper Trim Panel Replacement* in SI.

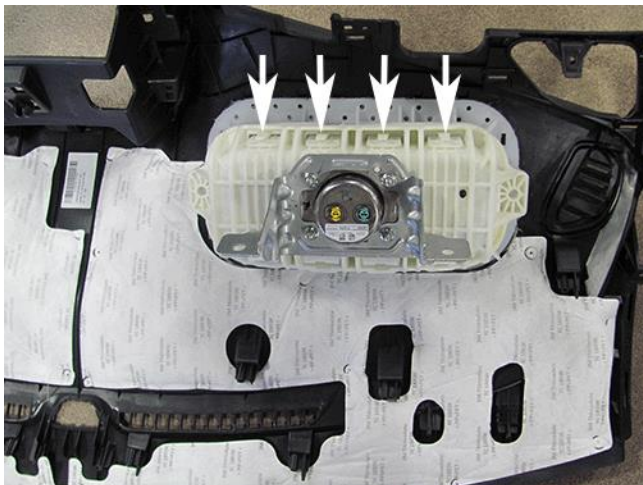
4828654

- Apply pressure to the outboard side (far side) of the airbag, engaging the four locking tabs. This requires considerable pressure, you will feel and hear the tabs engage.

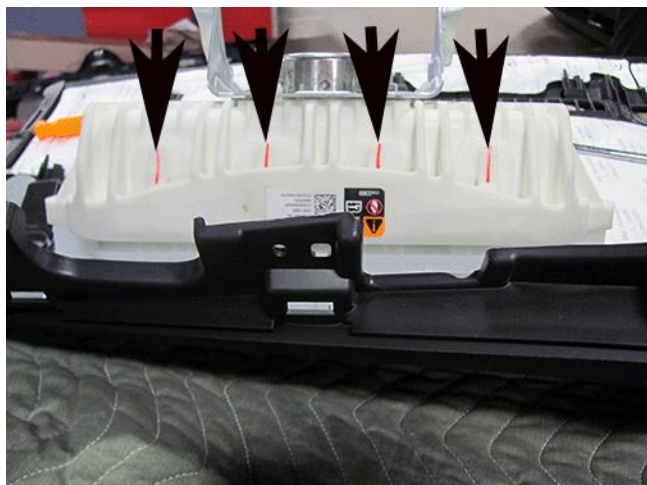
4828661

4. Using a red paint pen, mark each of the eight tabs as they are being verified for full engagement.
5. Separate the instrument panel upper trim panel and airbag instrument panel module for deployment and disposal. Refer to *Airbag Instrument Panel Module Replacement* in SI.
