TECHNICAL SERVICE BULLETIN

Bulletin Number: T-17-04

2015-2017 SLINGSHOT – Swingarm Rubber Grommet Installation

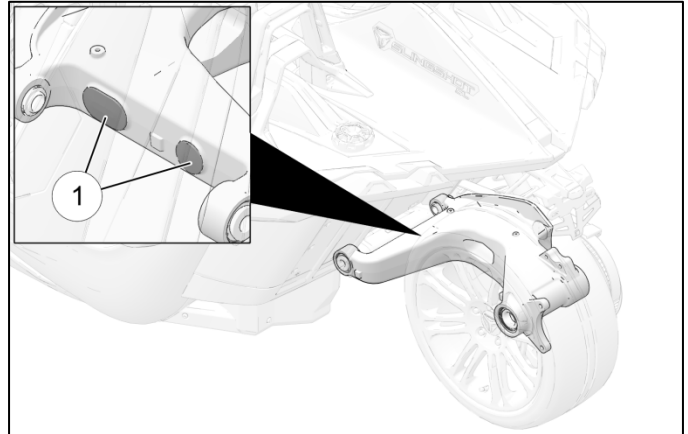
3. Slide your hand along the swingarm to inspect that the two rubber grommets ① are installed and fully seated in the swingarm.
 - If grommets are installed, proceed to step 4.
 - If grommets are missing, proceed to “Rubber Grommet Installation”

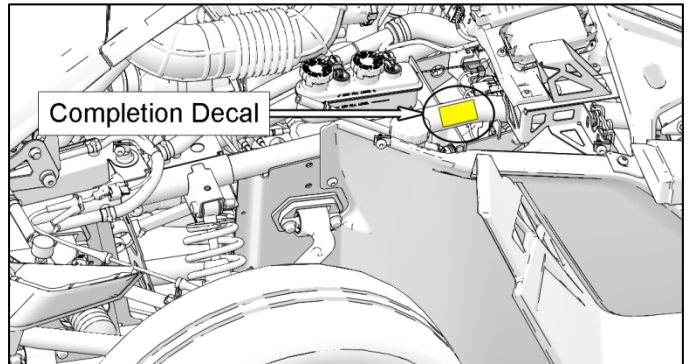
4. Open Vehicle hood and install a completed Service Bulletin Completion Decal (7170107). Close the vehicle's hood. File Bulletin T-17-04-A

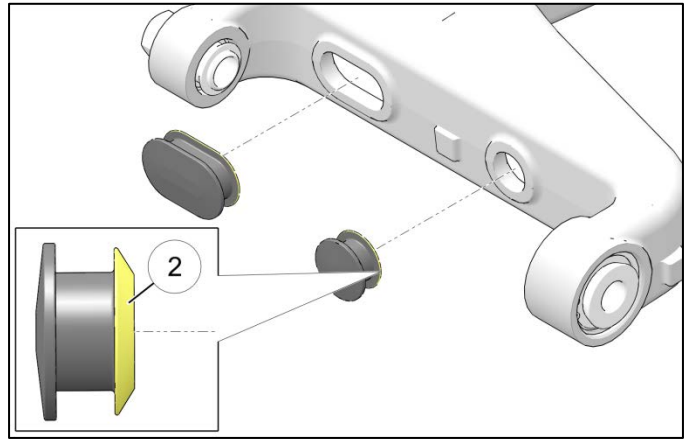
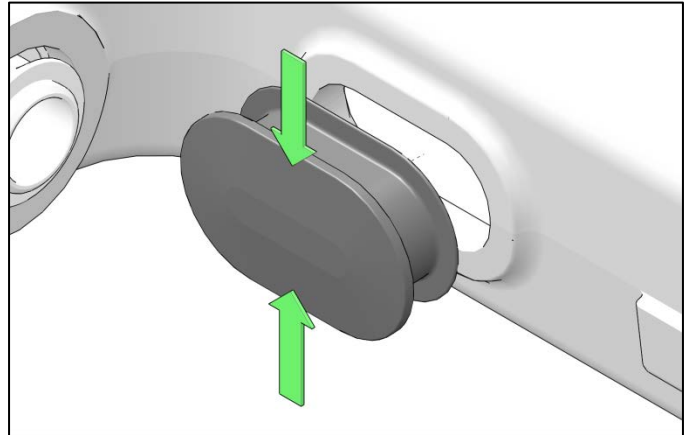
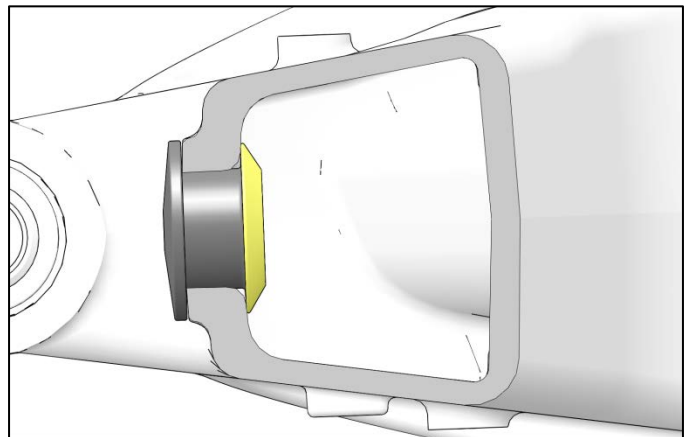
2. Install both grommets into the appropriate opening in the swingarm.

1. Use water to wet the edge of the grommets ② before inserting into the swingarm.

Squeezing the middle of the large grommet may aid in getting the grommet started into the swingarm.

Once started, work your way around the perimeter of the grommet until it is installed and fully seated in the swingarm.

If the grommet gets pushed through the opening and into the casting, use a needle nose pliers and a flashlight to retrieve.

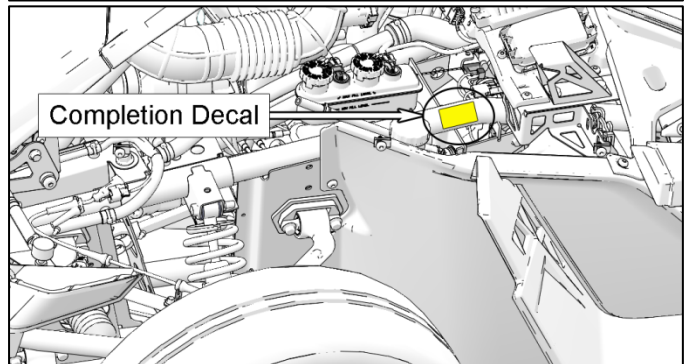
3. Open Vehicle hood and install a completed Service Bulletin Completion Decal (7170107). Close the vehicle's hood. File Bulletin T-17-04-B
