Accessory Parts FMVSS Noncompliance Recall

17258 Front Head Restraint Removable After Tablet Holder Installed

Reference Number: N172095270

Release Date: August 2017
Revision: 00

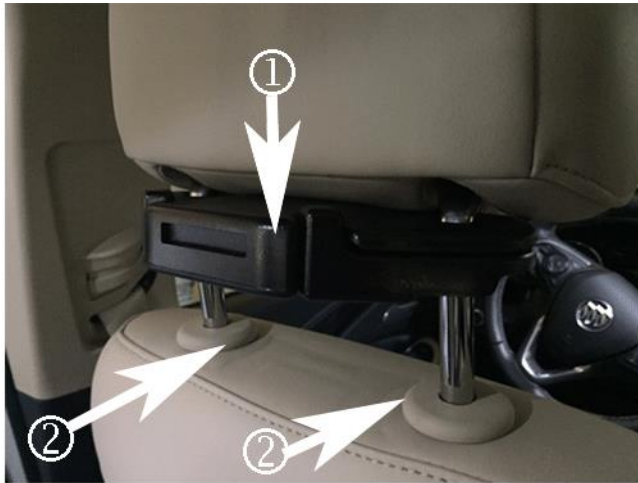
4825302

1. Push the head restraint release button on the headrest and raise the head restraint. If a tablet type device is installed in the tablet holder, remove and store the tablet in a safe environment.
2. Lift the tablet holder (1).

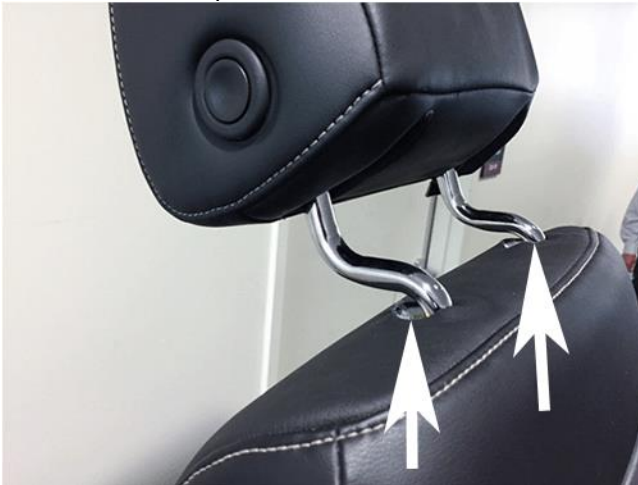
4825303

3. Determine if the head restraint guide bezels (2) are present.
 - If the head restraint guide bezels are present proceed to step four below.
 - If the bezels are not present, proceed to step seven below.
4. Lower the seat back rearward to gain space between the head restraint and the roof. Ensure sure that the cushion is locked in place on the posts and will not move and then, pulling vertically on the head restraint assembly, remove the head restraint from the seat back. If the head restraint will not come out of the seatback, refer to *Front Seat Head Restraint Guide Replacement* in SI. Leave the tablet holder on the head restraint posts.

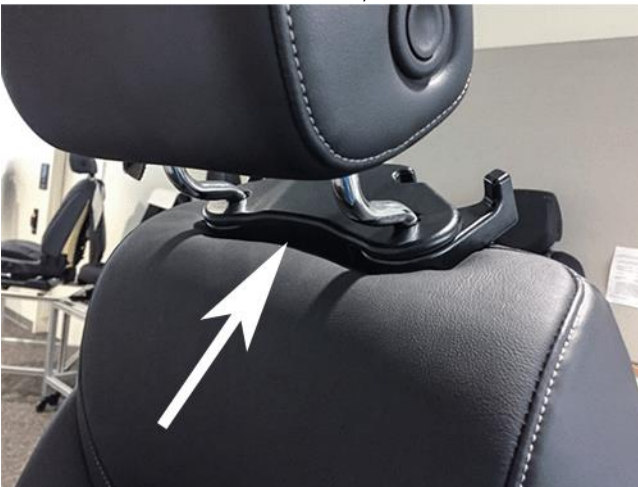
4825307

5. With the head restraint removed, remove the two bezels. Store the bezels in the vehicle glove box for future use.

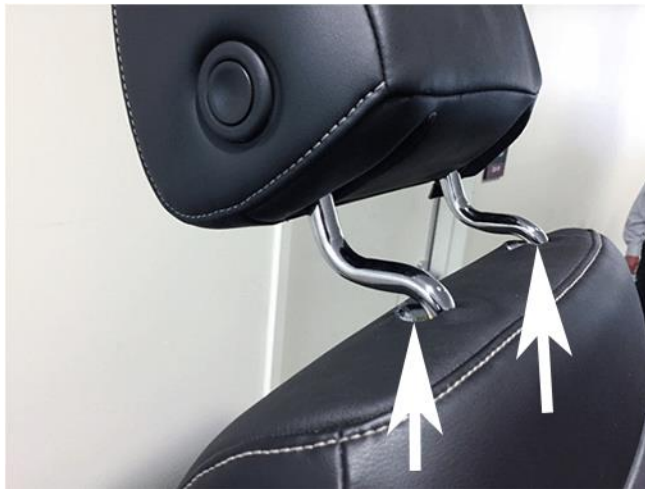
4825303

Lower the seat back rearward to gain space between the head restraint and the roof. Ensure that the headrest cushion is locked in place on the posts and will not move and then, pulling vertically on the head restraint assembly, attempt to remove the head restraint from the seat back. **If the head restraint will not come out of the seatback, no further action is required.** Please retain the included instruction sheet below for your records in case you should ever wish to remove the universal tablet holder and reinstall it.

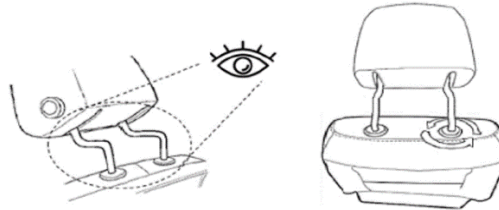
1. - Remove the button caps on the headrest posts to remove the headrest per vehicle procedure.
- Déposer les capuchons à bouton des montants d'appui-tête, afin de déposer l'appui-tête conformément à la procédure du véhicule.
- Retire las tapas de plástico en los postes de la cabecera para quitar la cabecera de acuerdo al procedimiento del vehículo.

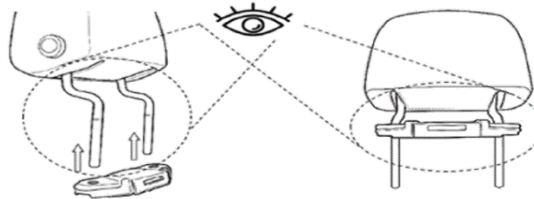
2. - Install the tablet holder base.
- Installer la base du support de tablette.
- Instale la base del soporte de tableta.
