**SAFETY  
RECALL**

**SR17-31**

DATE :	May 2018	SECTION :	23 ACCESSORIES
SUBJECT:	2½ lb AND 5 lb FIRE EXTINGUISHER REPLACEMENT

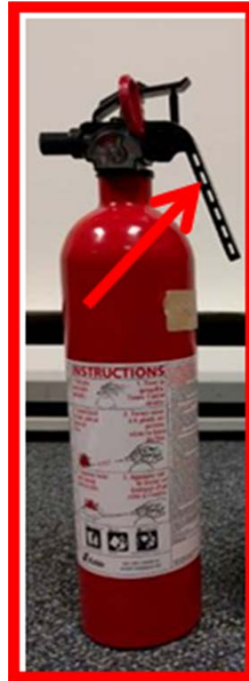
FIGURE 2

2. Replace all existing 2½ lb fire extinguishers with plastic handle and valve p/n 901360 (Figure 2) with the new 2½ lb fire extinguishers with the metal handle and valve (Figure 3).

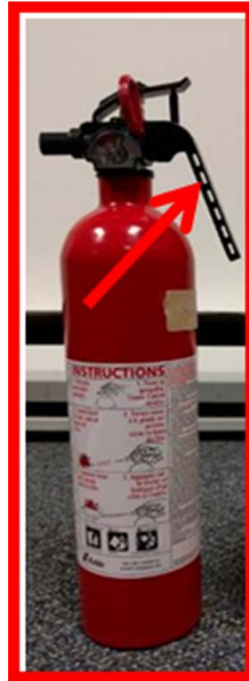
FIGURE 6

6. Replace all existing 2½ lb fire extinguishers with plastic handle and valve p/n 901360 (Figure 6) with the new 2½ lb fire extinguishers with the metal handle and valve (Figure 7).

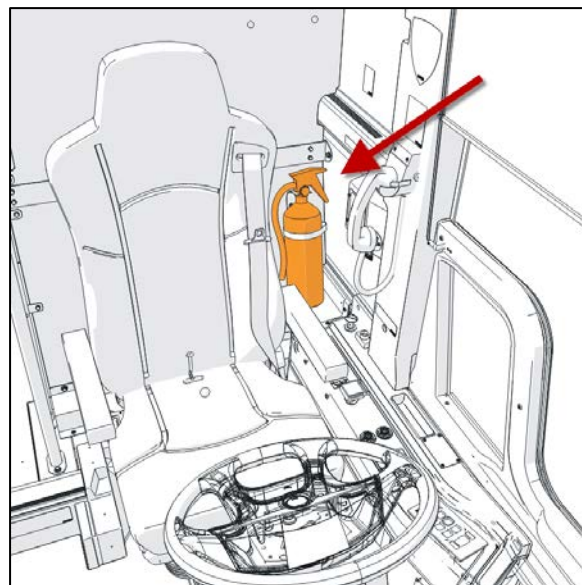
**FIGURE 9**

9. Locate the existing 5-lb fire extinguisher behind the driver's seat of the vehicle.

<b>NOTE</b>
Figure 9 shows the installation when the vehicle was delivered. Location of the fire extinguisher might be different.

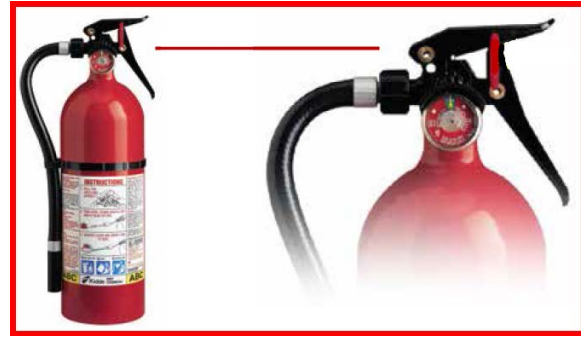
**FIGURE 10**

10. Check the handle and valve on the existing fire extinguisher.
11. If the extinguisher is equipped with a plastic handle and plastic valve (Figure 10), move to step 12, otherwise the bulletin is complete.

12. Replace existing 5 lb fire extinguisher with the plastic handle and valve (Figure 10) with the new 5 lb fire extinguisher with the metal handle and valve (Figure 12).
13. Bulletin is complete for this vehicle model.

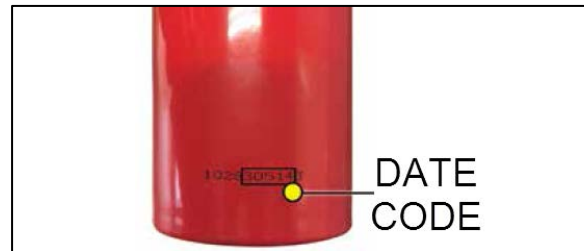
**FIGURE 11**

Figure 11 shows the location of the 10-digit date code on the side of the cylinder. Digits 5 through 9 represent the day and year.

All fire extinguishers with the date code XXXX29715X (October 24, 2015) or later have to be replaced.
