Brembo Front Brake Master Cylinder

Recall Bulletin SRV-RCL-18-001

NHTSA Campaign I.D. Number: 17V-812

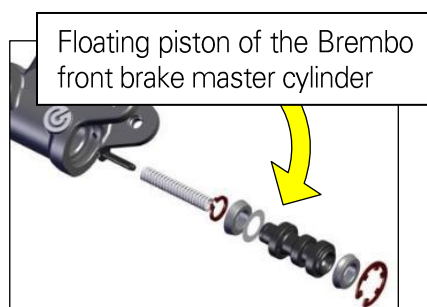
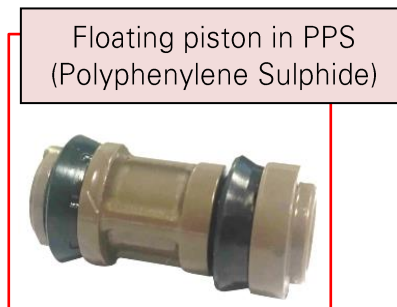
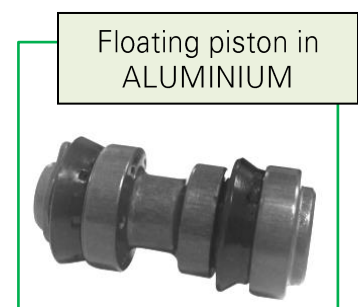
Ongoing quality testing on the motorcycles as manufactured, as well as analysis of field reports, has identified a possible fault with PPS (Polyphenylene Sulphide) floating piston with diameters of 15 mm and 16 mm fitted on the Brembo front brake radial master cylinders of the models mentioned above, manufactured from 2015 to 2018. It's necessary to replace the floating piston with one made from aluminum, which ensures a higher mechanical strength.

Failure of the floating piston could result in failure of the component (creation of the crack) under high-stress conditions typical of track use, frequent ABS interventions or bike tip-over. If a crack is created, it could compromise front brake operation, thus jeopardizing the vehicle's braking capability; the rear brake is not affected by this problem.

Although the possibility of this fault is remote, we deem it necessary to preventively replace all floating pistons in PPS (Polyphenylene Sulphide).

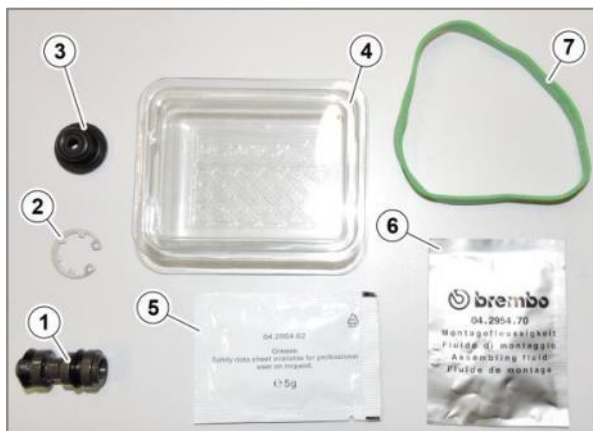
- 1) Floating piston:
Ø16 for kit part no.61041881A
Ø15 for kit part no.61041891A
- 2) New snap ring
- 3) New dust cap
- 4) Kit box
- 5) White grease
- 6) Assembly fluid
- 7) Elastic band for final test

- Part no. 61041881A for the KIT containing the aluminum floating piston with a diameter of 16 mm;
- Part no. 61041891A for the KIT containing the aluminum floating piston with a diameter of 15 mm.

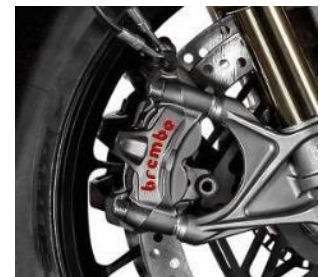
**KIT containing the aluminum
floating piston, diameter 16 mm
Part no. 61041881A**

Models with 2 calipers
M50 of the front brake

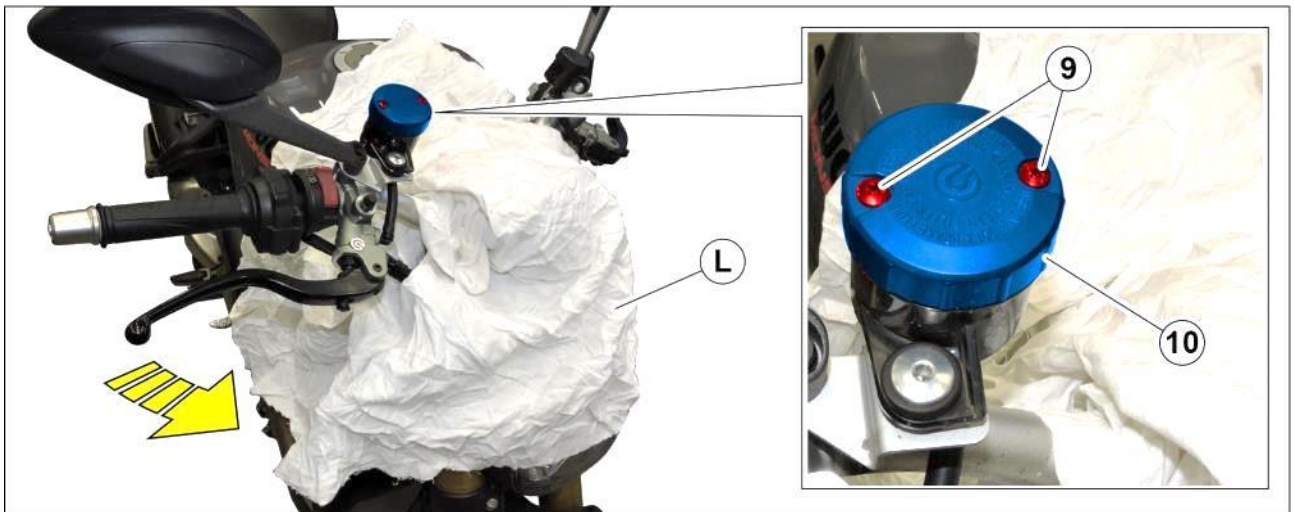
- 3) Unscrew the **2 screws M4x45 (9)** and remove the **cover (10)**.

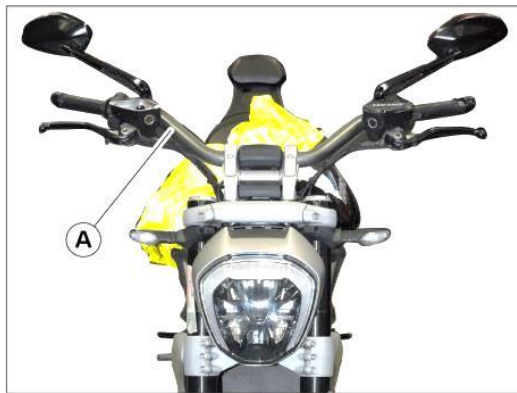
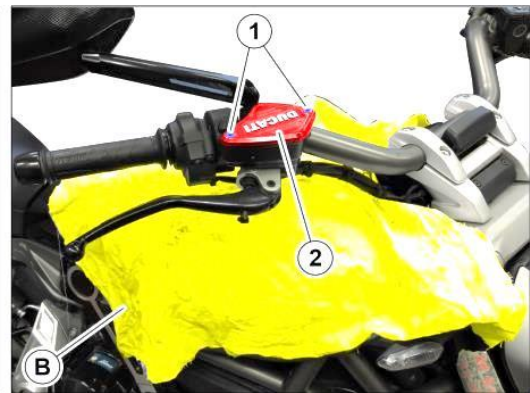
XDIAVEL S ONLY

- Turn **handlebar (A)** straight and use a **cloth (B)** to protect the parts near and under the front brake master cylinder, as shown in the figure.
- Unscrew the **2 screws M4x15 (1)** and remove the **cover (2)**.

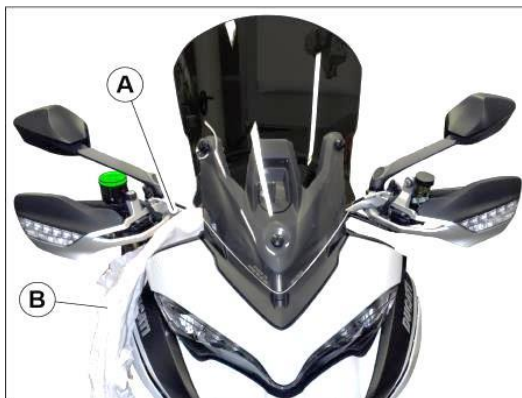
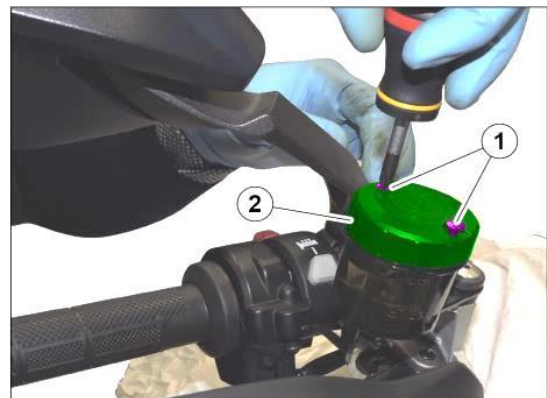
MULTISTRADA ONLY

- Turn **handlebar (A)** straight and use a **cloth (B)** to protect the parts near and under the front brake master cylinder, as shown in the figure.
- Unscrew the **2 screws M4x45 (1)** and remove the **cover (2)**.

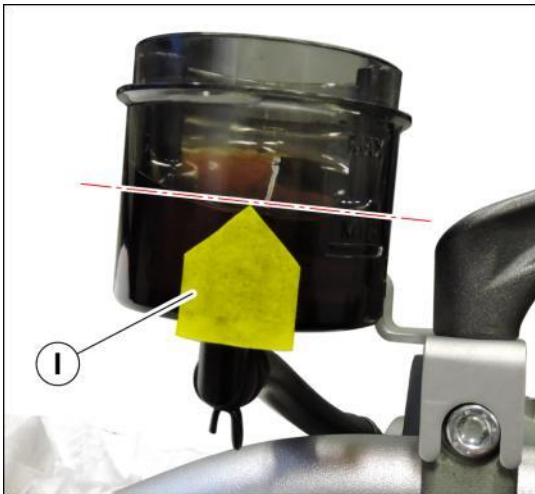
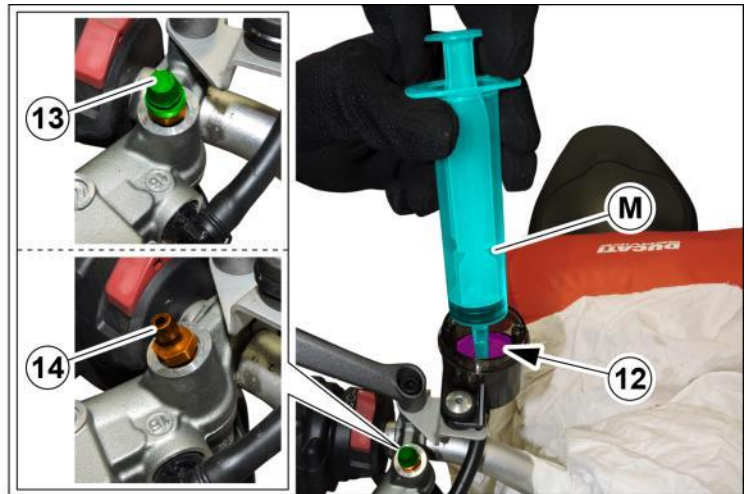
- 1) Prepare a reference arrow using **adhesive tape (I)** and stick it on the reservoir to mark the initial fluid level, as shown in the figure.
- 2) Completely drain the **fluid (12)** from the reservoir using the **syringe (M)**.
- 3) Remove **bleed cap (13)** from **bleeder union (14)**.

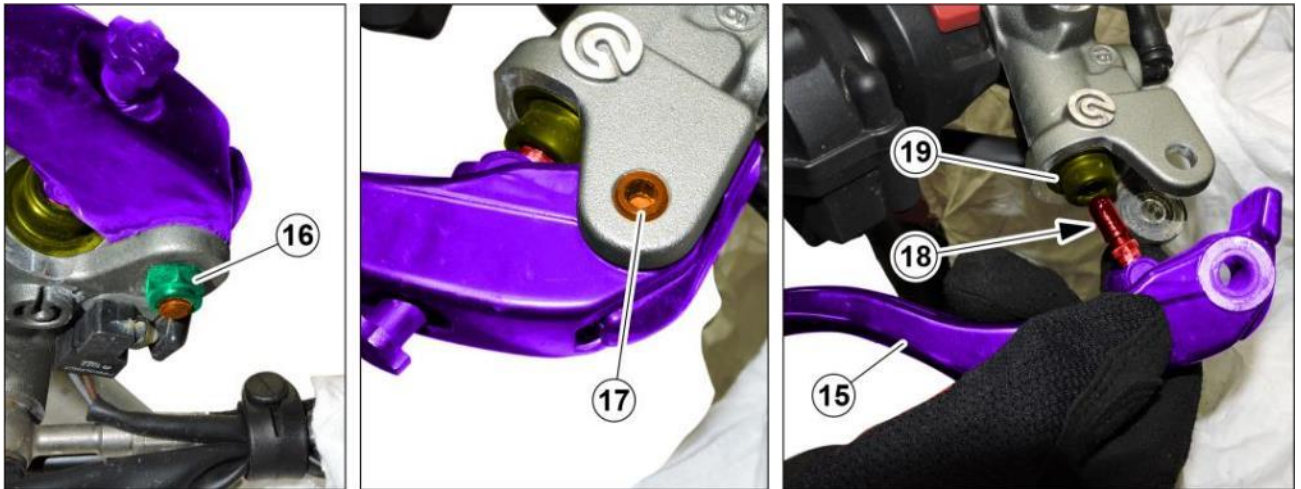
- 6) Remove the lever (15), by removing the pin (18) from the old dust cap (19).

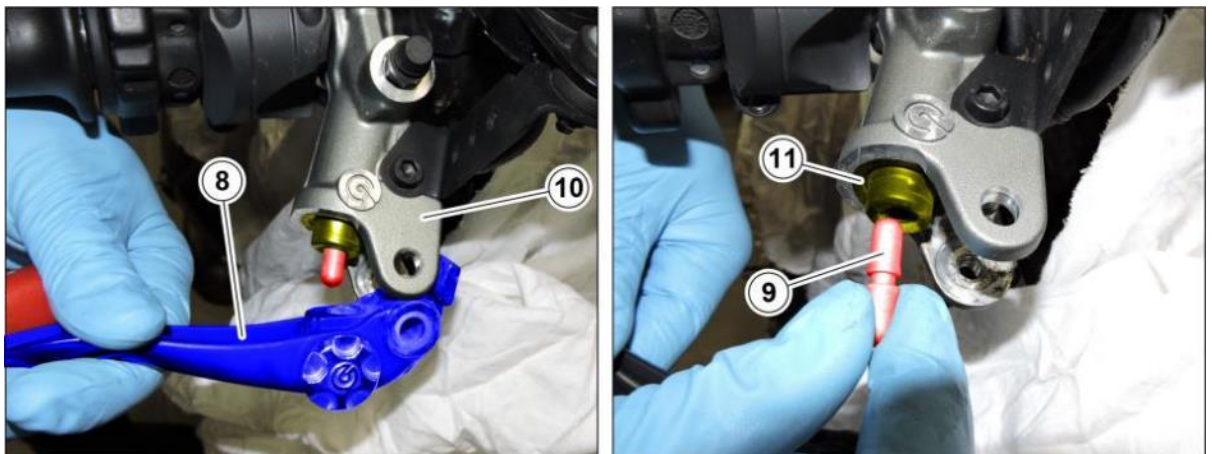
**SCRAMBLER
CAFÈ RACER ONLY**

- a) Remove the brake lever (8) from the brake master cylinder (10).
- b) Remove pin (9) from the old dust cap (11).

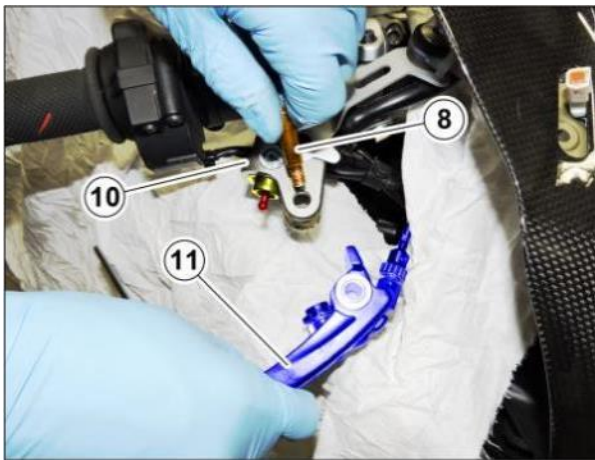
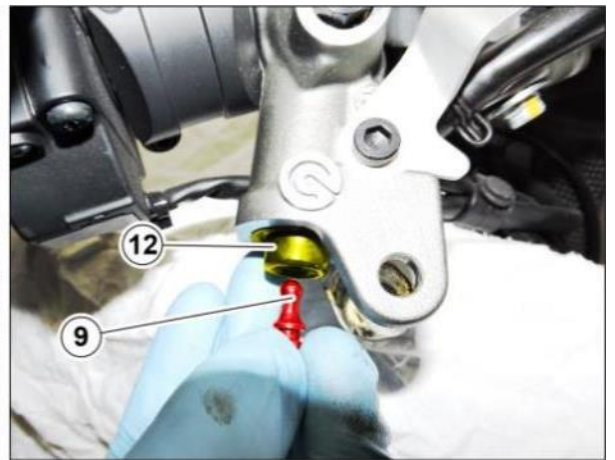
**1299 SUPERLEGGERA
ONLY**

- a) Remove the **brake lever (11)** from the **brake master cylinder (10)**, and lay it onto the cloth previously arranged on the headlight fairing.
- b) Remove **pin (9)** from the **old dust cap (12)**.

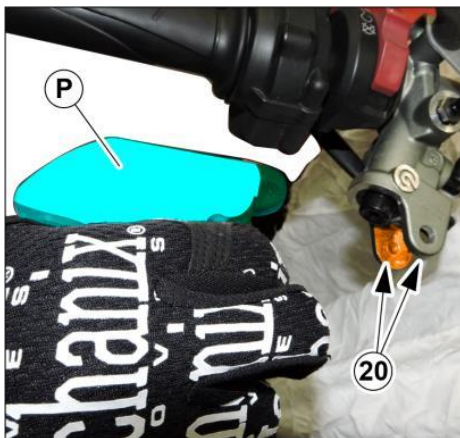
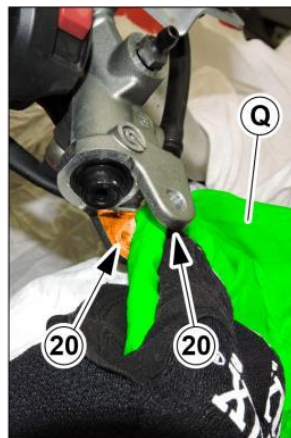
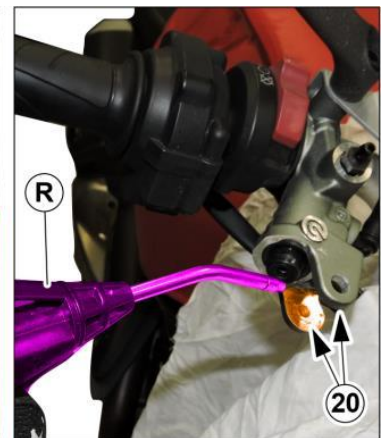
- 7) Use a **sprayer (P)** to wash the **surfaces (20)** with WATER.
- 8) Clean and dry the **surfaces (20)** using a **cloth (Q)**.
- 9) Blow **compressed air (R)** to thoroughly remove all excess water from **surfaces (20)**.

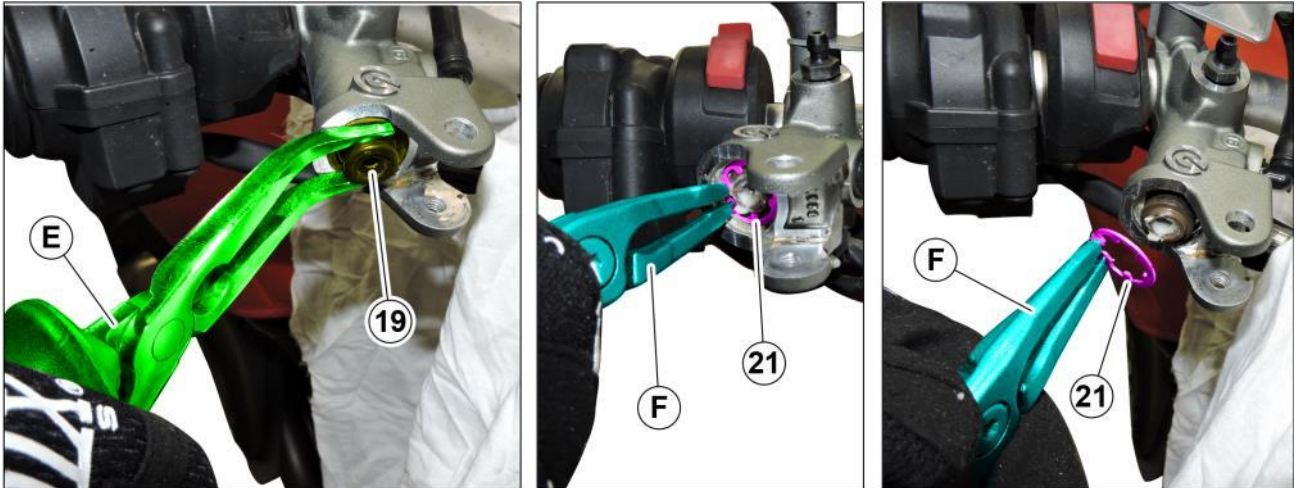
- 10) Remove the old dust cap (19) using pliers (E).
- 11) Remove the old snap ring (21) using the suitable pliers (F), as shown in the figure.

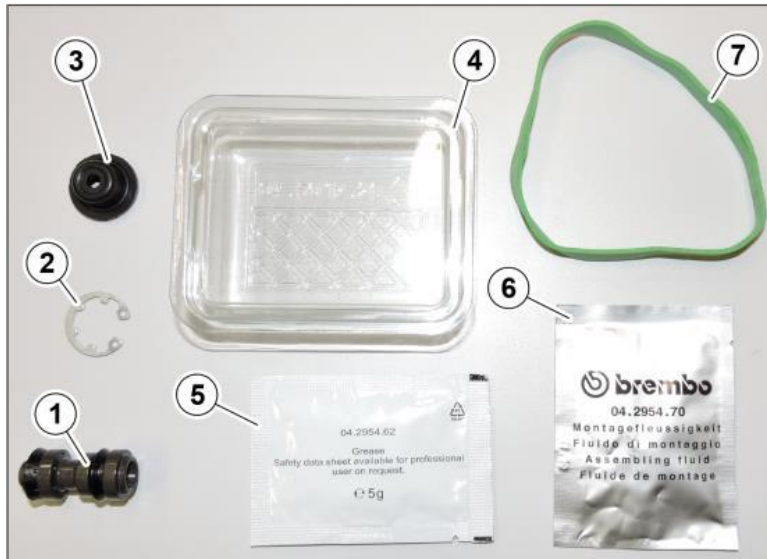
13) The 2 kits include the following parts:

- 1) Floating piston:
Ø16 for kit part no.61041881A
Ø15 for kit part no.61041891A
- 2) New snap ring
- 3) New dust cap
- 4) Kit box
- 5) White grease
- 6) Assembly fluid
- 7) Elastic band for final test

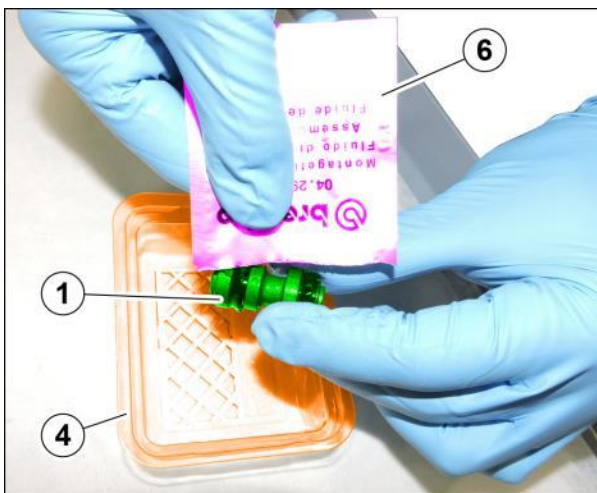
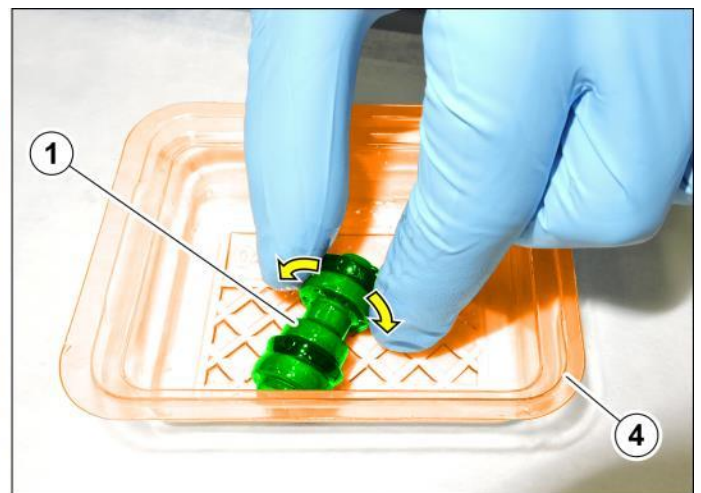
14) Open the **assembly fluid sachet (6)** and pour its content onto the **new floating piston (1)** while turning it around, and collect any excess fluid in the **kit box (4)**.

15) Lay the **floating piston (1)** inside the **kit box (4)**, making sure that the assembly fluid is present on the seals and all over the piston surface.

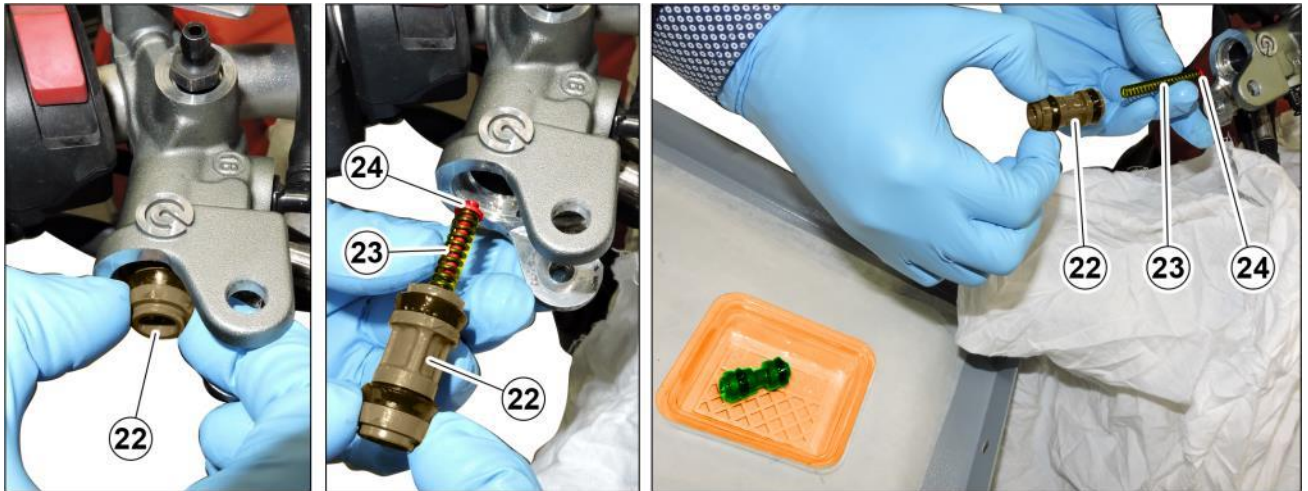
- 17) Remove and keep pin (24) with spring (23) from the old floating piston (22).

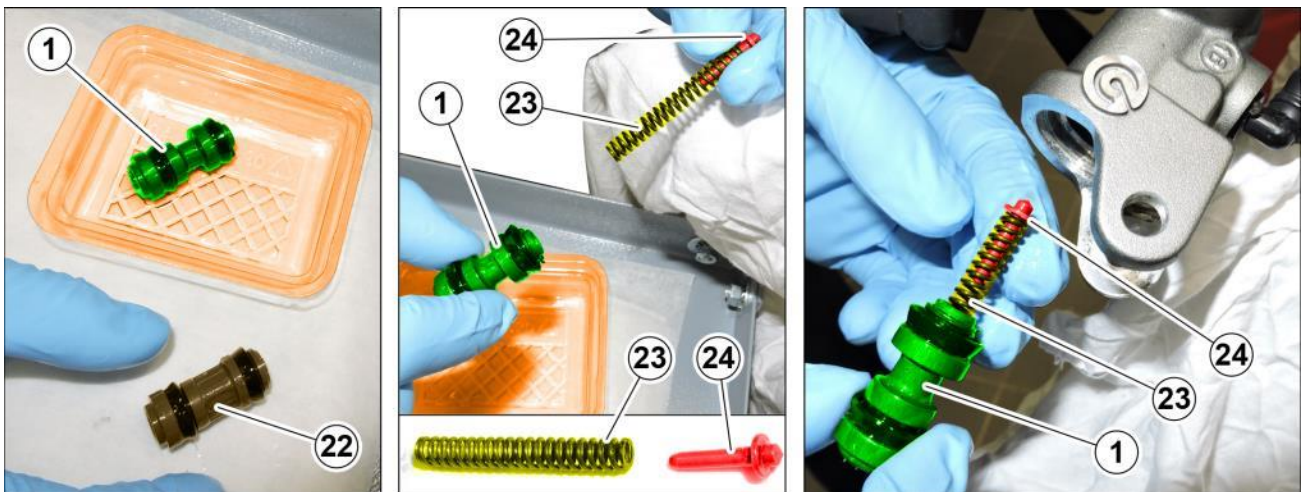
- 19) Take the new floating piston (1) and install spring (23) and pin (24) to it, as shown in the figure.

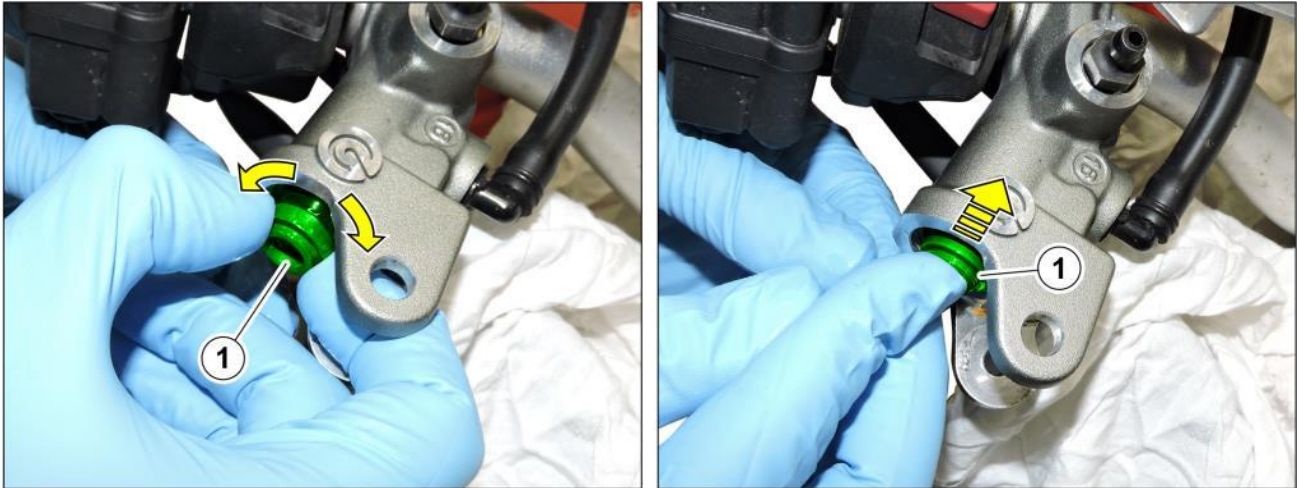
- 21) Slightly turn the **new floating pin (1)** so as to help settling the **pin (24)** in the brake master cylinder.
- 22) Press on **floating pin (1)**, to make sure that **pin (24)** is perfectly seated in the brake master cylinder.

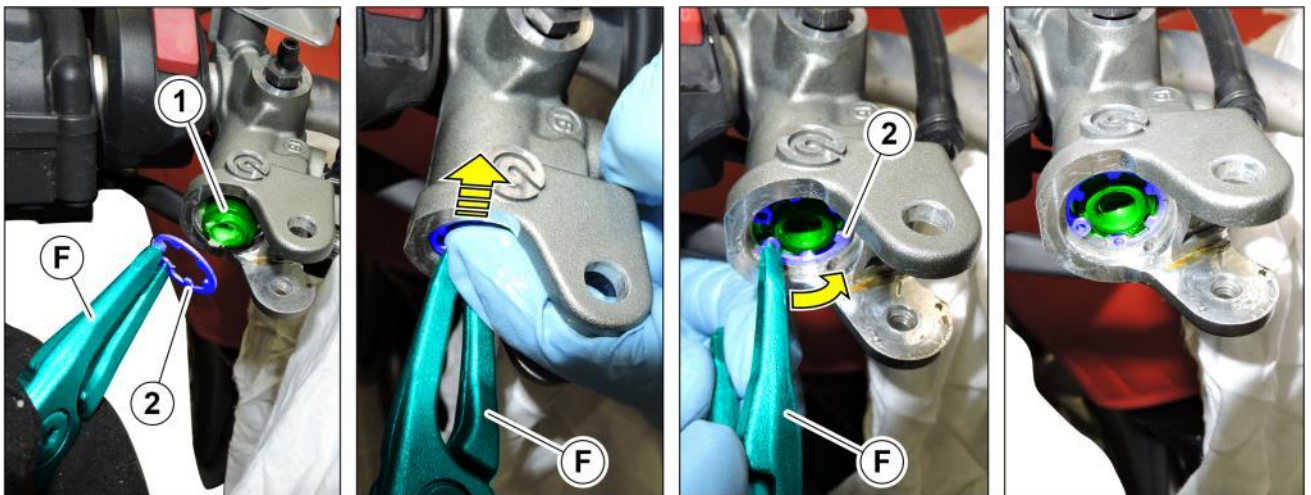
- 23) Use the **pliers for circlips (F)** to install the **new snap ring (2)** on the brake master cylinder, while holding the **new floating piston (1)** pressed inward.

To make sure that the **new snap ring (2)** is properly installed and seated, use the **calipers for circlips (F)** and turn the snap ring by one fourth of a turn.

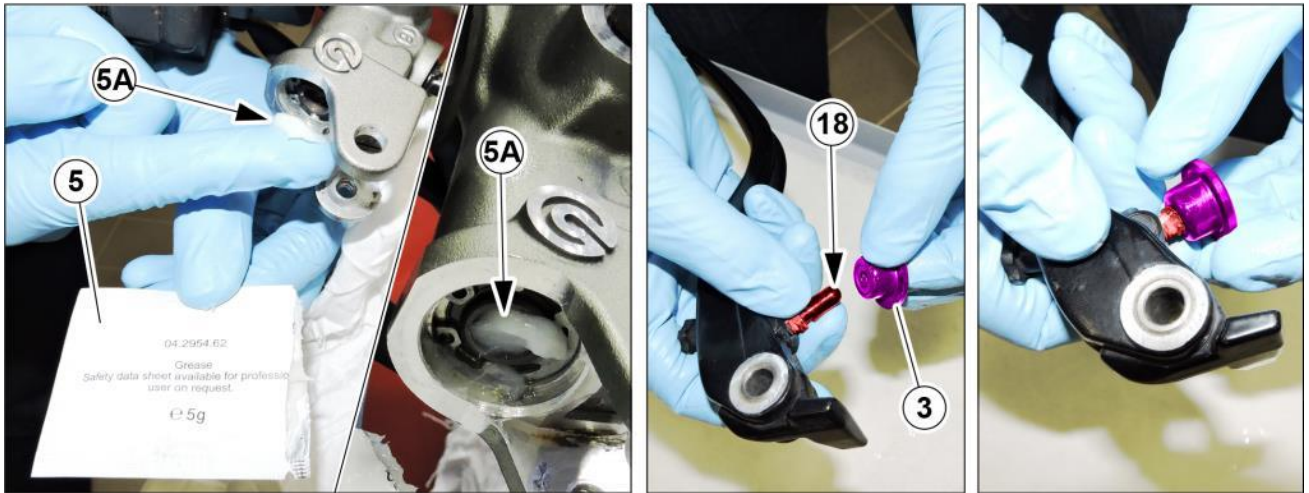
- 24) Open the **sachet of white grease (5)** and smear the **new floating piston (1)** with a small quantity of **white grease (5A)**, as shown in the figure.
- 25) Fit the **new dust cap (3)** to **pin (18)**, bring it fully home and make sure it is properly seated on the pin.

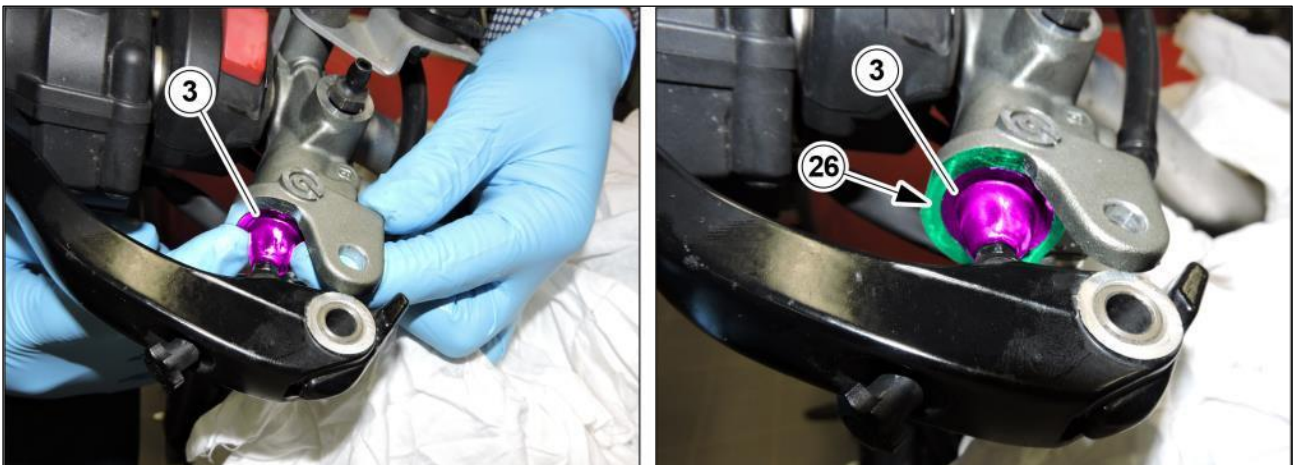
- 26) Install the **new dust cap (3)** on the brake master cylinder, bringing it fully home and evenly pressing all around. The **dust cap (3)** is properly installed if it is flush with the **machined surface (26)** of the brake master cylinder.

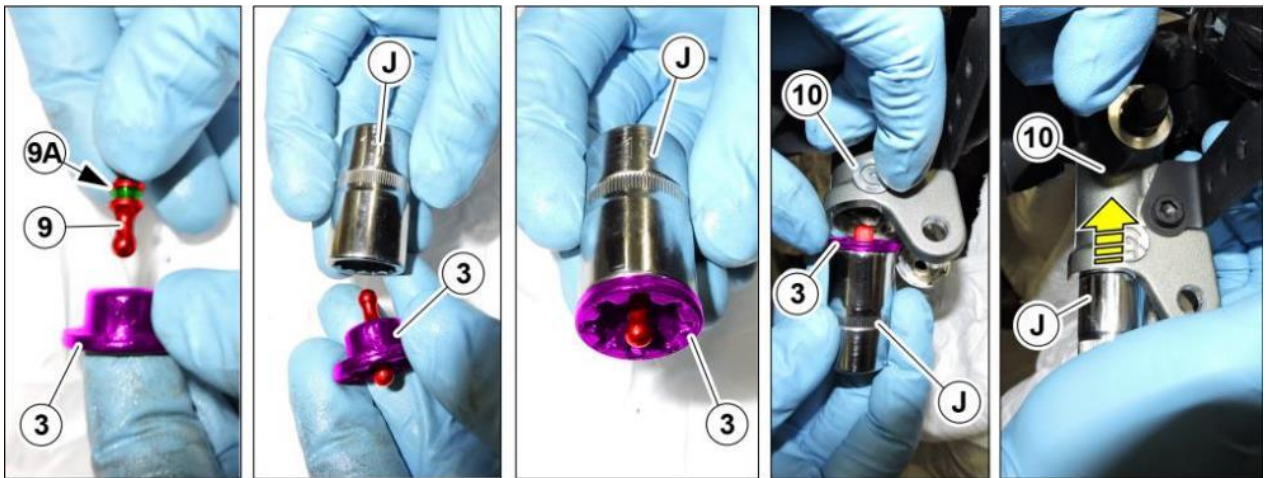
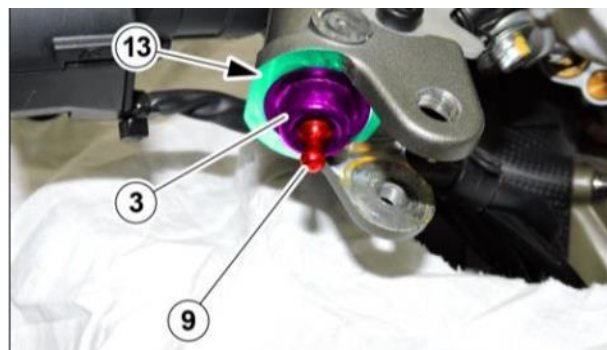
**1299 SUPERLEGGERA
ONLY**

- Fit the **new dust cap (3)** on **pin (9)**, aiming it as shown in the figure and bring it in its seat (**9A**).
- Fit the **new dust cap (3)** on a **15 mm socket (J)**.
- Fit the **new dust cap (3)** bringing it fully home on **brake master cylinder (10)**, pressing the **15 mm socket (J)** on the master cylinder.

- The **new dust cap (3)** is properly installed if it is flush with the **machined surface (13)** of the brake master cylinder.

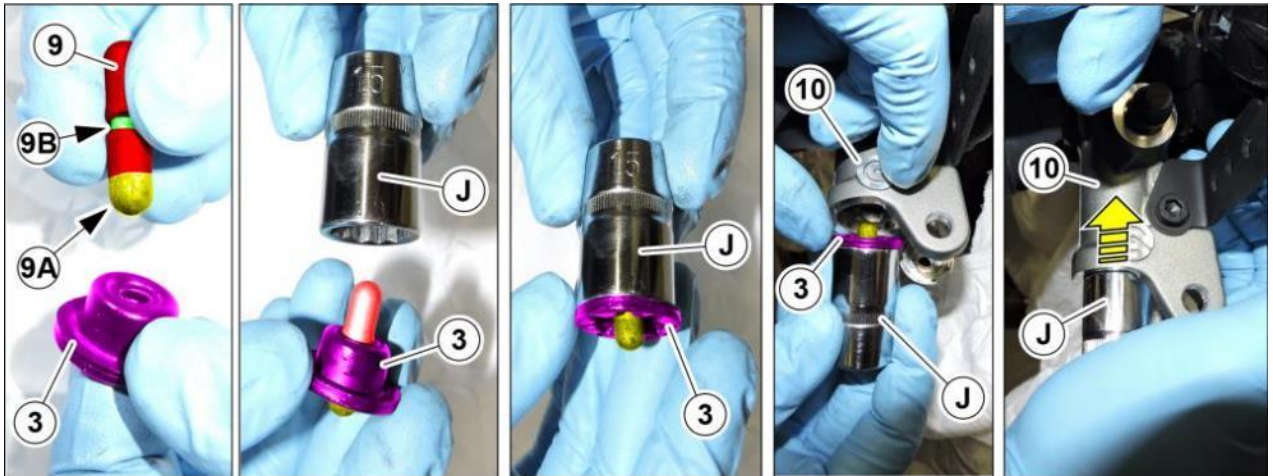
**SCRAMBLER
CAFÈ RACER ONLY**

- Fit the **new dust cap (3)** on **pin (9)**, aiming it as shown in the figure and inserting it from the **most worn side (9A)**, bring it in its **seat (9B)**.
- Fit the **new dust cap (3)** on the **15 mm socket (J)**.
- Fit the **new dust cap (3)** bringing it fully home on **brake master cylinder (10)**, pressing the **15mm socket (J)** on the master cylinder.
- The **new dust cap (3)** is properly installed if it is flush with the **machined surface (12)** of the **brake master cylinder (10)**.

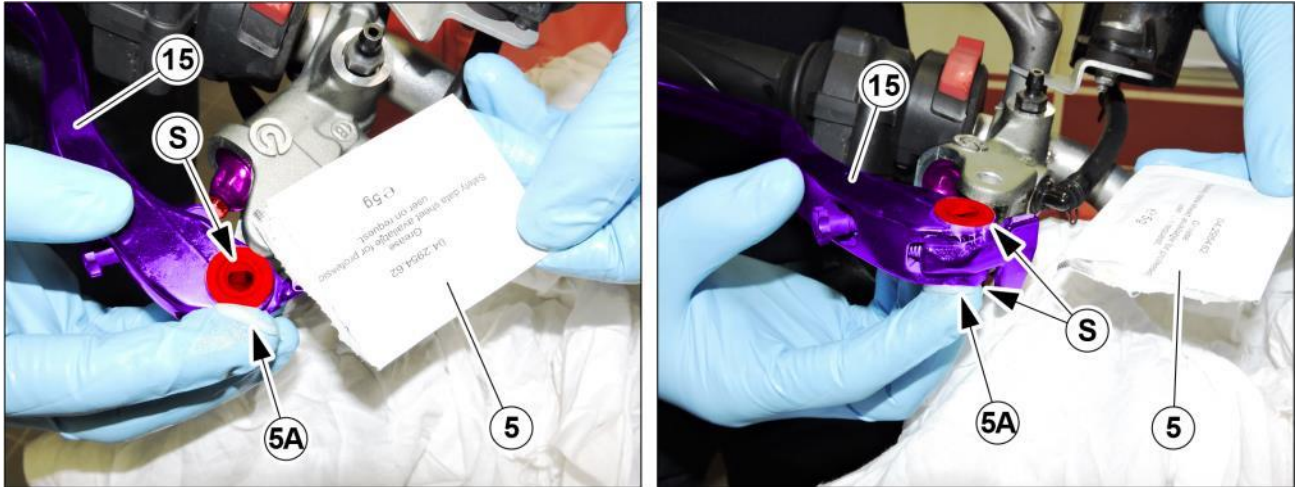
28) Fit the brake lever (15) to the brake master cylinder.

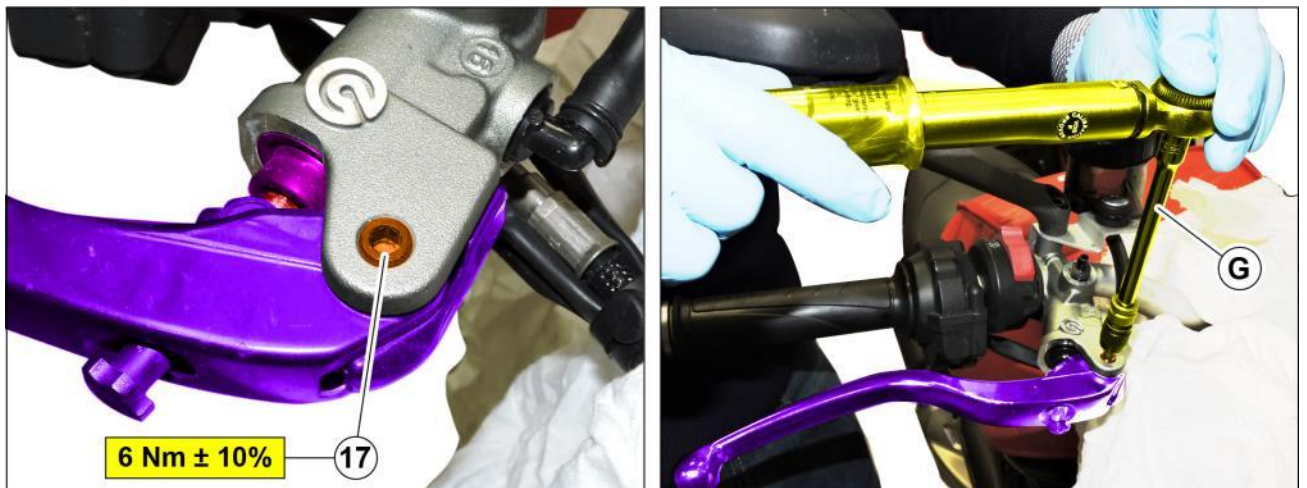
29) Snug and tighten pin (17) to **6 Nm ± 10%**, using a torque wrench (G).

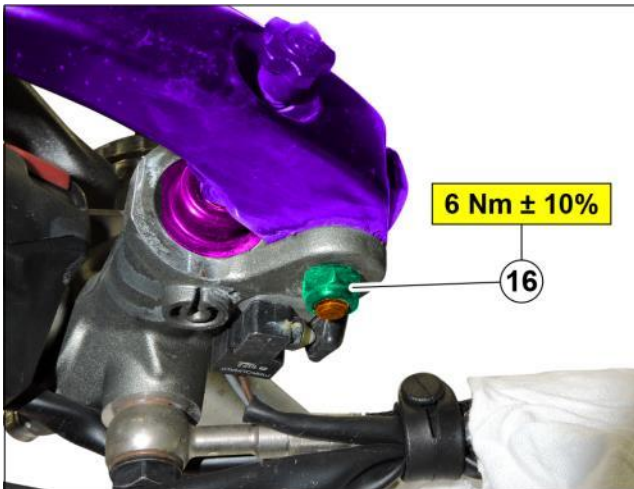
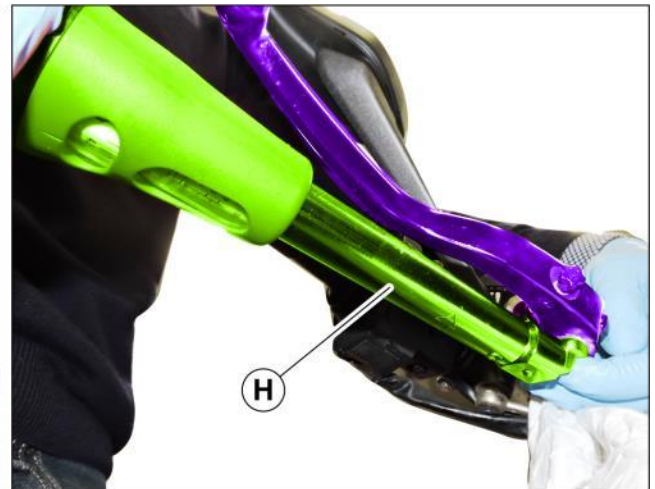
- 30) Snug and tighten nut (16) to **6 Nm ± 10%**, using a torque wrench (H) while holding the pin (17) on the opposite side.

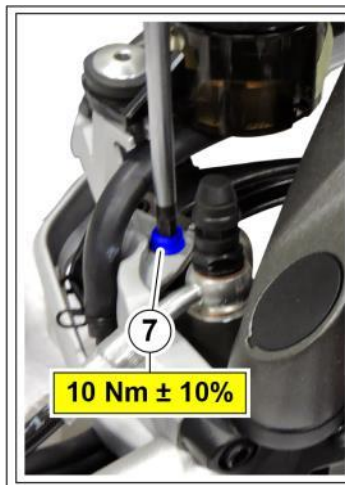
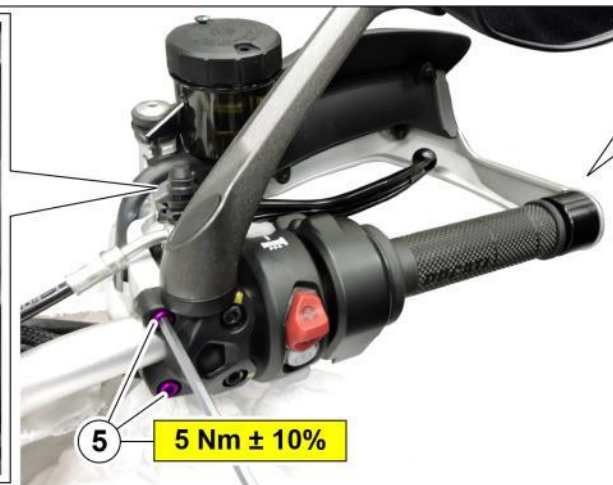
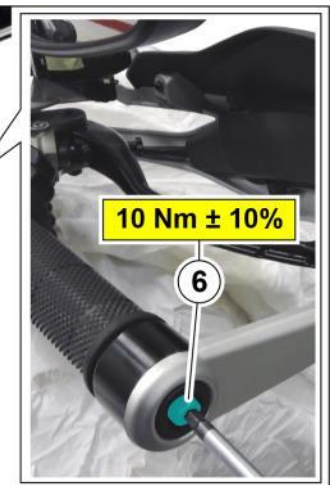
MULTISTRADA ONLY

- a) Refit the RH hand guard and start the 2 screws M5x18 (5), screw M6x55 (6), screw M6x18 (7). Tighten screws to the torque specified in the figure.

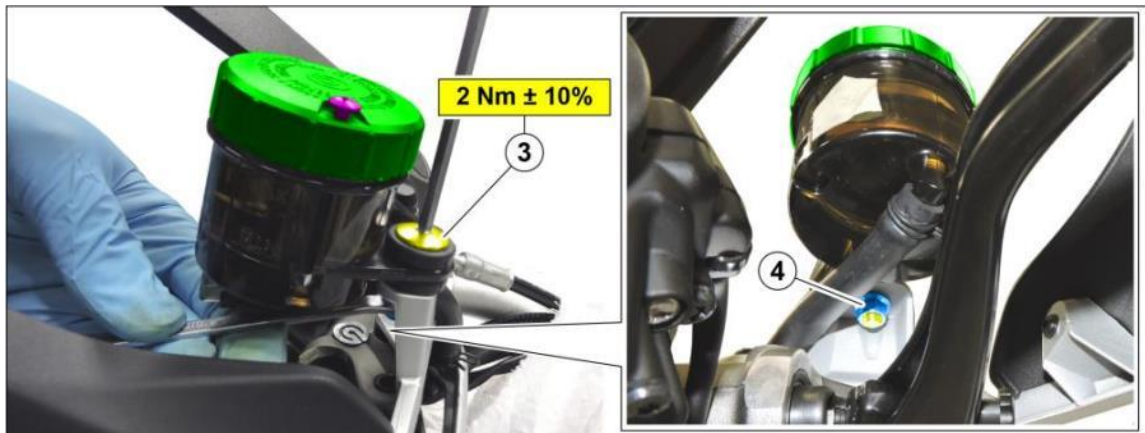
- c) On the opposite side, tighten nut **M5 (4)** on special screw **M5 (3)** thread.
- d) Tighten the **special screw (3)** to a torque of **2 Nm ± 10%**, while holding the **nut (4)**, on the opposite side.

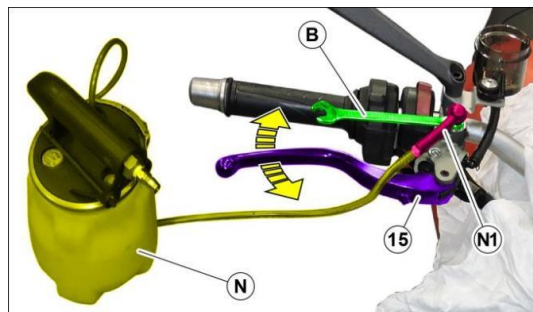
- 31) Fill the reservoir until maximum level using **new DOT 4 brake fluid**.
- 32) Fit **wrench (B)** in the flat on bleeder union.
- 33) Fit **cap (N1)** of **bleeder vessel (N)** on bleeder union.
- 34) Loosen bleeder union and pump with the **lever (15)**, while progressively filling the reservoir so that the fluid level never goes below the half of the reservoir. **Pump using lever (15) until you no longer see air bubbles coming out of the bleeder tube.**
- 35) Tighten the bleeder union to a torque of **14 Nm ± 10%** and remove the **cap (N1)** and **wrench (B)**.

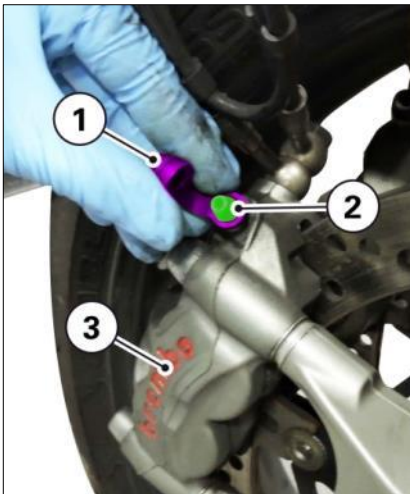
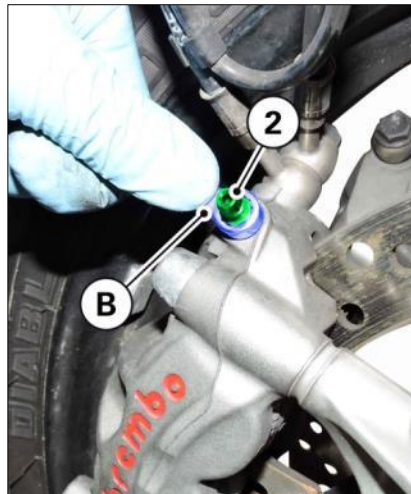
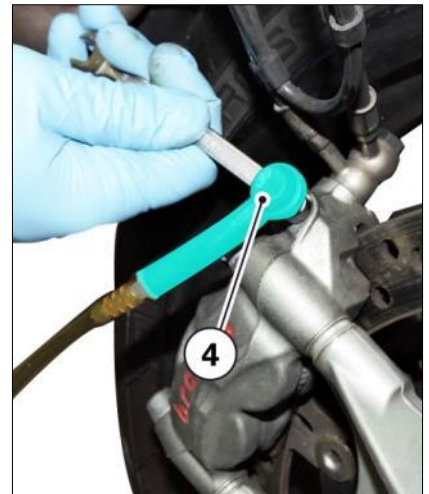
- 3) Fit **wrench (B)** in the flat on **bleeder union (2)**.
- 4) Fit **cap (4)** of bleeder vessel on bleeder union.

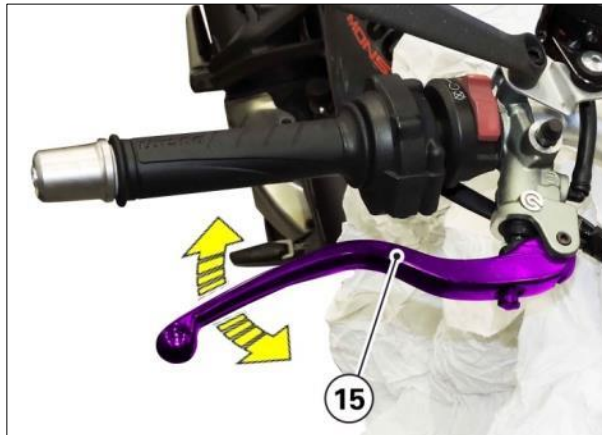
- 6) Pump using the **front brake lever (15)** until you see the **new DOT 4 brake fluid** coming out of the bleeder tube, or until draining a quantity of fluid equivalent to the reservoir content.

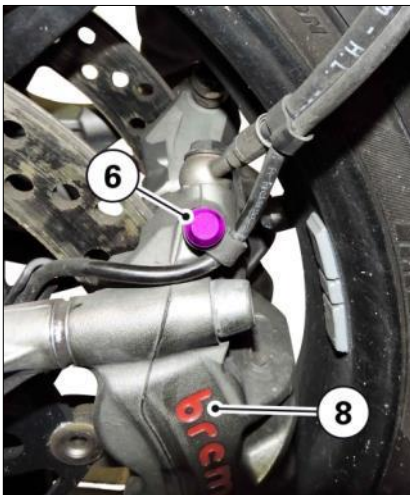
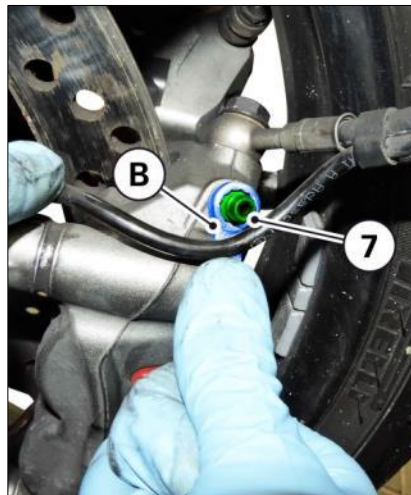
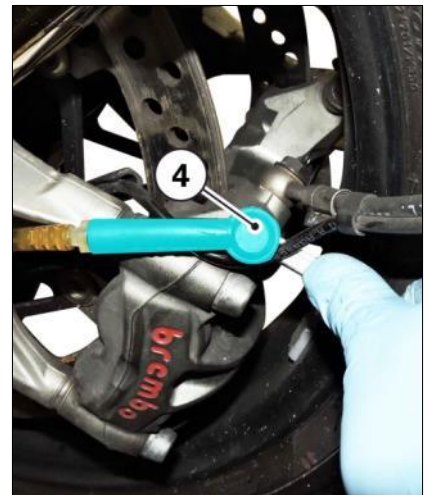
- 7) Tighten the **bleeder union (2)** on main front brake caliper to a torque of **10 Nm** and remove the **cap (4)** and **wrench (B)**.
- 8) Remove the **bleeder cap (6)** from **bleeder union (7)** on **secondary front brake caliper (8)** (the secondary front brake caliper is the one featuring 1 union).
- 9) Fit **wrench (B)** in the flat on **bleeder union (7)**.
- 10) Fit **cap (4)** of bleeder vessel on **bleeder union (7)**.

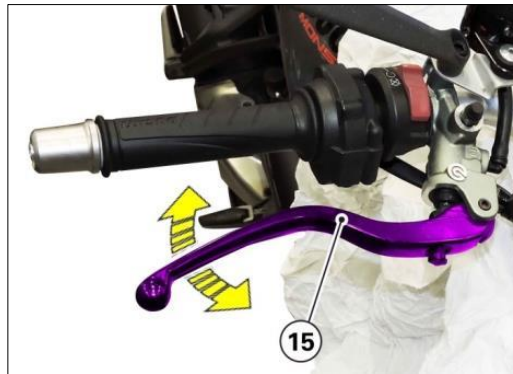
- 11) Loosen **bleeder union (7)** and pump with the **front brake lever (15)**, while progressively filling the reservoir so that the fluid level never goes below the half of the reservoir.
- 12) Pump using **the front brake lever (15)** until you see the **new DOT 4 brake fluid** coming out of the bleeder tube, or until draining a quantity of fluid equivalent to the reservoir content.

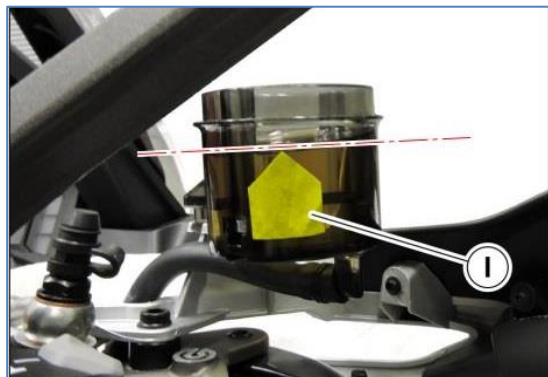
- 1) Top up the reservoir using **new DOT 4 brake fluid** until reaching the **reference arrow (I)**.

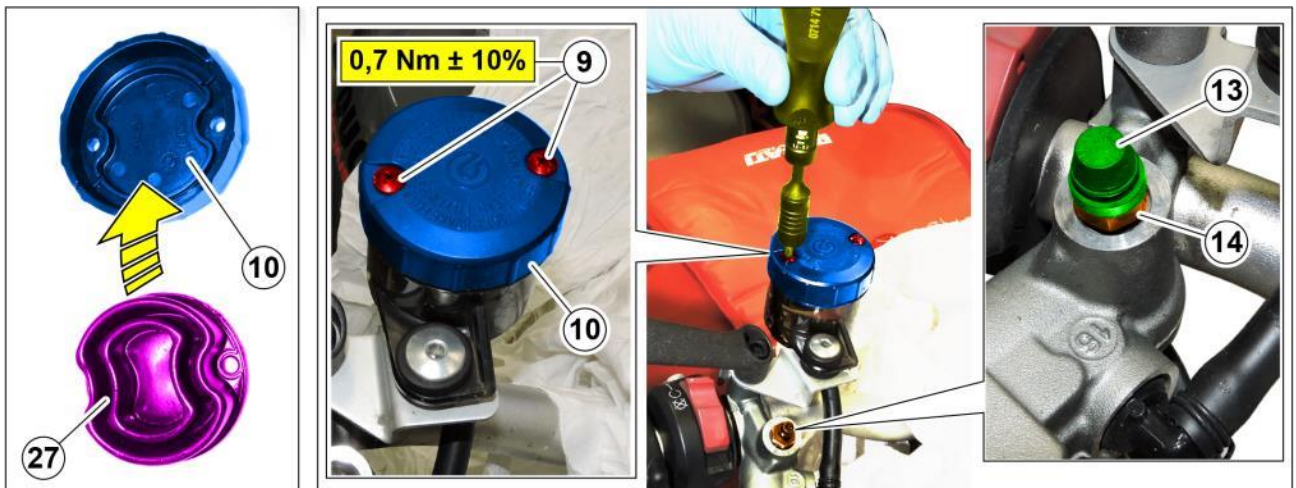
- 2) Flush **diaphragm (27)** and **cover (10)** with abundant WATER and dry with compressed air.
- 3) Install **diaphragm (27)** inside **cover (10)**.
- 4) Install **cover (10)** on brake fluid reservoir, start the no. 2 screws **M4x45 (9)** and tighten them to the indicated torque.
- 5) Install **bleed cap (13)** to **bleeder union (14)**.

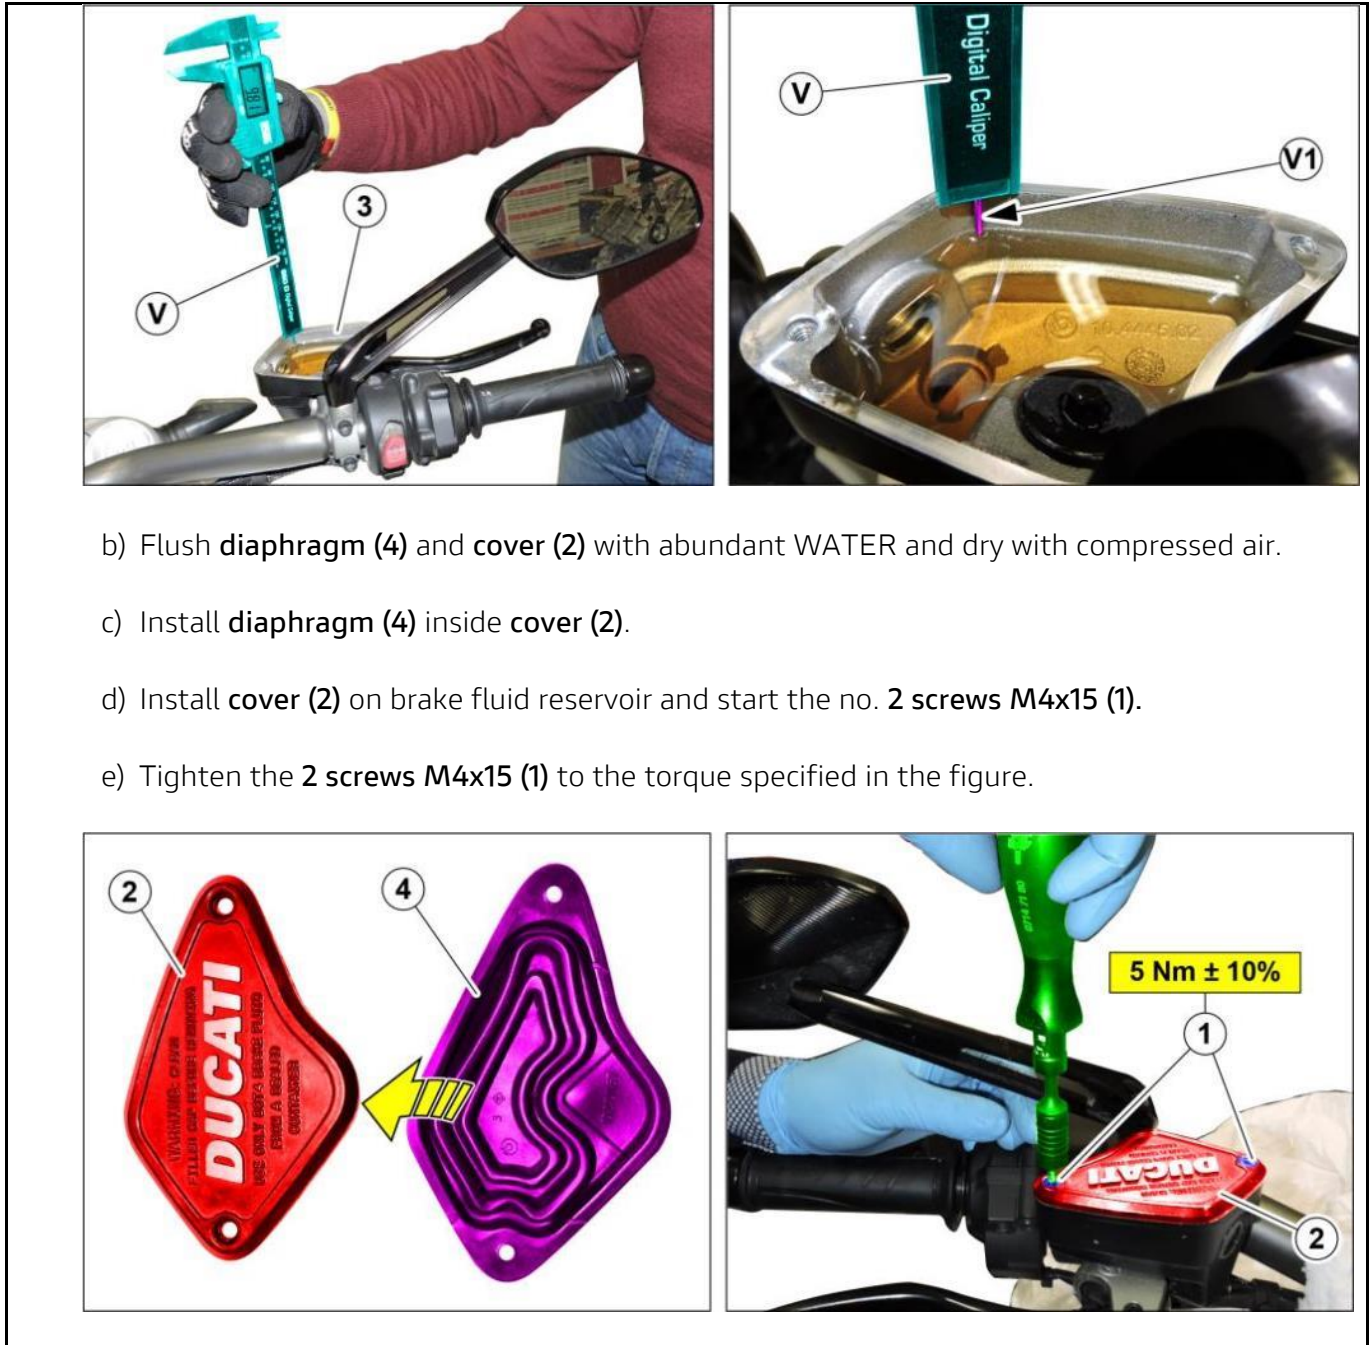
XDIAVEL S ONLY

- b) Flush diaphragm (4) and cover (2) with abundant WATER and dry with compressed air.
- c) Install diaphragm (4) inside cover (2).
- d) Install cover (2) on brake fluid reservoir and start the no. 2 screws M4x15 (1).
- e) Tighten the 2 screws M4x15 (1) to the torque specified in the figure.

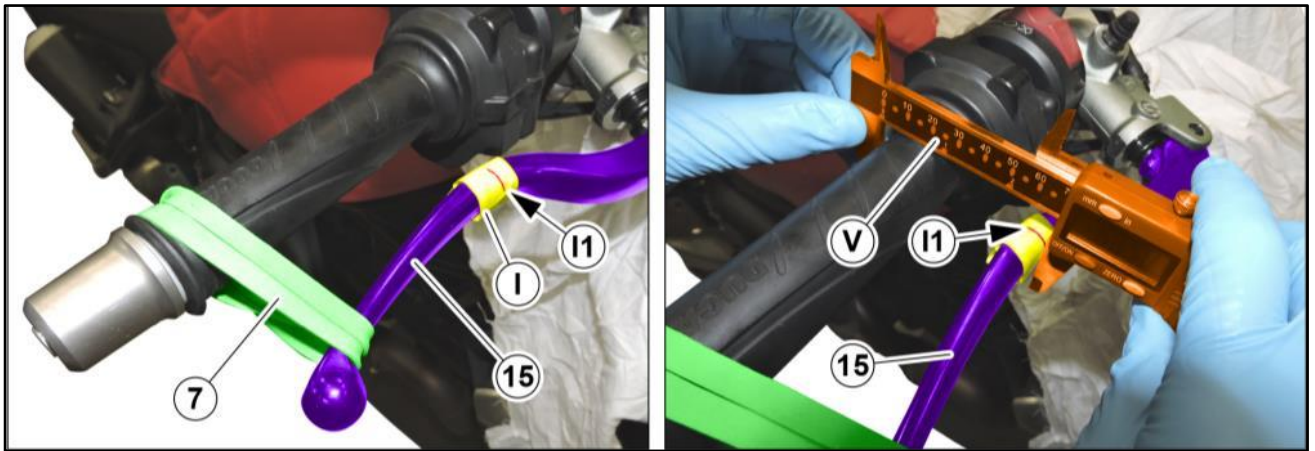
- 2) Apply some **adhesive tape (I)** at the point where **brake lever (15)** bends. Mark the centre of the **adhesive tape (I)** with a **reference mark (I1)** as shown in the figure.
- 3) Use a **gauge (V)** to measure the distance from the throttle twist grip to the **reference mark (I1)** as shown in the figure.
