Brembo Front Brake Master Cylinder

Recall Bulletin SRV-RCL-18-001

NHTSA Campaign I.D. Number: 17V-812

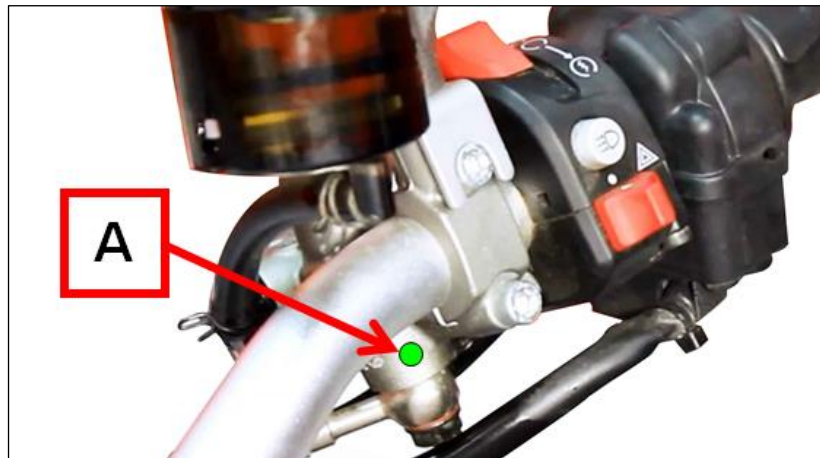
After this service, use a green permanent marker to mark successful completion of the service, draw a clearly visible dot (A) in the area indicated in the picture below:
