FIAT CHRYSLER AUTOMOBILES

Campaign T59 - Brake Booster on 11-14 WK/WD

November 2017

Summary of T59

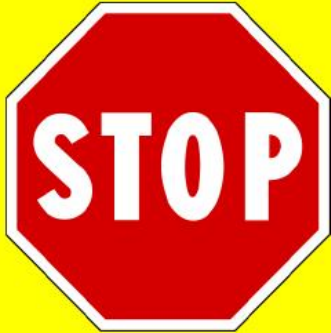
Brake booster water shield must be installed correctly in order to function properly.

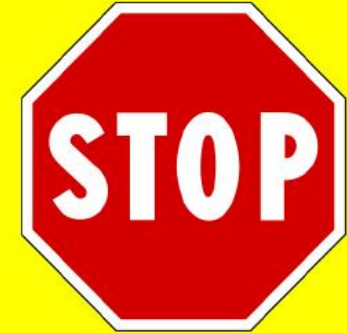
1 Tab edges must be flush with edges of the brake booster.

Refer to the instructions in recall document T59 for further detail.

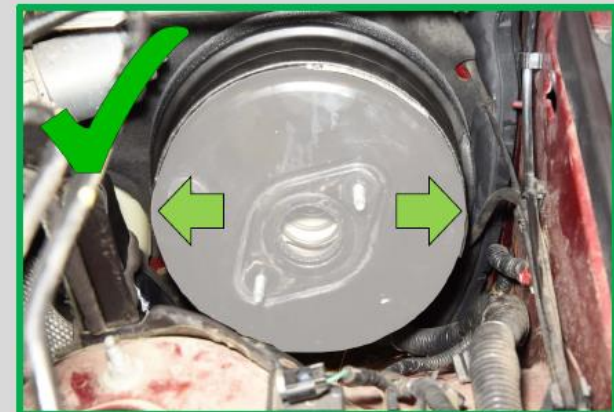
CORRECT

2 Tabs must be positioned at three o'clock and nine o'clock positions with booster installed in vehicle.

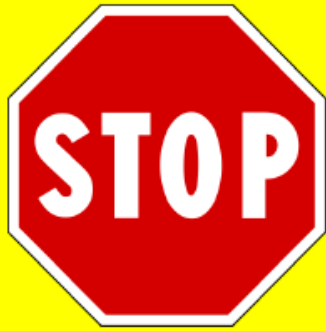
Brake booster water shield must be seated correctly in order to function properly.

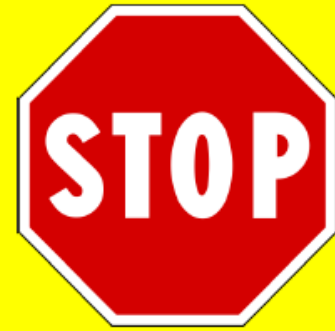
INCORRECT

Shield **must** be fully seated on the booster in the direction shown (arrows), with the tabs clearly visible (circled).
