MARKER LIGHT AND HEADLIGHT WORK INSTRUCTIONS FOR RECALL 17V 797

RELEVANT COACHES

Model: Bay Star, Bay Star Sport

Year(s): 2018

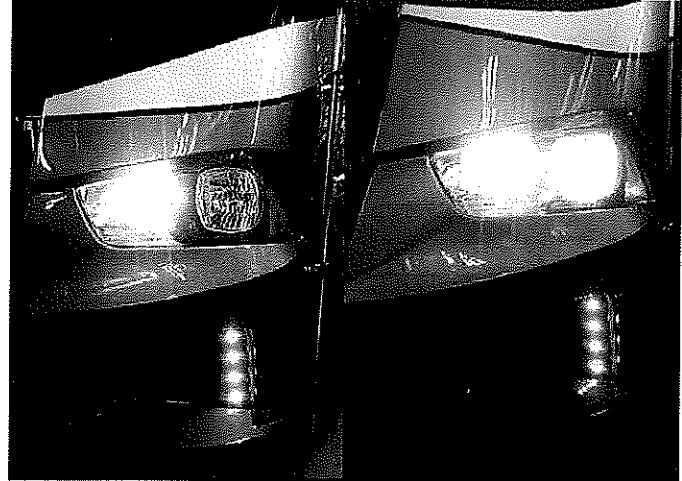
Recall 17V 797: The front side marker lights are not connected into the wiring harness. When the headlight high beams are activated, only the high beam bulbs illuminate. The intention of the high beam function on the affected coaches is to have both the high beam and low beam bulbs illuminate together.

Marker Lights and Headlights on high beam before the harnesses are installed (left) and after the harnesses are installed (right).

Follow the service procedure below to correct the condition.

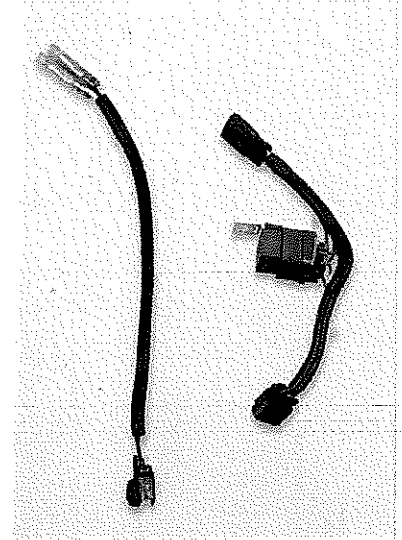
New Marker Light Harness (Left) and Headlight Harness with Relay (Right)

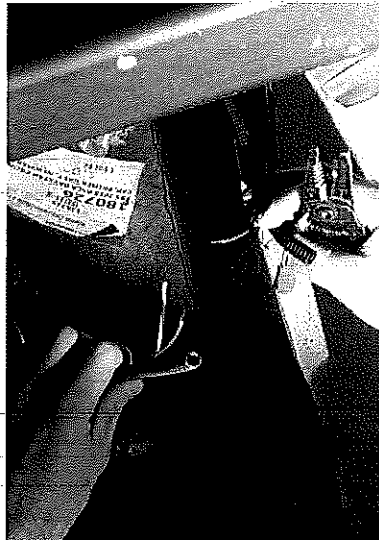
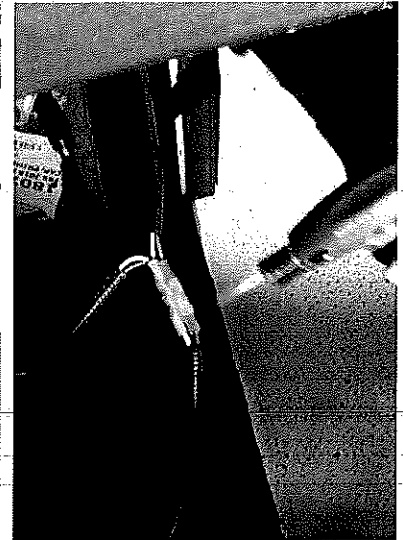
6. Cut the wire feeding into the four lower marker lights.
7. Pull the wire ends out of the loom, and strip the end of each wire.
8. Twist the white wires together, and crimp the yellow connector from the new marker light harness to the white wire.
9. Twist the brown wires together, and crimp the yellow connector from the new marker light harness to the brown wire.
10. Cut off the excess flexible conduit.
11. Heat the butt connectors with a small torch or lighter to create a water tight seal.
