P083NAS1

TECHNICAL BULLETIN

501-20B: Supplemental Restraint System

SAFETY RECALL: Takata Passenger Airbag

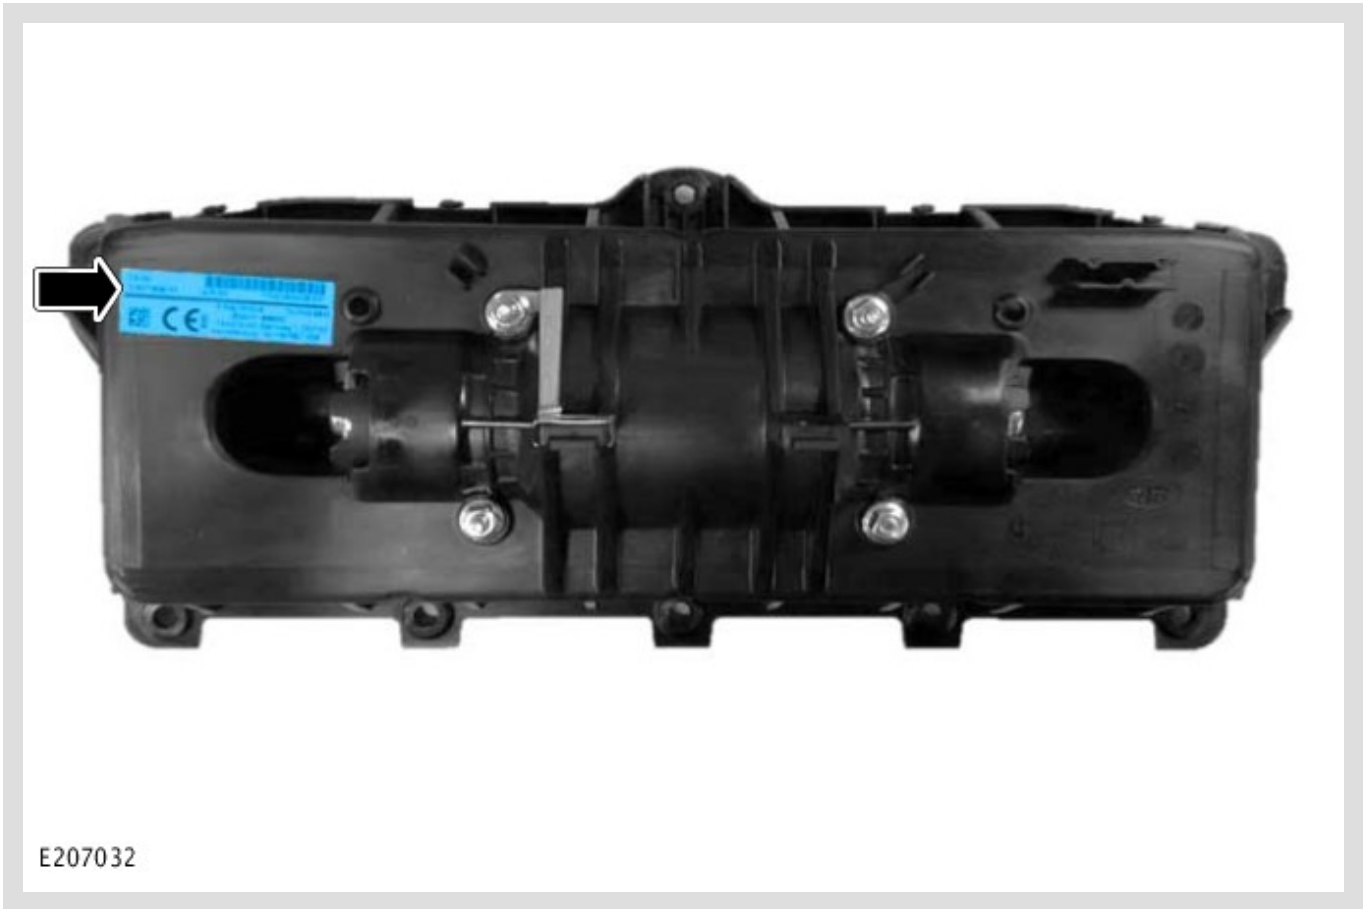
1

Locate the label on the rear side of the replacement passenger airbag module.

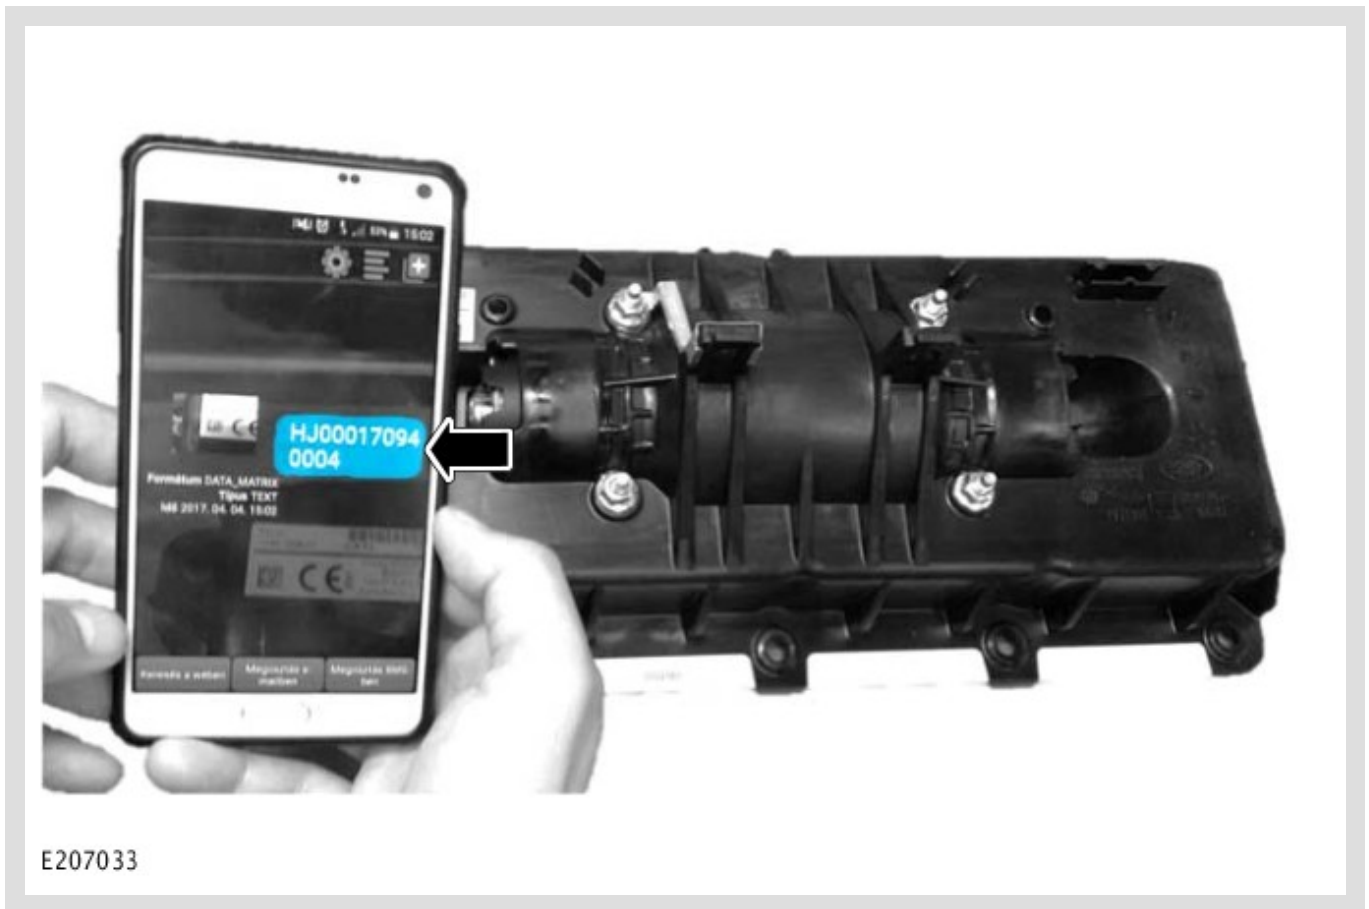
3

Use a smartphone with a QR scanner application to scan the QR code on the passenger airbag module label.

- The passenger airbag module serial number will be displayed on the screen.

- Record the replacement airbag serial number on the claim verbatim.
- If access to a smartphone or tablet with a QR scanner is not possible, take a clear photograph of the QR label and email to jlrcamp@jaguarlandrover.com with the Vehicle Identification Number (VIN) of the affected vehicle. A response will be sent with the passenger airbag module serial number, which must be recorded on the claim verbatim.
