P084NAS1

TECHNICAL BULLETIN

501-20B: Supplemental Restraint System

SAFETY RECALL: Takata Passenger Airbag

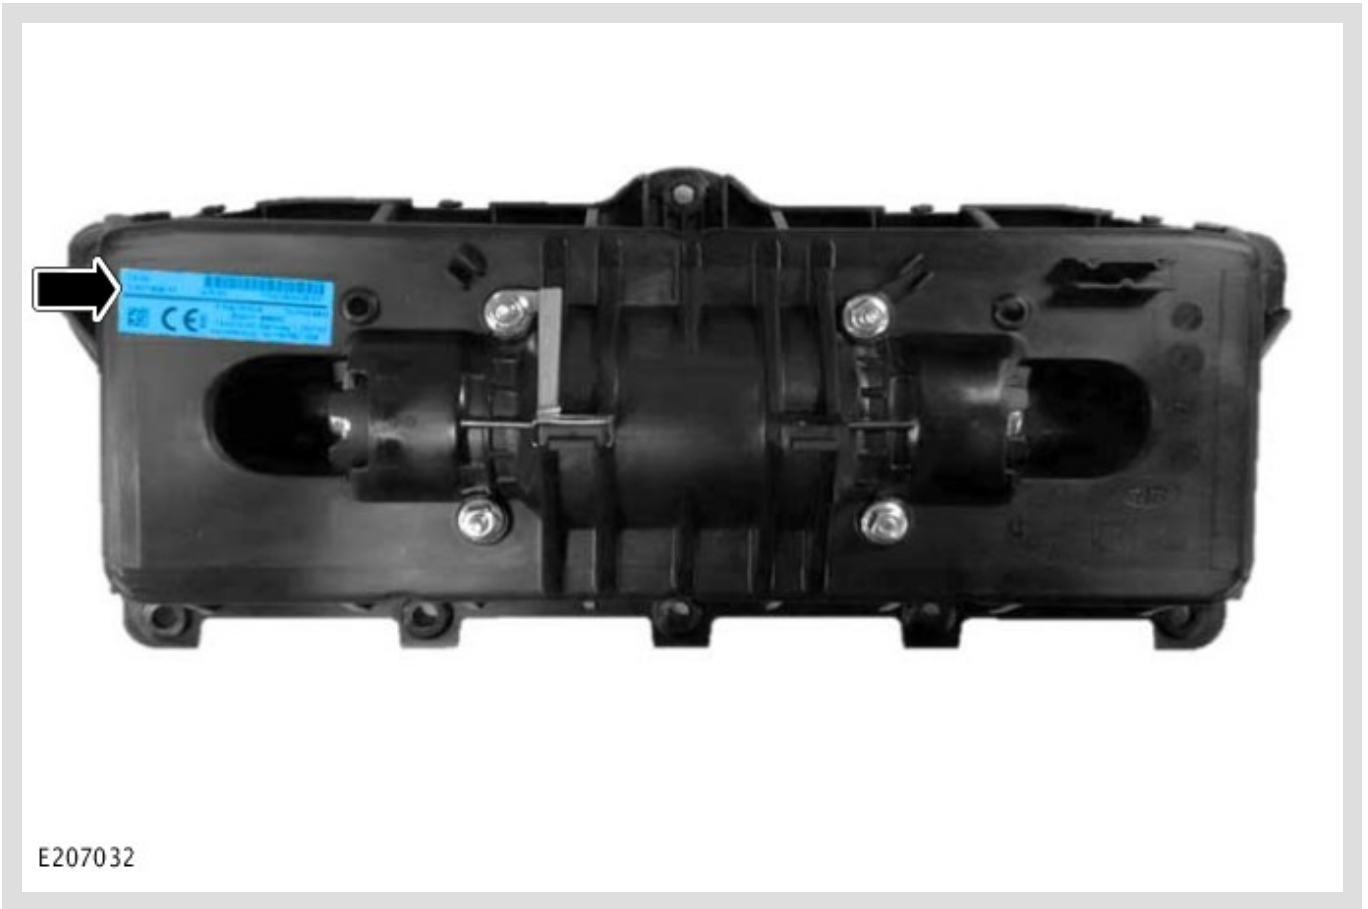
1

Locate the label on the rear side of the replacement passenger airbag module.
