Recall Campaign

FL761A-C

Subject: TBB Minotour Wheelchair Lift Interlock

Models Affected: Specific Thomas Built Buses Minotour buses equipped with an optional wheelchair lift manufactured June 22, 2007, through December 8, 2017.

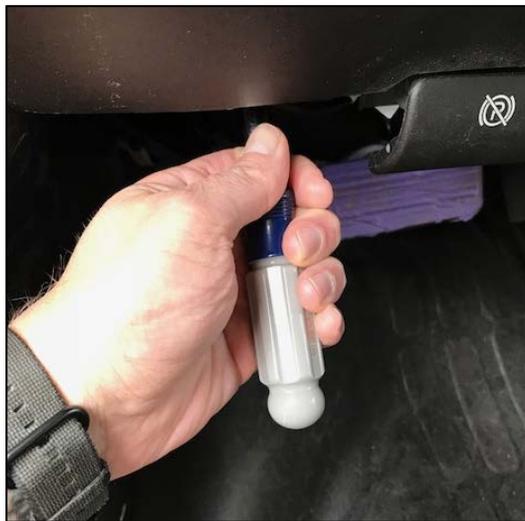
Figure 1: Location of Screws Beneath the Steering Column Panel

1. If necessary, park the vehicle, shut down the engine, place in park, set the parking brake, and chock the tires.
2. Remove the panel just below steering column. Using a 10 mm socket, remove the two screws underneath the panel. See **Figure 1**.

1. If necessary, park the vehicle, shut down the engine, place in park, set the parking brake, and chock the tires.
2. Remove the panel just below steering column. Using a 10 mm socket, remove the two screws underneath the panel. See **Figure 1**.
3. Compare the connections to **Figure 2**.
If the connections are the same, continue with the next step.
If the connections are different, install TBB 175974 (HARNESS, LIFT INTERLOCK, 2012 GMC) and perform the inspection and repair for FL761A&C. Go to *FL761A & FL761C – Wheelchair Lift Interlock Inspection (Standard Operation)*.
4. Open the PC circuit board cabinet (above the driver's seat) and prop the door open. See **Figure 4**.
5. Remove the three screws indicated in **Figure 4** and lay the PC board down.

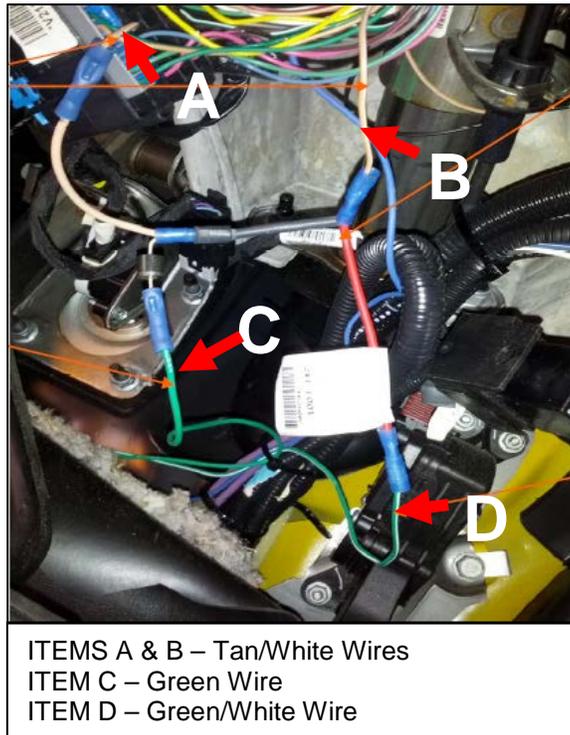
Figure 2: Current Harness Installation

3. Cut the two brown wires between the connectors shown in **Figure 2 Items A and B** as close to the butt splice as possible (to allow connection to the new harness).
4. Install new harness TBB 175974 as shown in **Figures 2 and 3**.
 - 4.1 Connect the new harness to Positions A and B, where the brown wires were cut.
 - 4.2 Connect the existing green wire to Position C on the new harness.
 - 4.3 Connect the existing green/white wire to Position D on the new harness.
5. Repeat the inspection procedure.

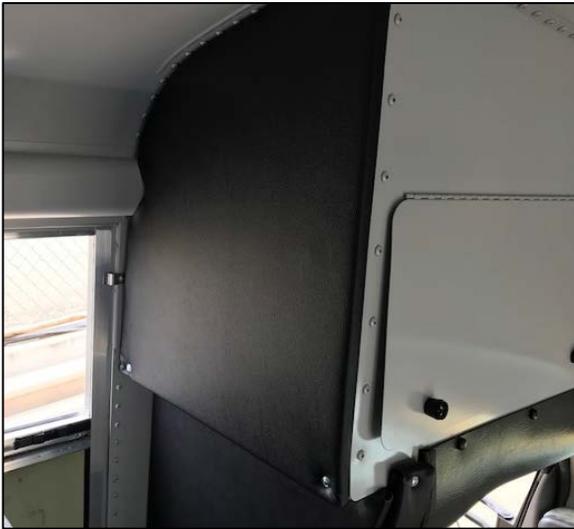
Figure 5: Side Cushion

6. Remove the side cushion, retain it and screws. See **Figures 5 and 6**.

12. Verify the system works correctly by repeating the earlier inspection procedures in these work instructions. If it does not, verify the installation and make any changes needed.
13. Secure any loose wires. Verify there are no wires that could rub or contact a rough/sharp surface.
14. Reinstall the side cushion with the screws removed earlier.
15. Remount the PC board mounting panel.
16. Remove chocks from the tires.

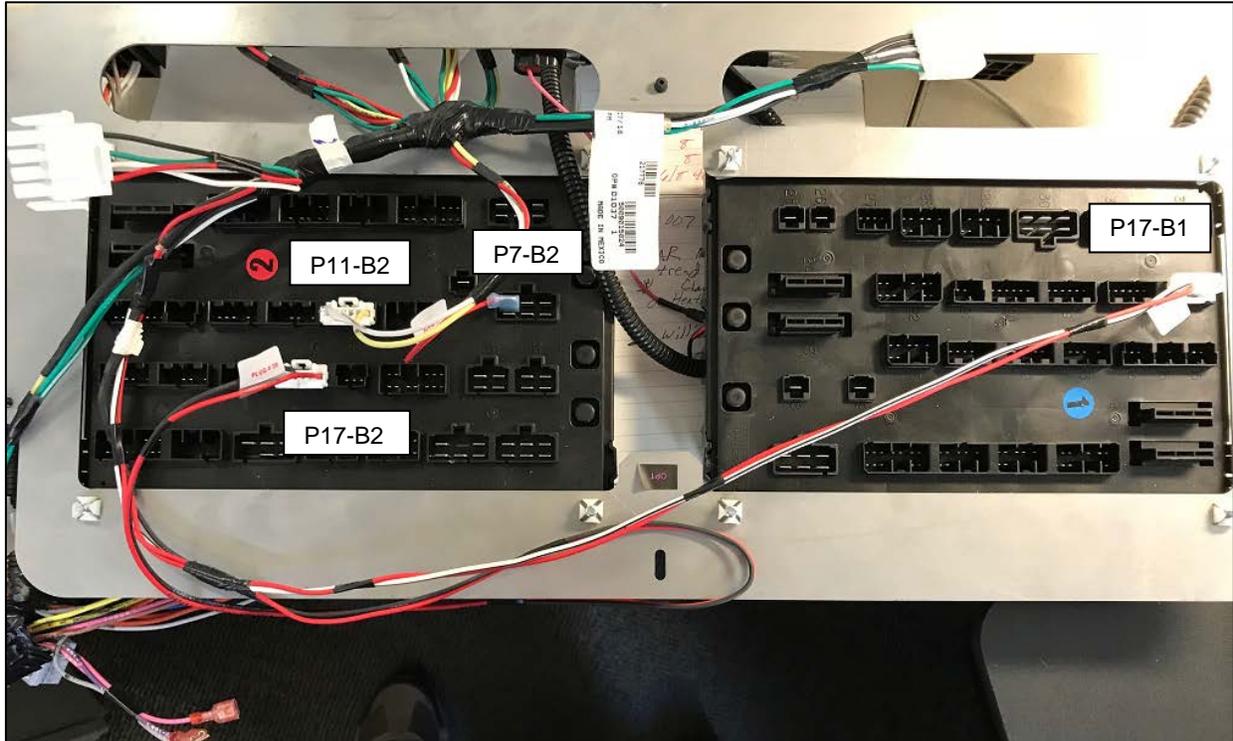
Figure 7: Rear of PC Boards Showing Connections, Only

7. Remove the existing harness and install the new harness TBB 217778. The old and new harnesses have the same connection points on the back of the boards and connecting harnesses. **Figure 7** shows the locations on the back of the PC board. The remaining plugs on the harness will be connected to harnesses that are not plugged into the PC boards.

8. Remove each plug on existing harness TBB PC150043 from the PC Boards one at a time and replace with the corresponding plug from the new harness TBB 217778. Once the PC board plugs are swapped, do the same with the remaining connections to harnesses as labeled.
