# Recall Bulletin 180315REV

Inspection /  
Correction  
of HVAC  
potentiometer  
wiring

**KEYWORDS:**  
HVAC, Aurora,  
wiring

**ISSUE DATE:**  
May 2018

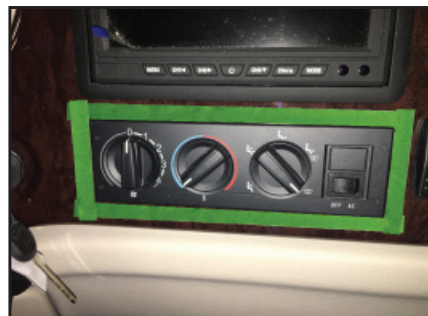
3. Locate the HVAC control panel on the dash. See Figure 1. Apply painter's tape to the perimeter of the HVAC control panel to avoid scratching the dash.

19. Reinsert the HVAC control panel assembly into the dash mounting bracket. Push on the HVAC control panel until a click is heard and the HVAC control panel's face plate is flush with the mating component. Refer to Figure 1 on Page 2.

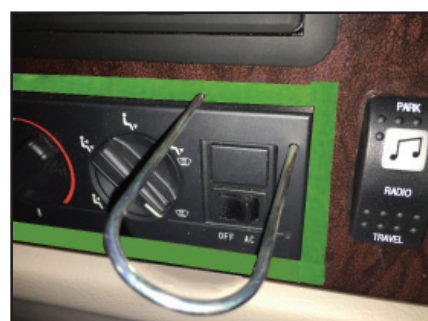
Figure 2

- If the knock-out plugs have been removed proceed to Step 7.
  - If the knock-out plugs have not been removed, use a pair of HVAC control panel removal tools (see Tools list on Page 7) to punch out the knock-out plug on one of the corners on the HVAC control panel. Repeat for the remaining three knock-out plugs. Refer to Figure 2.

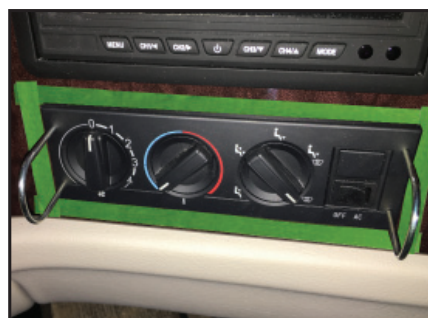
Figure 3

7. Slide the pair of HVAC control panel removal tools into face of the HVAC control panel until both have been inserted approximately 2" and/or you hear them "click" into place. See Figure 3.

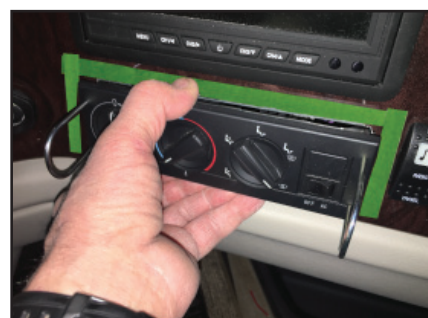
Figure 4

8. Grab the edges of the HVAC control panel face plate as shown in Figure 4. Gently pull on the face to remove the entire HVAC control panel assembly. Use extreme care when sliding out the HVAC control panel assembly to prevent displacing any of the six purple wires on the back side.

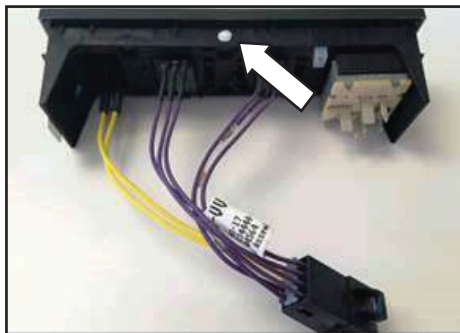
Figure 5

- If a white dot is present on the top of the control panel as shown in Figure 5, the panel has already been replaced by Aurora and it may be reinstalled.

**Photo Requirement:** Take photos of the top and back of the controller clearly showing the white dot; submit them with the claim and also keep on file at the dealership.

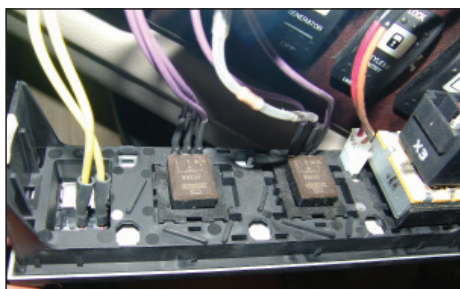
Figure 6

- If a white dot is not present on the back of the control panel, **and** if the purple wires on the back of the control panel are attached to a square potentiometer (as shown in Figure 6) , refer to Figure 7 and remove the plug connections (labeled 1 and 2) from the back of the control panel; leave the yellow and purple wires attached to the control panel.

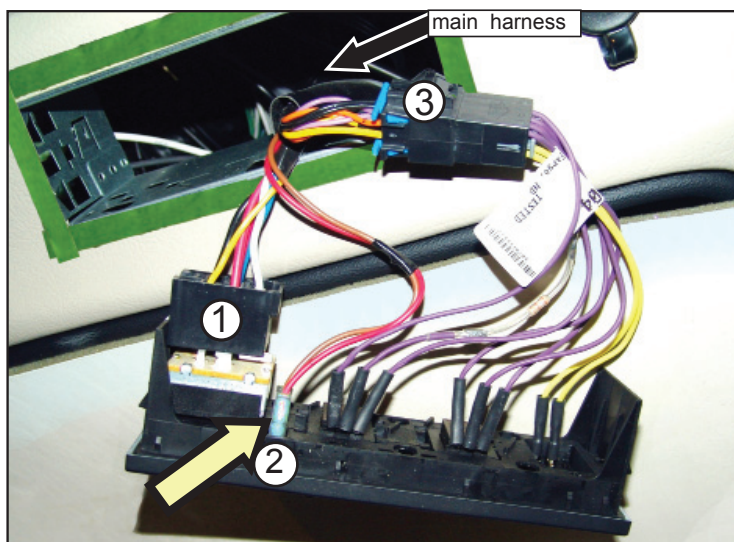
Trace the yellow and purple wires approximately 6" and disconnect the large black connector (labeled 3) from the main harness.

Disconnect connectors indicated by balloons labeled 1, 2 & 3, above

18. Position the HVAC control panel near the opening from which it was removed. Referring to Figure 7 on Page 3, re-attach the large connector (labeled 3) to the main harness. Reconnect the remaining two connectors to the back of the HVAC control panel. Ensure all connectors snap into place.

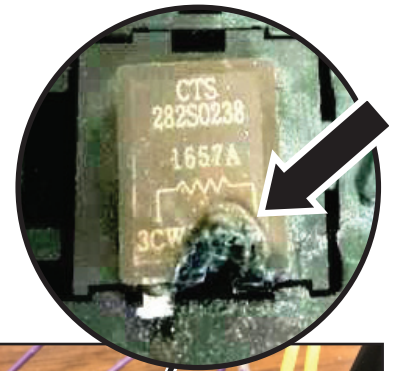
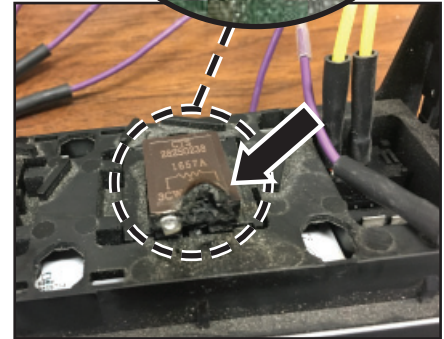
**Figure 8**

11. Inspect the back of the HVAC control panel assembly for evidence of burnt components similar to what is shown in Figure 8. If no damage to the components is found, and if all 6 purple wires are connected, take photos, and then proceed to Step 12.

**IMPORTANT:** If any burnt components or incorrectly connected wires are found, contact REV Dealer Technical Support for instructions and to obtain a new Aurora brand HVAC control panel assembly.

**DO NOT REINSTALL A MIS-WIRED OR DAMAGED HVAC CONTROL PANEL ASSEMBLY.**

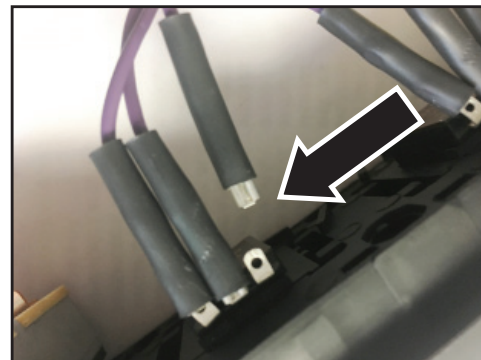
Figure 10

13. Carefully remove one purple wire from the back side of the HVAC control panel and push back the protective sleeve to expose the terminal. See Figure 10.

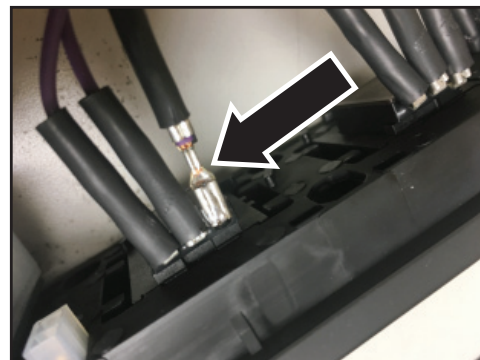
Figure 11

14. Reconnect the purple wire to the terminal from which it was removed and solder the termination as shown in Figure 11. Exercise care when soldering the connections and applying heat. Only heat the connection enough to allow the solder to flow over the connection.

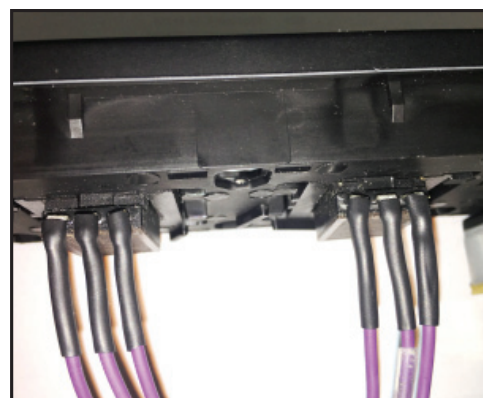
Figure 12

15. Allow the soldered termination to cool completely. Slide the protective cover on the purple wire over the soldered connection as shown in Figure 12.

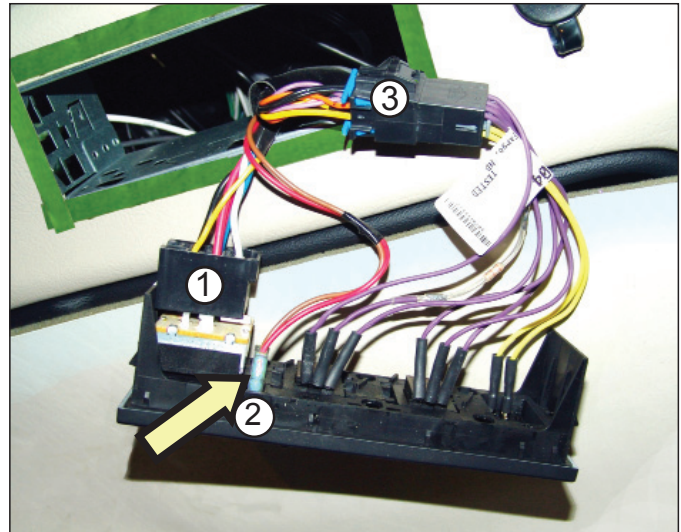
Figure 13

24. Position the new Aurora HVAC control panel near the opening in the dash. Referring to Figure 13, attach the large connector (labeled 3) to the main harness. Reconnect the remaining two connectors (labeled 1 and 2) to the back of the HVAC control panel.

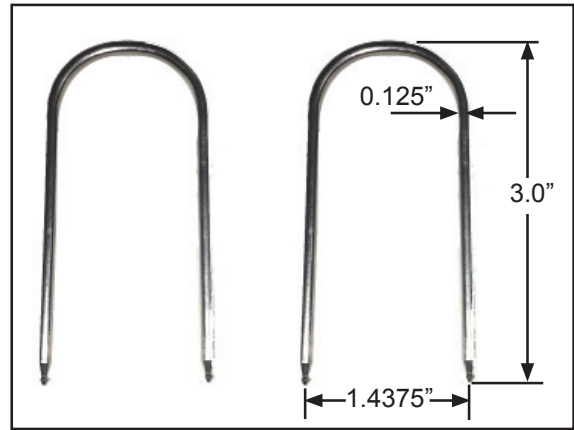
HVAC Control Panel Removal Tools - 1 pair

Note: HVAC removal tools (pictured) are the same tools commonly used for radio removal.
