IMPORTANT! U34 Safety Recall Update

TO: ALL ALFA ROMEO GROUP DEALERSHIPS IMPORTANT U34 SAFETY RECALL UPDATE WATER INTRUSION ON 2018 ALFA ROMEO STELVIO LIFT GATE

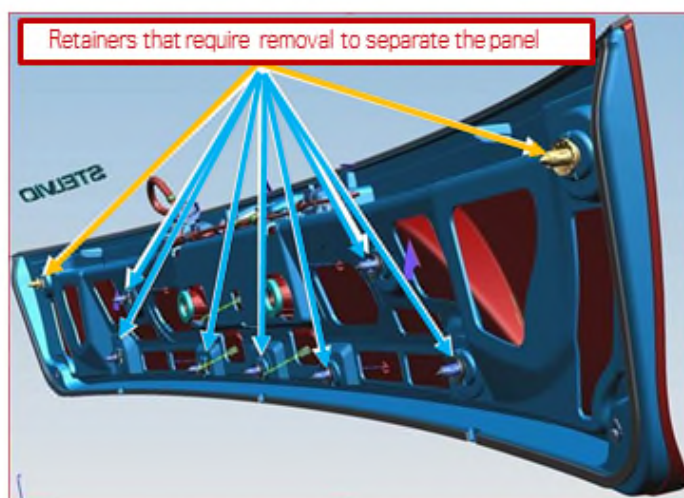
When removing the interior trim panel of the lift gate *please exercise care*. The clips utilized require the inner retainer to be released from the clip housing prior to pulling on the panel. Please reference the picture below showing the number and location of the trim clips. Please utilize:

**Part#
68255569AA
(Qty 2)**
*designated by
yellow arrows
below*

**Part#
68413365AA
(Qty 7)**
*designated by blue
arrows below*

- A trim remover tool (Special tool # C-4829A) or suitable trim stick to release the clips.

To remove the clip, slip a trim removal tool under the head of the retainer (shown in yellow) and press upwards.

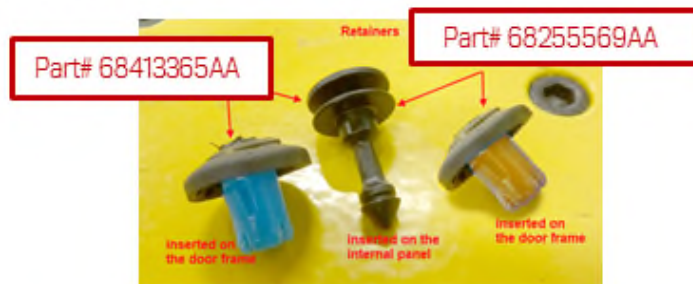
If, in the process of the recall repair, the clips are damaged, replacement clips will be available through Mopar. Below are descriptions and photographs of the parts for reference.

Part#	Pack Size (MSQ)
68255569AA	5
68413365AA	10
