TO: Mercedes-Benz Dealer Principals, General Managers, Sales Managers, Service Managers, Parts Managers	FROM: Gregory Gunther, Department Manager, Vehicle Compliance and Analysis, Engineering Services
RE: Recall Campaign 2018040007 – Phase 1 Launch Notification Check Seatback Lock MY17 18 205 238 (C-Class, E-Class Coupe & Cabriolet)	DATE: April 27, 2018

Campaign No. 2018040007, April 2018

SUBJECT: **Models 205 and 238 Model Years 2017 and 2018**
Check Seat Back Lock

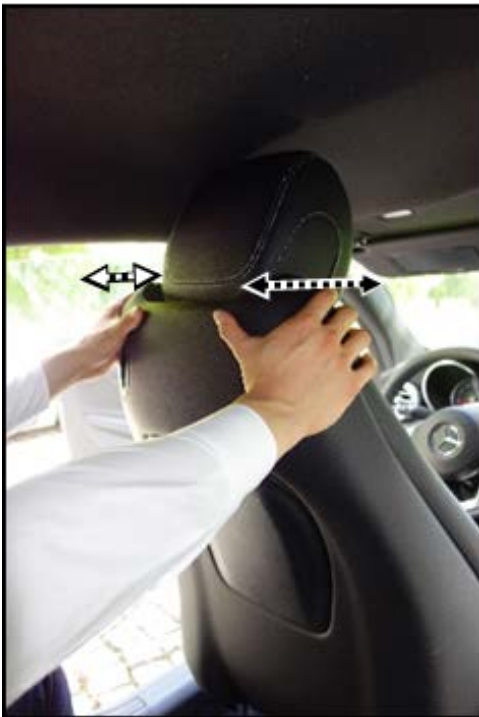
Figure 1 (left front seat)

i The play must be the **same** on both the right and left sides.

i If the play is not correct, the **right** side of the seat backrest has a **significantly larger amount of play** than the left (figures 1 and 2)!

- a. **Play** of the seat backrest frame **not** ok: Carry out **work procedure**.
- b. **Play** of the seat backrest frame is **ok**: **End measure**.

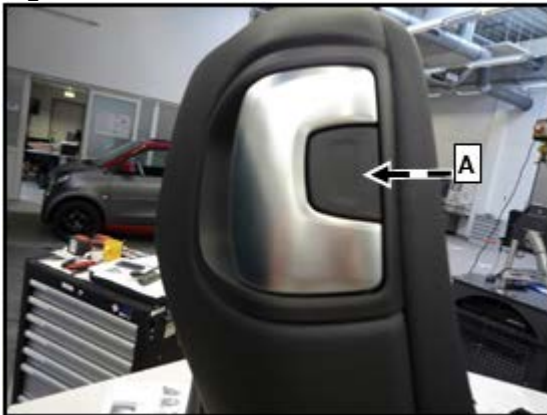
Figure 4

- 2.2. Press release handle (**A**) of the front seat (**figure 4**).

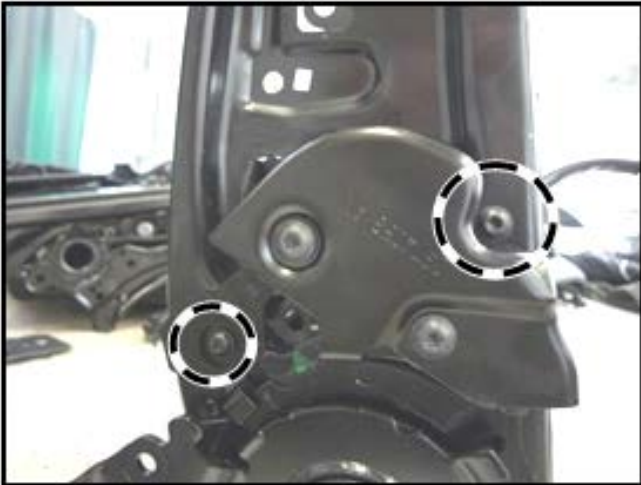
Figure 9

9.3.1. Remove screws/bolts (figure 9).

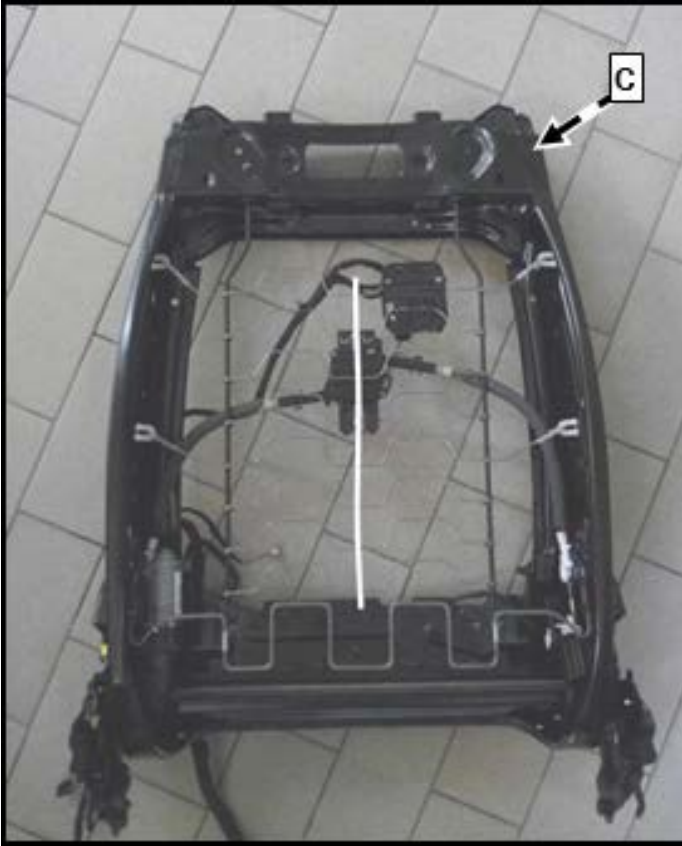
Figure 11

10. Replace seat backrest frame (C) (figure 11).
