**SUBJECT: NEW VEHICLE DEMONSTRATION / DELIVERY HOLD -
 Safety Recall 18S37 - *Supplement #2***

Certain 2018 Model Year Expedition and Navigator Vehicles with 40/20/40 Second Row Seating
 Second Row Center Seat Frame Inspection

CERTAIN 2018 MODEL YEAR NAVIGATOR AND EXPEDITION VEHICLES — SECOND ROW CENTER SEAT FRAME INSPECTION

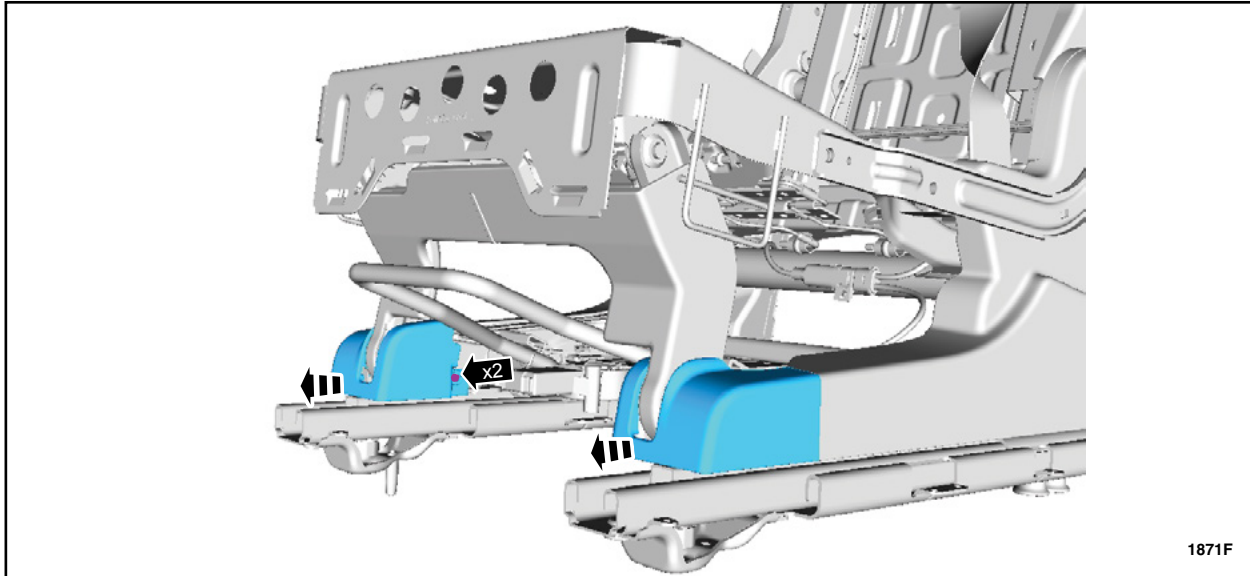
FIGURE 7

7. Remove the retainers and both front seat track shields. See Figure 7.

21. Install the seat outer side shields and the retainers. See Figure 11.
22. Install the inner side seat shields and the retainers. See Figure 8.
23. Install the front crossbar frame panel and the retainers. See Figure 7.

24. Position the seat cushion frame rearward toward the seat backrest frame and install the retainers. See Figure 8.
25. Install the front upper seat track covers and the retainers. See Figure 7.

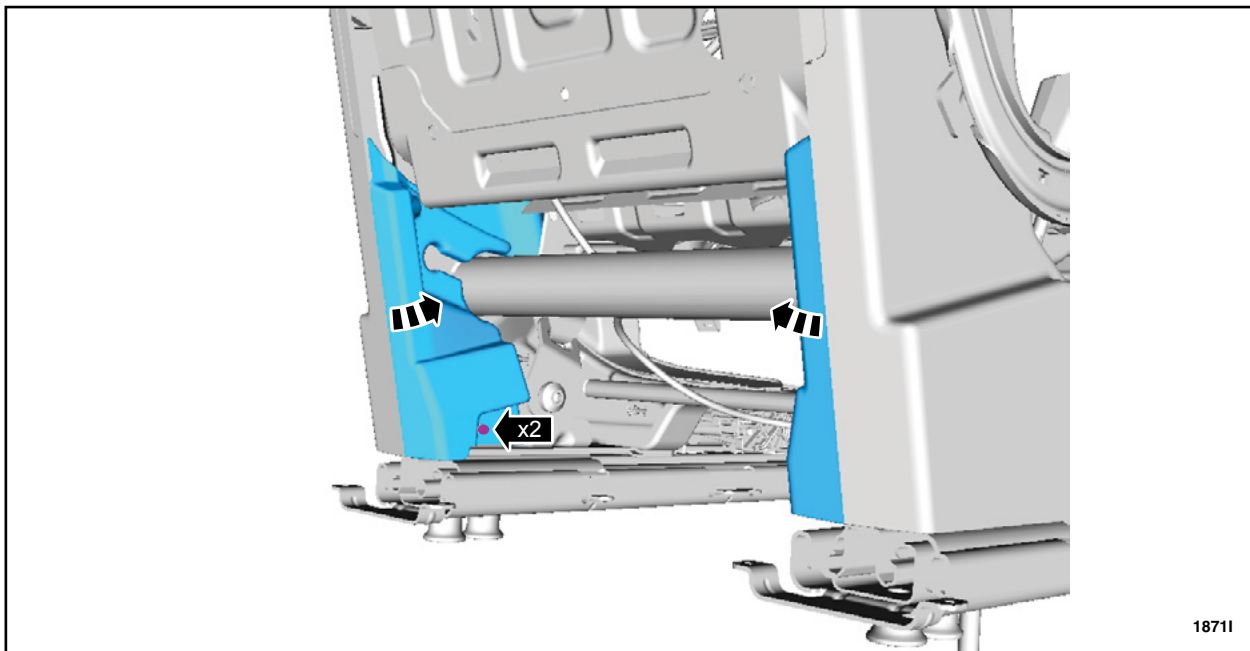
FIGURE 10

10. Remove the retainers and the inner side seat shields. See Figure 10.

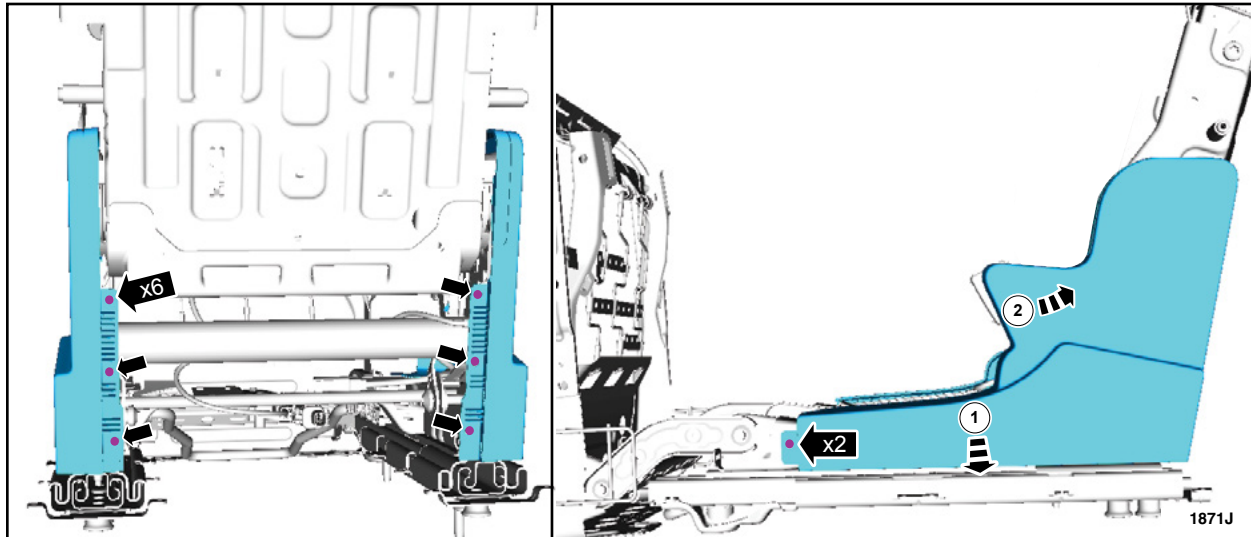
FIGURE 11

11. Remove the rear and the side retainers from the seat outer side shield and remove the shields.
See Figure 11.

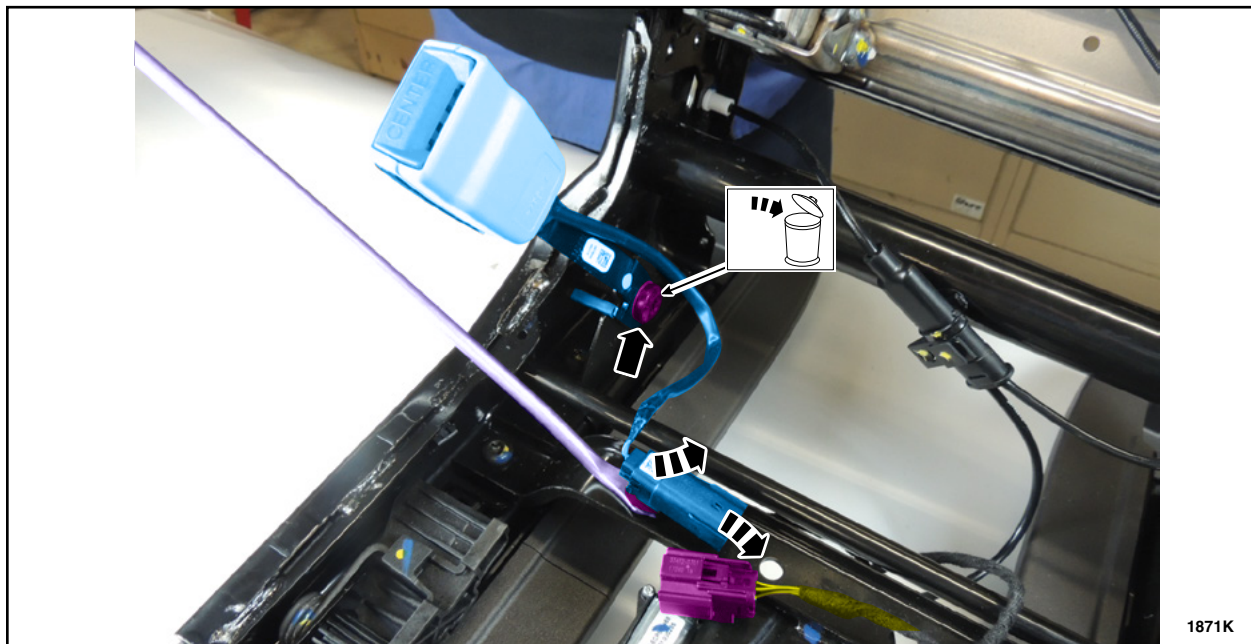
FIGURE 12

12. Detach the push pin retainer and disconnect the second row center seatbelt buckle electrical connector. See Figure 12.
13. Remove and discard the second row center seatbelt buckle retainer and position aside the buckle.
See Figure 12.

- Torque: 30 lb.ft (40 Nm).

19. Using a *new* retainer, install the seatbelt buckle. See Figure 12.
20. Connect the seatbelt buckle electrical connector and attach the push pin retainer. See Figure 12.

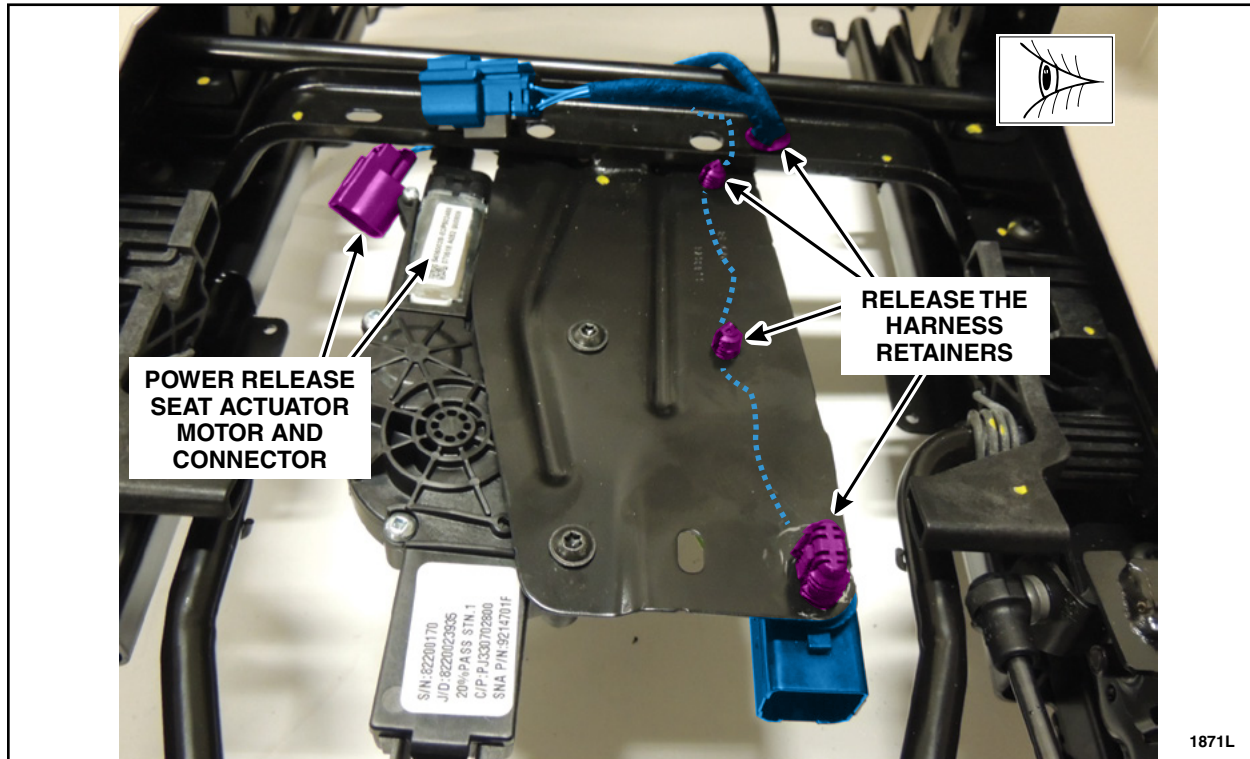
FIGURE 13

14. Disconnect the power release seat actuator motor electrical connector. See Figure 13.
15. Detach the pin-type retainers and remove the seat jumper harness assembly from the seat frame. See Figure 13.

NOTE: Note the jumper harness routing for proper installation.

17. Install the seat jumper harness assembly to the seat frame. See Figure 13.
18. Connect the power release seat actuator motor electrical connector. See Figure 13.
