# IMPORTANT SAFETY RECALL

**Mitsubishi Motors North America, Inc.**

**Reason for notice:** Mitsubishi Motors North America, Inc. (MMNA) has decided that certain 2018-2019 Outlander vehicles fail to conform to Federal Motor Vehicle Safety Standard (FMVSS) No. 110 "Tire Selection and Rims." Due to a production oversight, an incorrect rear wheel rim size was printed on the FMVSS Part 567 certification label (located at the lower portion of your vehicle's driver side B-pillar). If the wheels are replaced with those of an incorrect rim size, it can result in an increased risk of a vehicle crash.

## LABEL INSTALLATION PROCEDURE

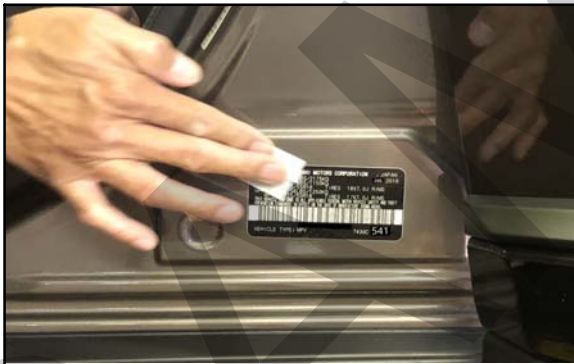
2. Gently clean and dry the surface of the original label with isopropyl alcohol and a clean cloth.

**Do NOT** use a denatured alcohol or any other higher solutions of alcohol.

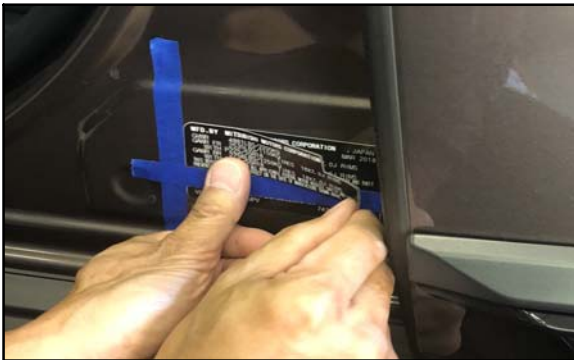
5. Apply the overlay label onto the original label.

**IMPORTANT:** Ensure the overlay label is properly positioned before allowing contact with the original label.

If the overlay label is not properly positioned or damaged, contact the Mitsubishi Customer Relations Department at 888-648-7820 for a new label.

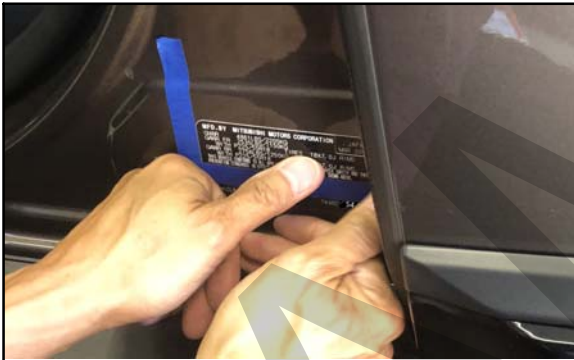
- a. Carefully align the overlay label with the vertical edge of the original label (or vertical painter's tape guide if used) and the top edge of the horizontal painter's tape guide, as shown.
- b. Once the overlay label is properly positioned, use your thumb to work out any air-bubbles or creases, starting from the bottom edge to the top edge.

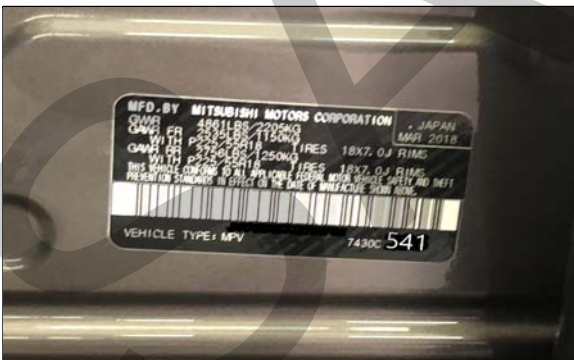
6. Remove the painter's tape carefully.
7. Close the driver's door to complete the procedure.
