IMPORTANT SAFETY RECALL

18V-750

ORIGINAL ISSUE DATE:	10/12/2018
REVISION DATE:	12/21/2018
SUBJECT:	ZF Rear Axle Caliper Swap Recall Campaign
RATIONALE:	Increased friction on caliper guide pins due to surface roughness creates a safety defect
VINS AFFECTED:	Proterra Specified 2015, 2016 & 2017 Catalyst Buses
COMPLETE BY:	Earliest Opportunity
SERVICE BULLETIN #:	SB-18-75 A
NHTSA RECALL NUMBER:	18V750
REVISION DESCRIPTION:	This Service Bulletin has been revised to clarify that these work instructions are provided pursuant to a Proterra initiated recall campaign and to specify that the required remedy be completed at the earliest opportunity. Please disregard earlier copies of Service Bulletin SB-18-75.
REMEDY KIT NAME / NUMBER:	Rear Axle Brake Calipers: RH=026230, LH=026231
ESTIMATED LABOR TIME:	3.5 Hours per Vehicle

ZF REAR AXLE CALIPER SWAP RECALL CAMPAIGN

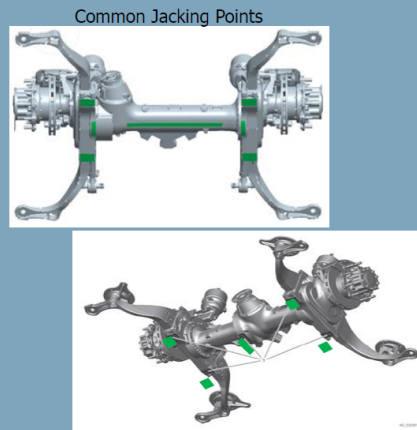
Jacking up the vehicle

1. Place lifting platforms under each single wheel and secure the vehicle against rolling away
2. Ensure by all means that ignition of the vehicle is OFF
3. Hoist the lifting platforms equally
4. Afterwards secure the vehicle with additional supports Increase the number of supports accordingly for an articulated bus (6 or 8 pieces)
5. Choose the correct supporting points of the vehicle Observe the vehicle manufacturer's instructions and stick to the markings
6. Place the support in a way to prevent it from being an obstacle
7. If using additional supports to secure the axle on the axle housing refer to ZF AV Axle Operating instructions manual for correct jacking points

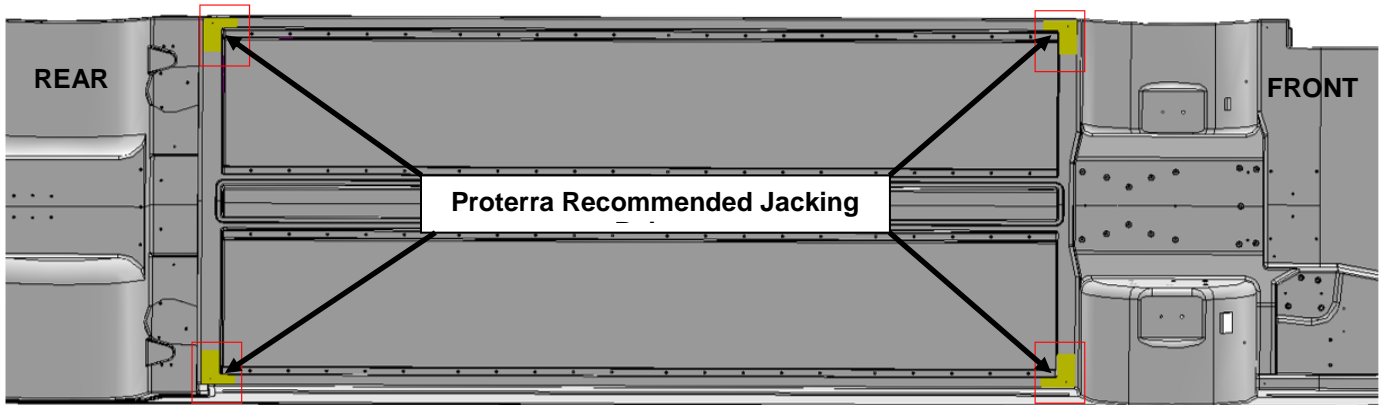
1. The locations shown below are the Proterra Recommended jacking/hoisting locations:

NOTICE! If the Jacking Plates can't be used, the preferred method to lift the bus is by using the Rear Axle and the Front 30" Lifting Areas shown below. The 35" Rear Lifting Areas may also be used if you can't lift by the Rear Axle.

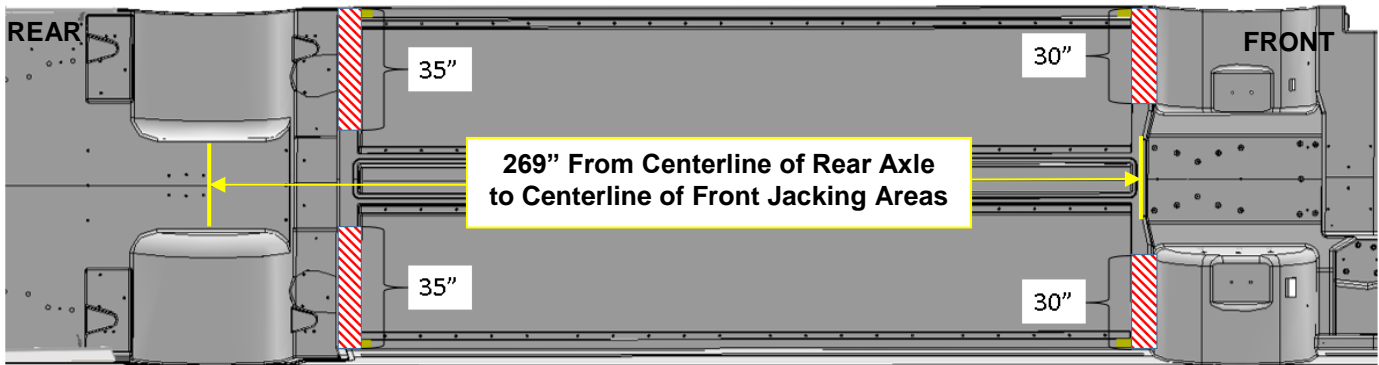
2. The bus may be picked up by the following locations, but **MUST** have a surface area of no less than 5 square inches per mounting pad that contacts the bus body. The zones shown below are acceptable lifting areas:

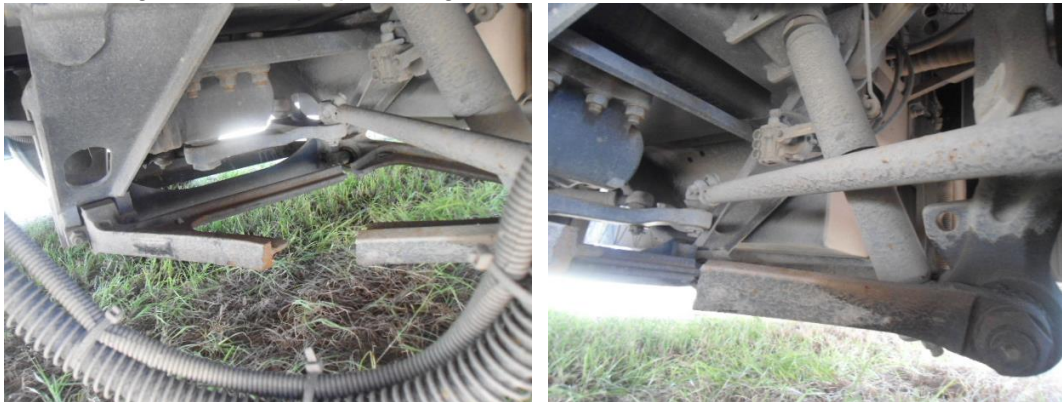
3. The bus should never be lifted by the front suspension A-arms. The following photographs show front end damage due to improper lifting.

NOTICE! If it is necessary to lift by the front suspension, only lift with the jack placed on the knuckle.

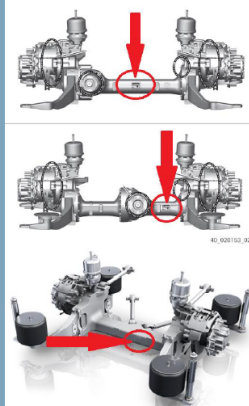
Type plate location

Serial number (2) and parts list number (3) information can be located on the I.D plate as shown below:

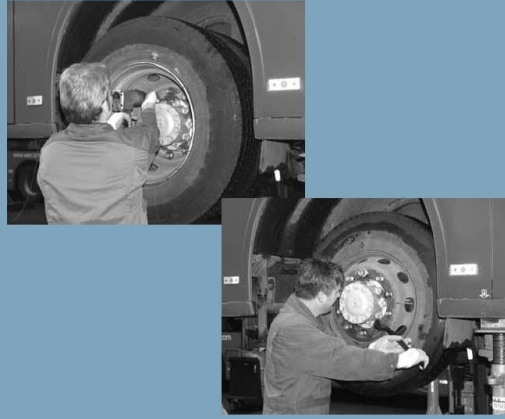
Removing the left and right wheels

1. Completely loosen the Lug nuts, but do not fully remove one of the nuts (in 12-o'clock position)
2. Support the wheel by a wheel lift, loosen the remaining Lug Nut and remove the wheel
3. Pay attention that the second wheel does not drop!
4. If the second wheel got stuck, screw in a Lug nut in 12 o'clock position by some thread turns
5. Then loosen the wheel by means of a suitable assembly lever
6. Support the wheel by means of a wheel lift. Unscrew remaining Lug nut and remove the releasing wheel

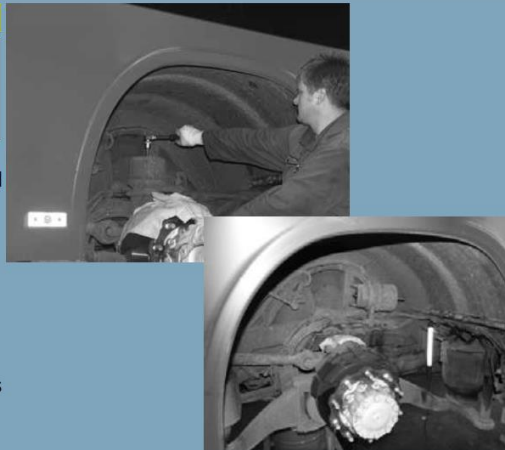
Removal of the brake chambers left and right side

1. Cage the parking brake

2. Do not use "power tools"!
3. Clean the surrounding of the attachment areas in order to avoid ingress of dirt into the interior of the brake
4. Loosen the locknuts and remove brake chamber
5. Fix brake chamber with suitable aids (e.g. wire, rope) in the wheel house and cover the openings
6. Inspect mounting face on the brake caliper for any signs of moisture (rust) or contamination
7. If corrosion or contamination is discovered inside the caliper, replace the caliper assembly per the manufacturer's instructions
8. Protect the mounting face on the brake caliper by an adequate protective cover or cloth

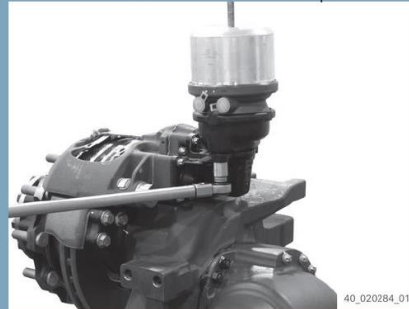
40_020284_01

- ✓ To install brake chamber proceed as follows:
 1. Ensure that the spring brake is still released by compressed air
 2. Mount brake chamber with the connections in direction as removed
 3. Fix brake chamber on brake caliper by means of new locknuts
 4. Tightening torque (M16x1.5) MA = 195 ± 15 Nm
 5. Release the caging bolt to the brake release position with the tightening torque specified by the manufacturer

Install new locknuts and torque

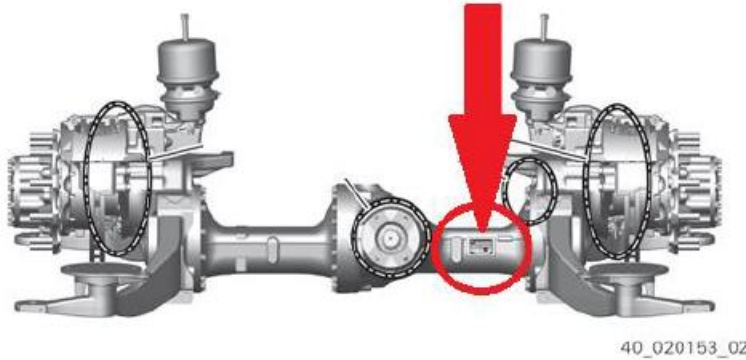
Record 1:	Record the ZF Axle Serial Number and Parts List Number		
	Location 2	Serial-No.	
	Location 3	Parts List No.

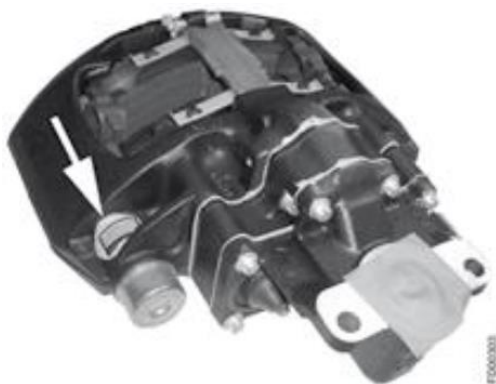
Record 2:	Record the Knorr-Bremse Brake Caliper Serial Numbers (Removed/Installed)		
		Circle One Side	Serial No.
	Removed Brake Caliper SN:	Curb Side / Street Side	
	Installed Brake Caliper SN:
