AJ12 - Checking Ski Bag and Replacing it if Necessary (Delivery Stop/Recall Campaign)

Model Line: **Cayenne (92A)
Macan (95B)**

Model Year: **As of 2017 up to 2018**

Subject: **Ski bag**

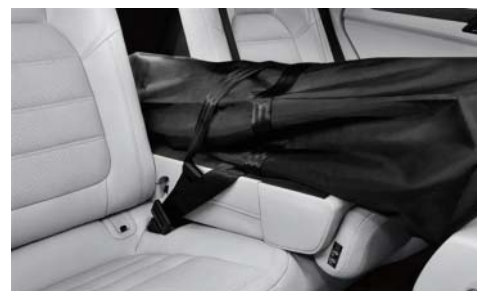
Ski bag

Information: **Ski bags on which the belt strap was sewn using unapproved sewing thread were supplied in the affected vehicles.**

The belt seams in question are not therefore as strong and robust as they should be.

As a result, there is a possibility that the belt strap will tear if pulled too tightly and the ski bag may not be held in position.

Remedial Action: Check date of manufacture of the ski bag and replace ski bag if necessary.

Work Procedure: 1 Check date of manufacture of the ski bag and replace the ski bag if necessary.

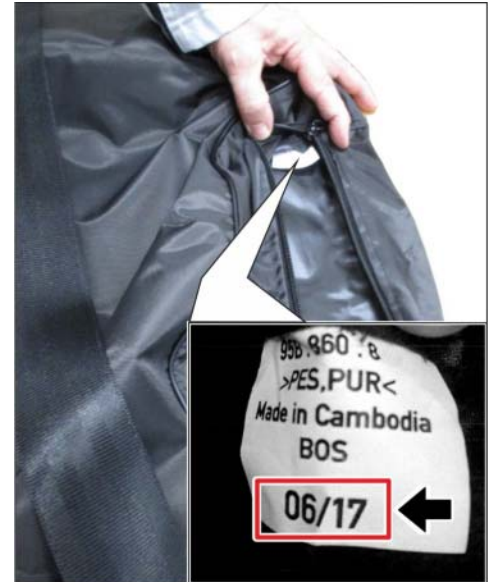
Date of manufacture of ski bag

Open the zip on the ski bag fully in order to check it. The label showing the date of manufacture is located on the inside of the ski bag at the end of the open zip
⇒ *Date of manufacture of ski bag -arrow-*.

- The date of manufacture is in the period **01/17 to 02/18** (inclusive): The ski bag must be **replaced**.
- The date of manufacture is **not within the period specified above**: The ski bag must **not be replaced**.
