Technical Service Bulletin: TSB180058

Belt Noise and Front Engine Accessory Drive Belt Re-routing: Tiffin Recreational Vehicles

- ISV 5.0 CM3230 V104

- Tiffin (**only** recreational vehicles with high mount refrigerant compressor options)

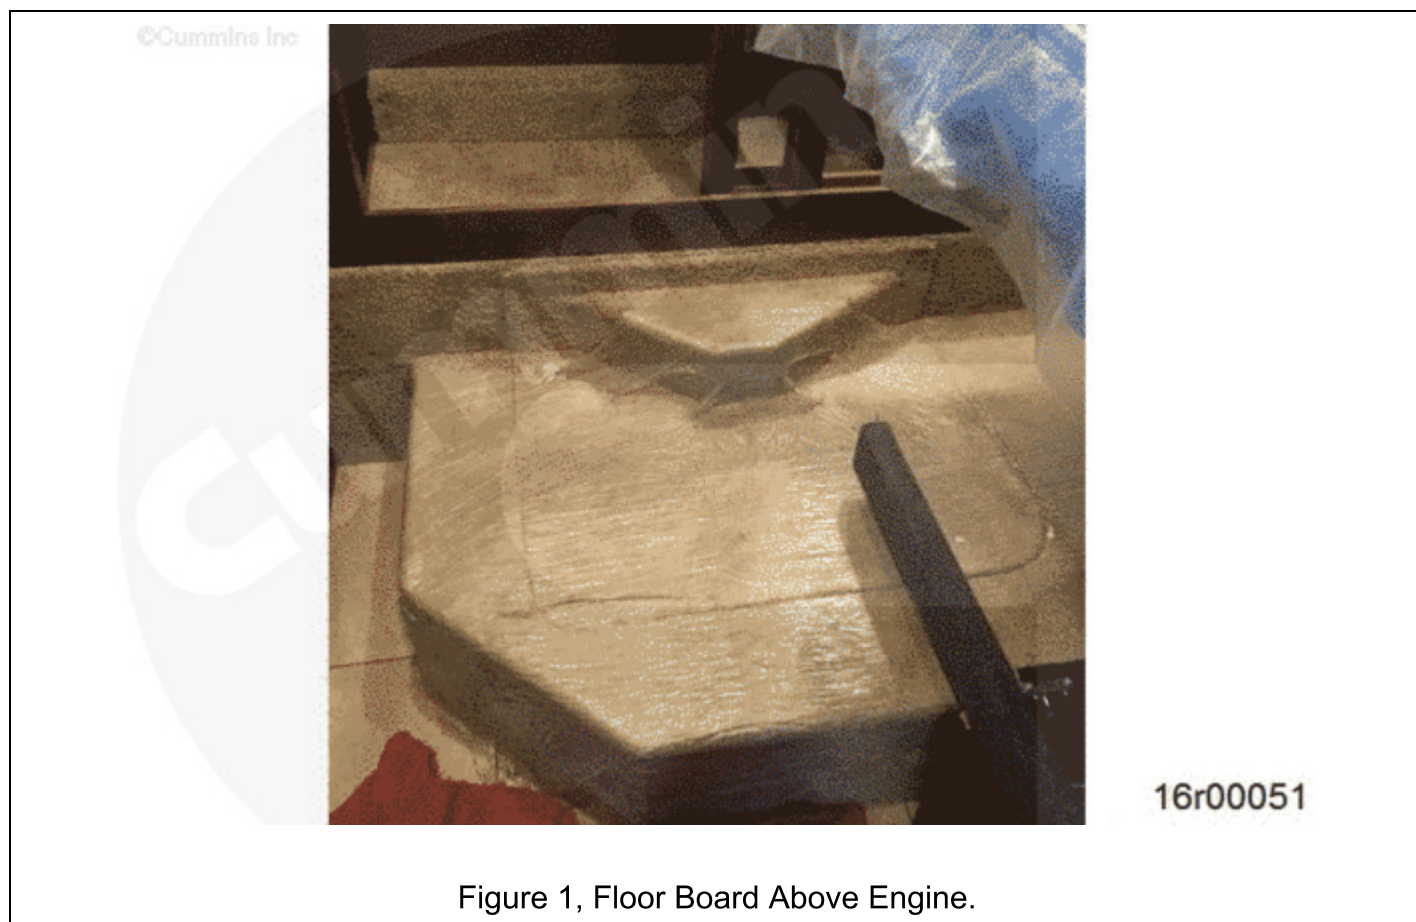
1. Remove floor board for access (Figure 1). See equipment manufacturer service information.
2. Evacuate refrigerant system. See equipment manufacturer service information.
3. Disconnect refrigerant pressure and return hoses (Figure 2). See equipment manufacturer service information. Secure hoses out of the way.

20. Leak check refrigerant system. See equipment manufacturer service information.
21. Fill refrigerant system with appropriate amount of oil. See equipment manufacturer service information.
22. Charge system with necessary amount of the proper refrigerant. See equipment manufacturer service information.
23. Test operation of dash air conditioning system. See equipment manufacturer service information.
24. Verify belt noise is no longer present.
25. Install floor board which was removed for access. (Figure 1) See equipment manufacturer service information.
26. Return vehicle to service.

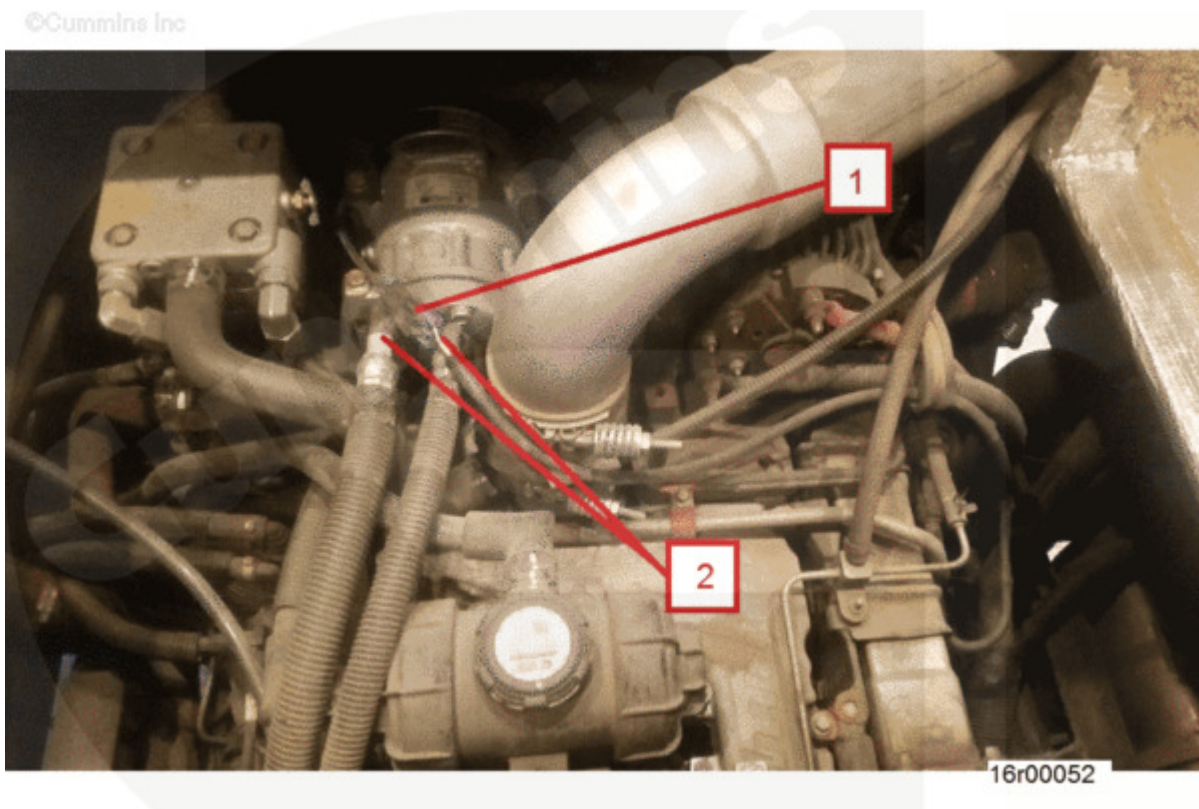
Figure 2, Top of engine.

1. Refrigerant compressor wiring connector.
 2. Refrigerant compressor supply and return lines.
4. Remove and discard belts, Part Number: 4335361 and 4335602 (Figure 3).
 5. Remove and discard lower idler pulley assembly, Part Number 4390735 (Figure 3).
 6. Remove refrigerant compressor (Figure 3) from upper refrigerant compressor support.
 - a. Mounted on refrigerant compressor support bracket, Part Number 4360003 (Figure 3).
 - b. Two Sanden refrigerant compressor models have been identified as being used in Tiffin production.
 - i. Model number U4520 - Reuse compressor.
 - Move from high mount location to low mount location.
 - ii. Model number U4897 - Replace compressor with U4520
 - Use in low mount location

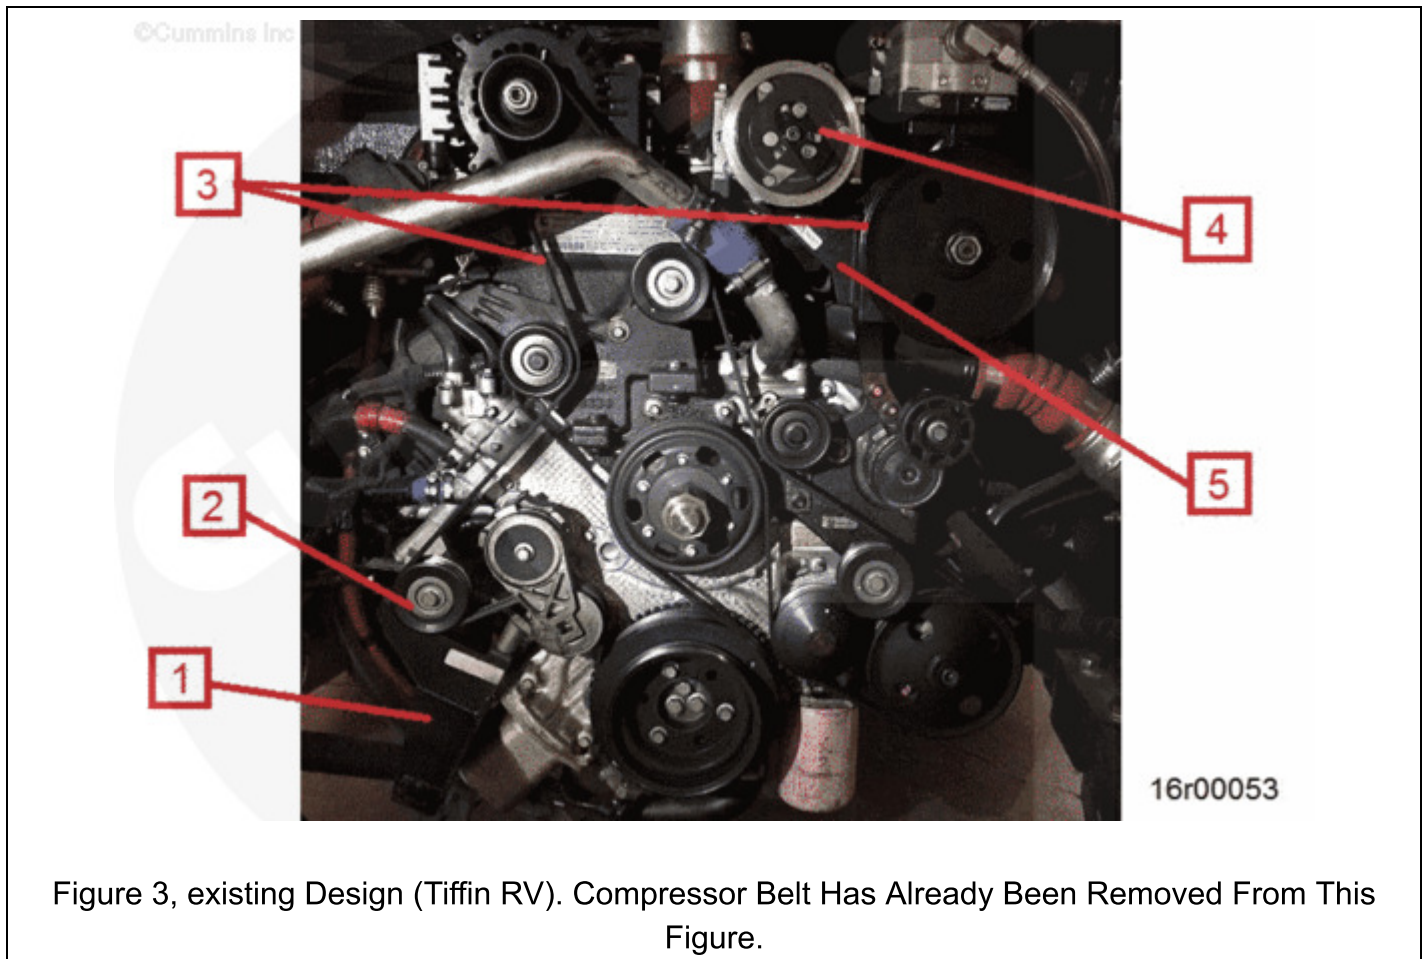
Figure 3, existing Design (Tiffin RV). Compressor Belt Has Already Been Removed From This Figure.

1. OEM Lower Fan Shroud Support Bracket.
 2. Lower Idler Pulley.
 3. Belts to be removed.
 4. Refrigerant compressor.
 5. Upper refrigerant compressor Support.
7. Remove L-Bracket (Figure 4 - 7) and P-clamp (Figure 4 - 8) assembly from lower accessory support, Part Number 4390708 (Figure 4 - 9).
 - Disconnecting P-clamp from bracket is **not** necessary.
 8. Remove OEM lower fan shroud support bracket (Figure 4 – 4) mounted to lower accessory support bracket, Part Number 4390708, (Figure 4 - 9) and OEM fan shroud.
 - a. Reuse p-clip mounting bracket (Figure 4 - 7), capscrews, washers, and nut at fan shroud position. (Figure 4) Tighten all fasteners to proper specifications.

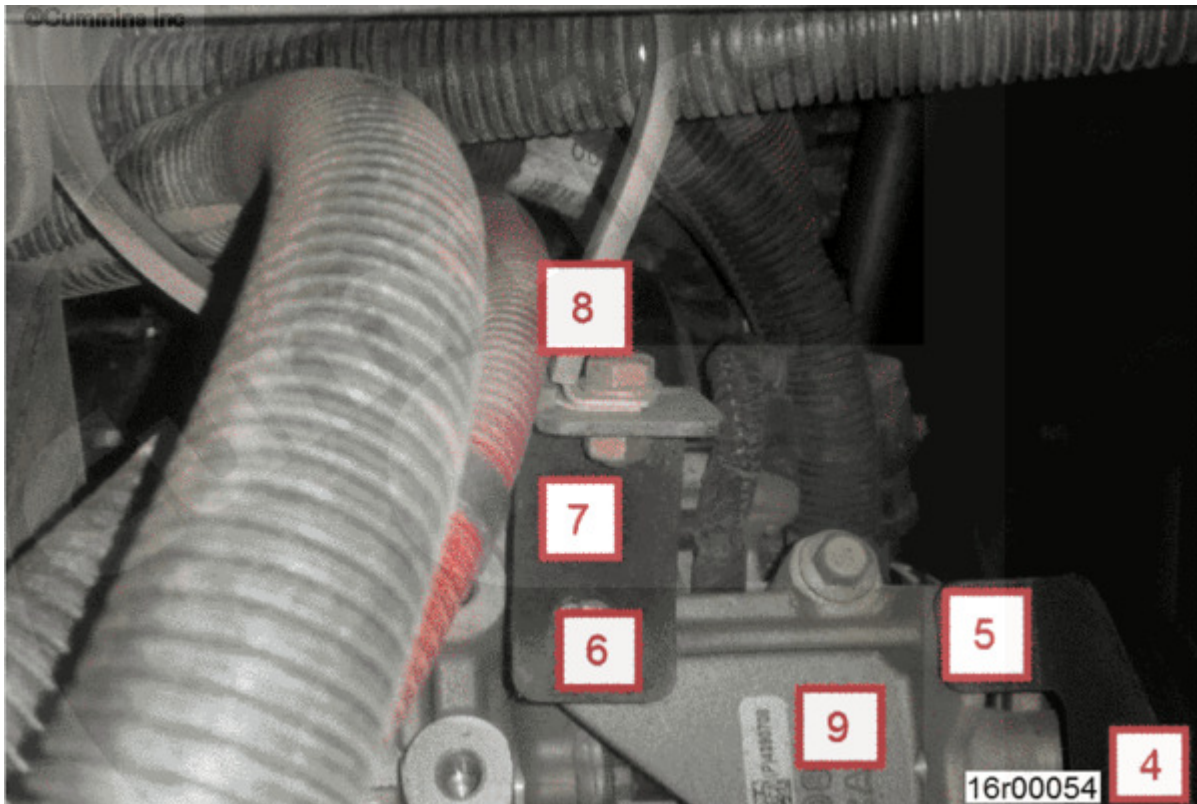
Figure 4, Lower Accessory Drive Mounting with L-Bracket and P-Clamp.

9. Install Sanden refrigerant compressor on lower accessory support, Part Number 4390708 (Figure 4 - 9).

- a. Do **not** tighten capscrews at this time.
- b. Reuse two of the OEM supplied refrigerant compressor mounting bolts from upper mount configuration. (capscrews M8 x 80mm x 1.25)
- c. Install first capscrew in the lower mounting hole towards the rear of the engine.
- d. Install second capscrew (Figure 4 - 6) through the L-bracket and P-clamp assembly (Figure 4 - 8) in upper mounting hole towards the rear of the engine.

Note : Note: P-clamp may be on the inner side of frame rail in existing configuration, but P-clamp will move to the outer side of frame rail when repositioned.

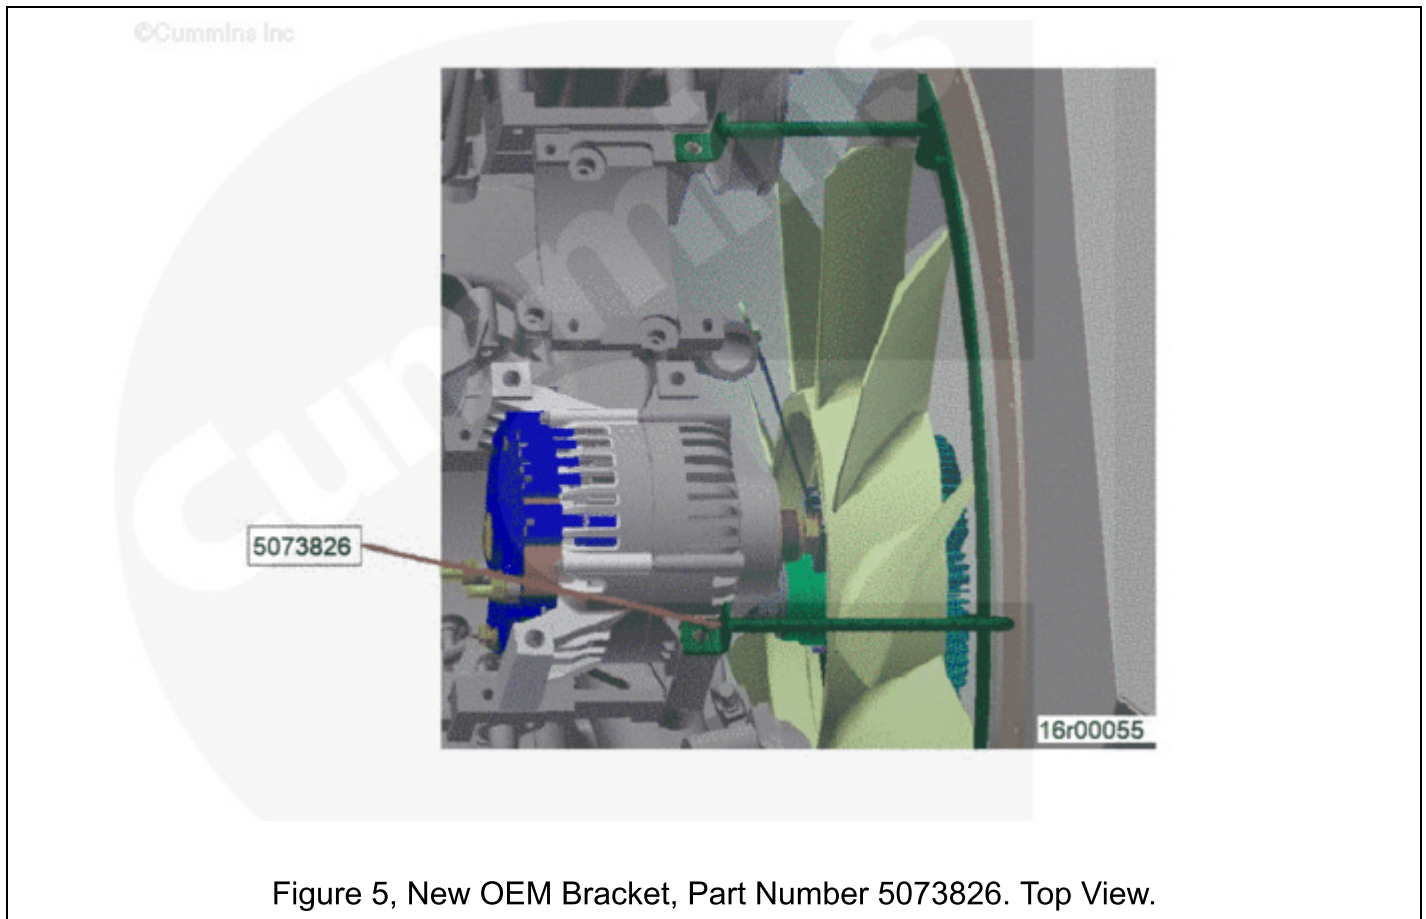
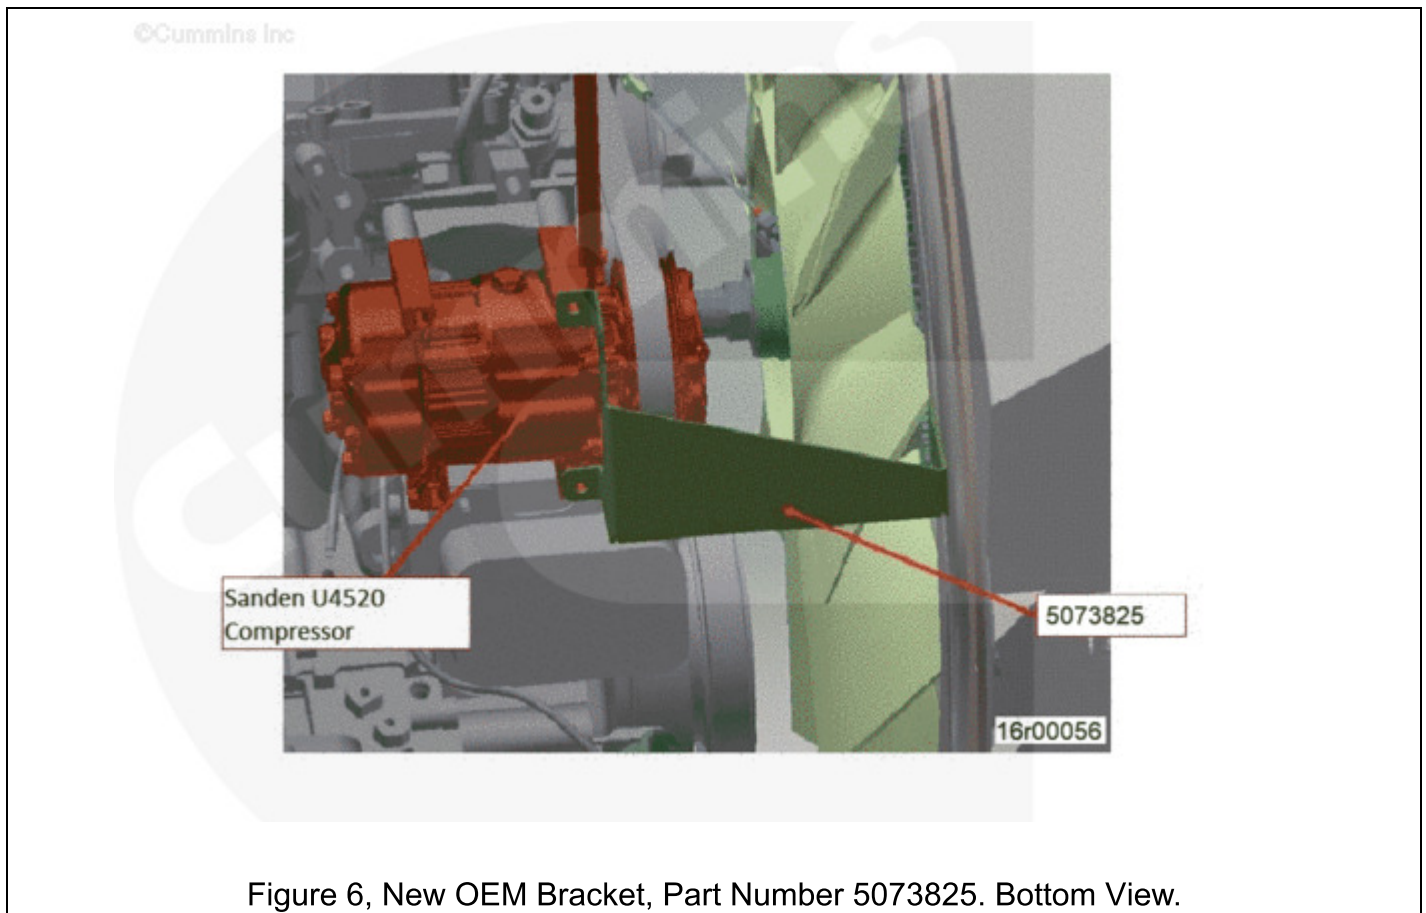
10. Install lower and upper OEM fan shroud support brackets as mentioned

below (Table 3) to securely mount the fan shroud to the engine at all mounting locations.

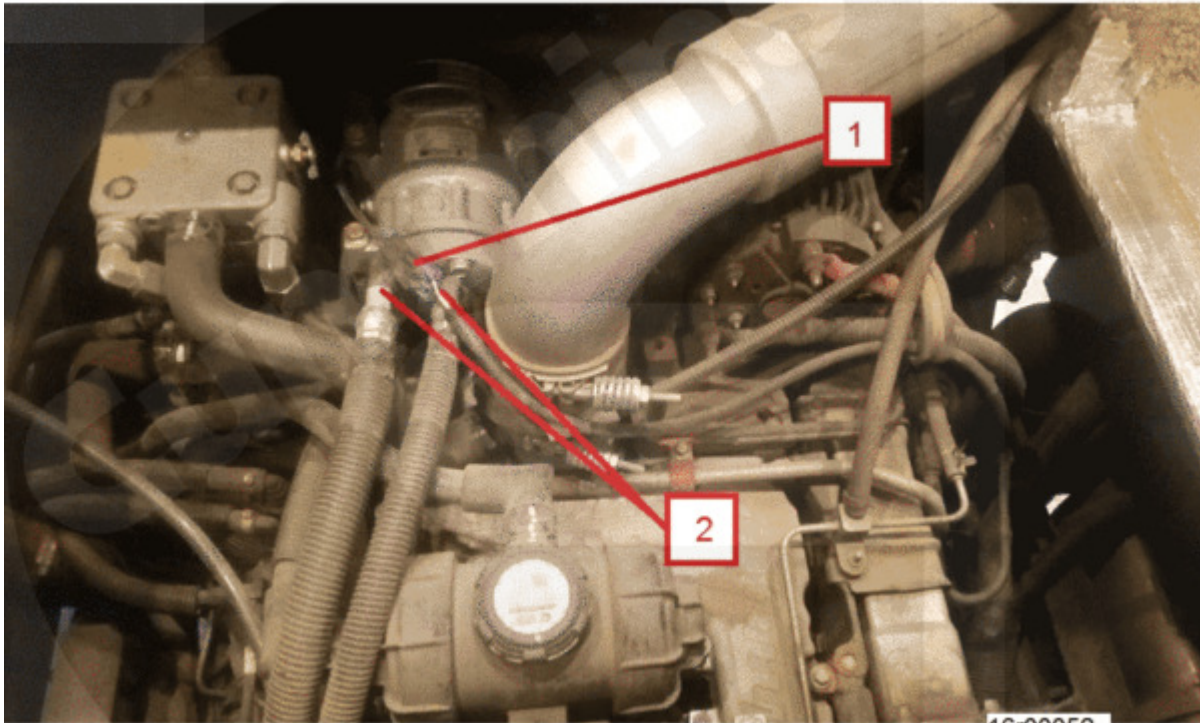
Figure 7, OEM as built wiring harness routing to refrigerant compressor.

- a. Disconnect wiring connector at refrigerant compressor. Figure 7
- b. Remove wire from p-clamp secured to alternator. Figure 8
- c. Route wiring harness down to new refrigerant compressor location and connect to refrigerant compressor clutch connector.
- d. Secure wiring harness with plastic ties away from heat sources. Bundle any extra length of harness.

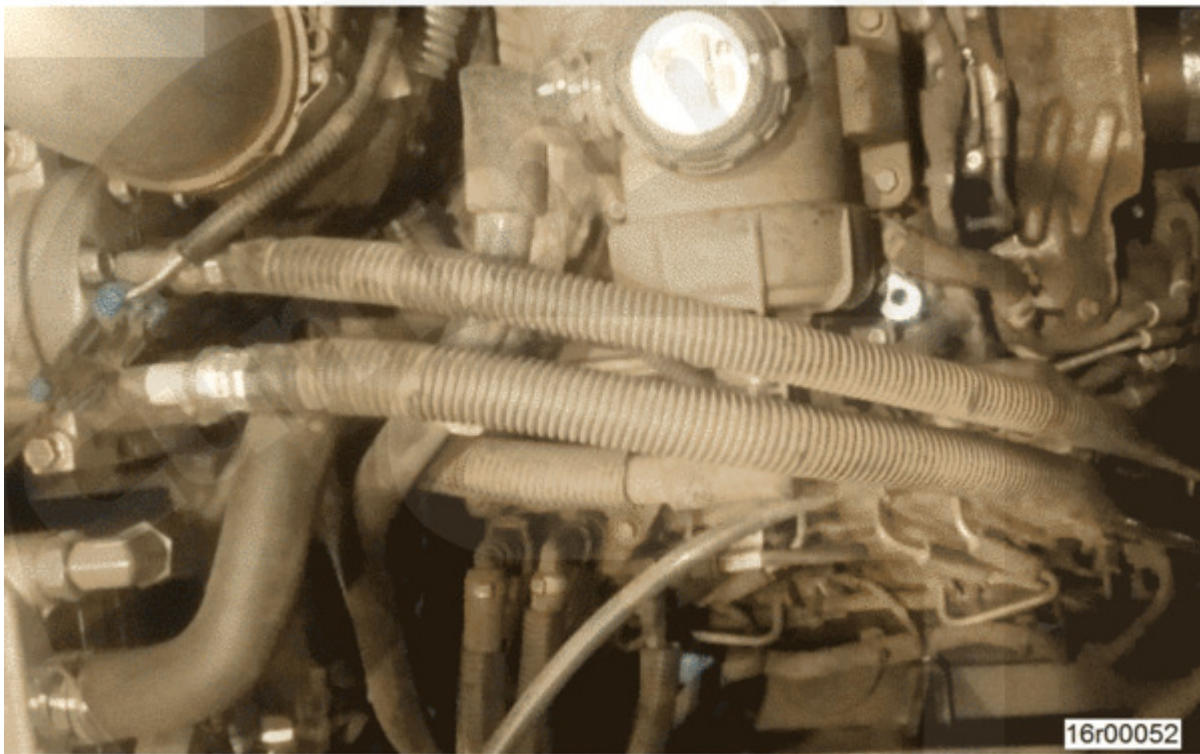
Figure 8, Existing Refrigerant Hose Mounting.

17. Route hoses to new low mount refrigerant compressor location. See Figures 8, 9, 10, and 11.

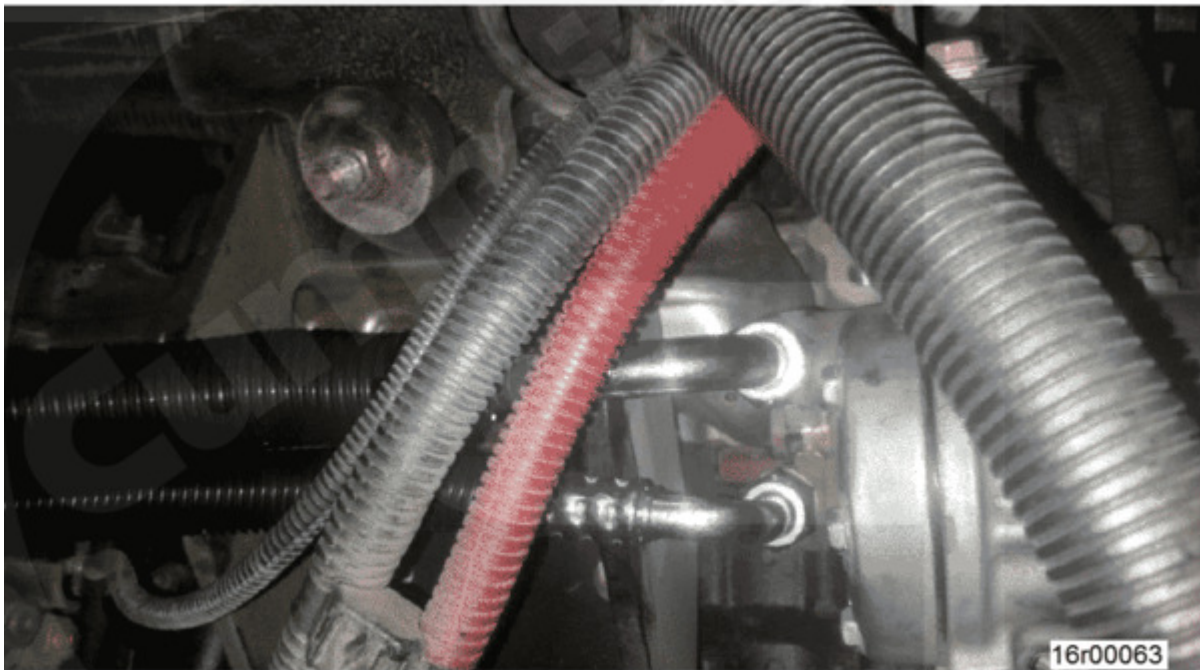
Figure 9, New Refrigerant Hose Mounting.

1. Use OEM Hose kit, Part Number 5083043, to attach existing hoses to new refrigerant compressor.
2. Low pressure return hose (smaller diameter of two hoses) **must** be extended.

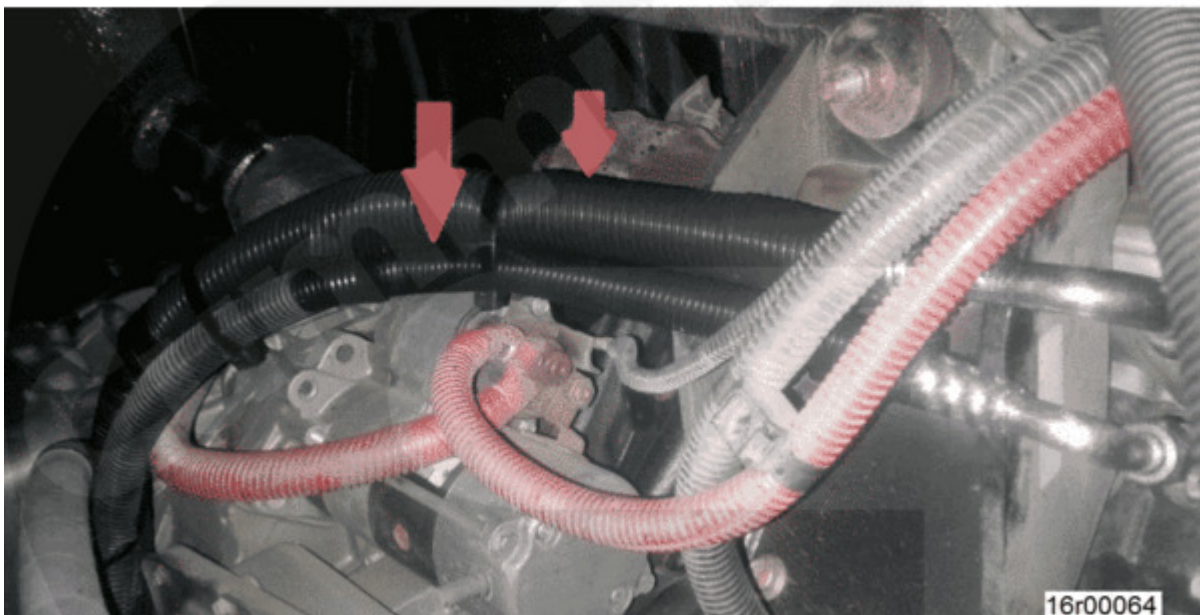
Figure 10, New refrigerant Hose Routing.

4. Route the new low pressure hose extension back to the existing hose under the engine.
 - o Route the new hose in a similar path as the existing hose.

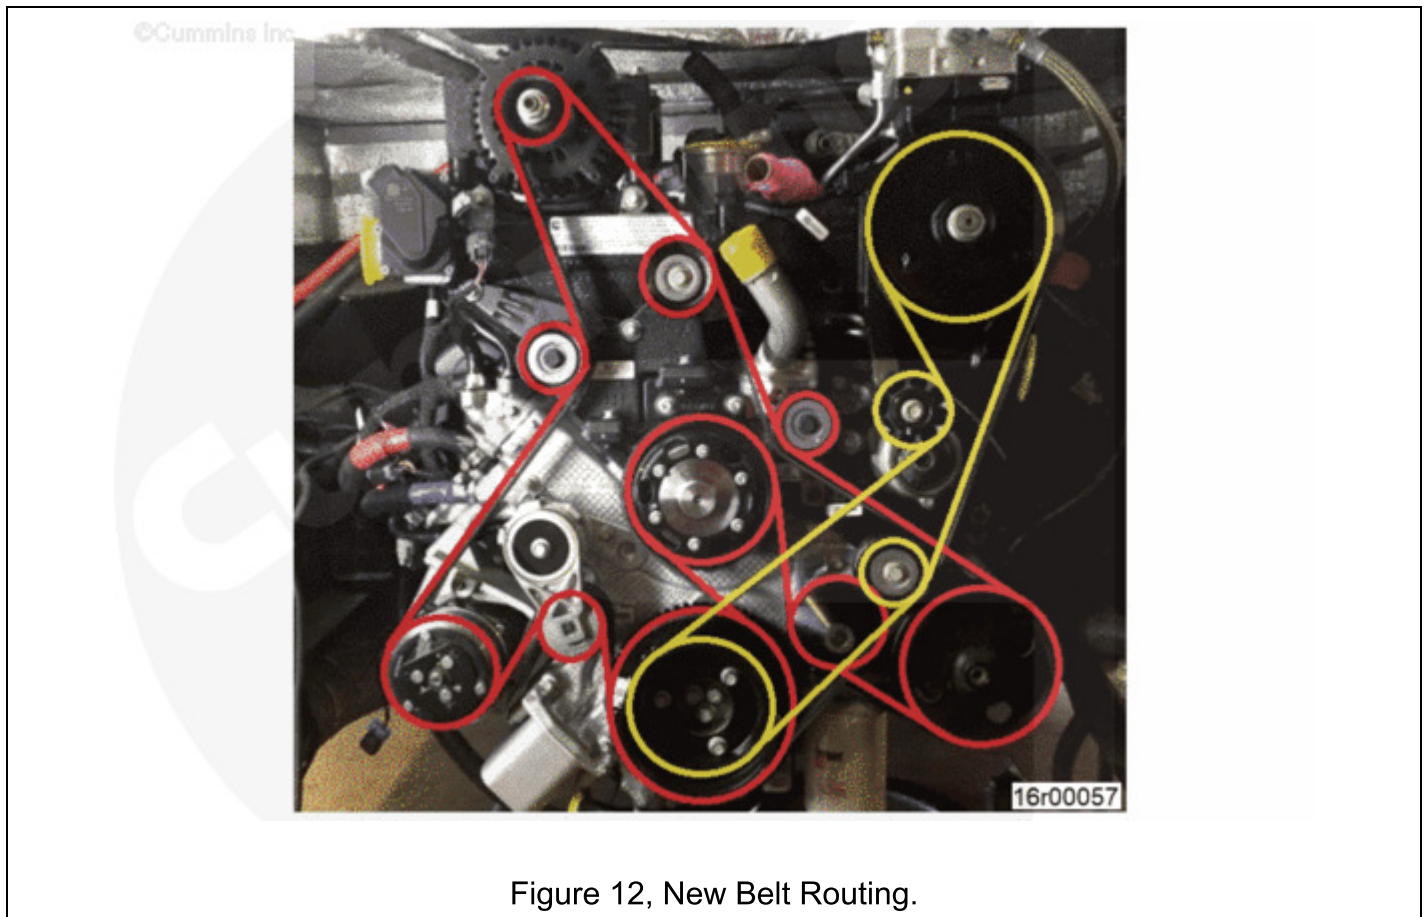
Figure 12, New Belt Routing.

- Change belt options to CP80008 and WP80038 for increased belt wrap on second belt plane around the air compressor.

11. Install primary drive belt, Part Number 4335605, for fan, hydraulic pump, water pump, alternator, and lower refrigerant compressor (Option WP80038).

12. Install secondary drive belt for air compressor, Part Number 4391015. (Option CP80008)
