Solenoid Diode Insertion: 18V-019

DATE: Feb 27, 2018
TO: E-ONE Customers and Dealers
FROM: Kevin Kearns, Customer Support Manager
SUBJECT: **Starter Solenoid Diode Insertion on ISL, L9, X15 Cummins Engines**

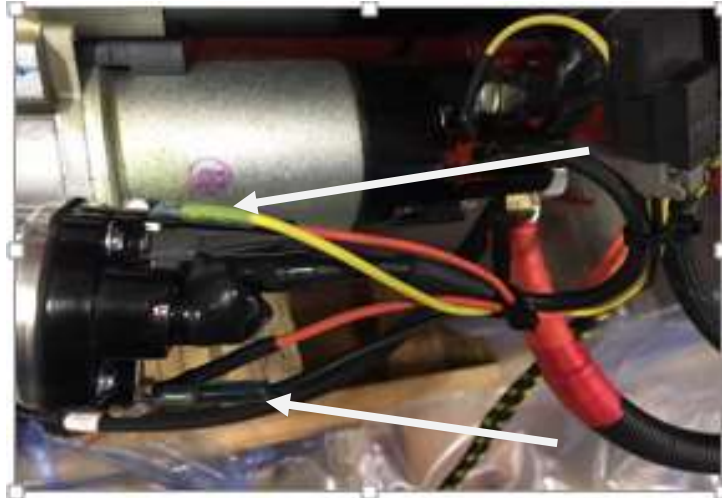
Figure 1: Diode Installation.

Add the diode's yellow wire to the solenoid terminal containing the wire labeled "Neutral Start". Add the diode's black wire to the terminal containing the wire labeled "Engine Start" as shown in **Figure 1**, below.

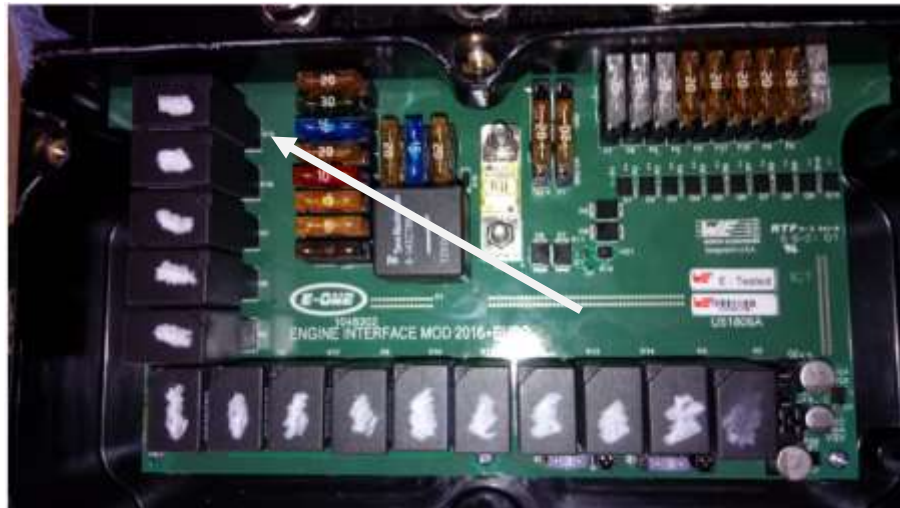
Figure 4: Relay Replacement

Replace K15 relay with new relay from the kit. See **Figure 4**.

Reinstall covers and verify apparatus starts.
