## TECHNICAL INSTRUCTIONS FOR SAFETY RECALL GLG/GLH and HLA

### FRONT PASSENGER AIRBAG INFLATOR REPLACEMENT CERTAIN 2006 – 2013 MY IS 250/350 and 2008 – 2013 MY IS F

#### UPDATE 4-18-18

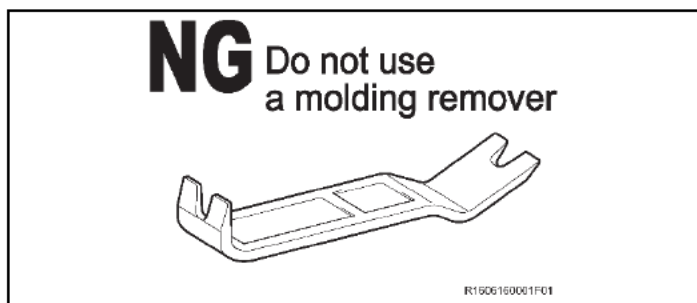
### Removing the No. 3 air register

Remove any peripheral parts on left and right side of the register to allow access to the back of the register.

Wrap the tip of a screwdriver with tape.

Lock the 4 claws inside the register as shown.

**NOTE:** Do not use a molding removal tool to remove the register it could be damaged.

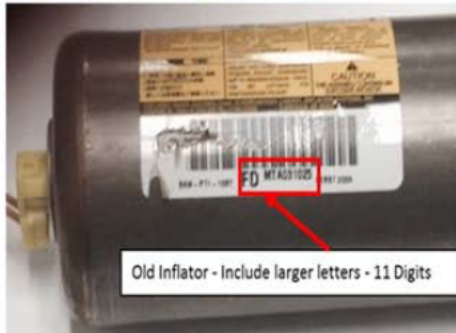
### Original Inflator

How to Identify the Inflator serial code on the Original and Replacement Inflator can?

The Inflator serial code is an 11 digit code on the Inflator can. It can be found with a bar code on removing the Inflator can from the Airbag Assembly unit.

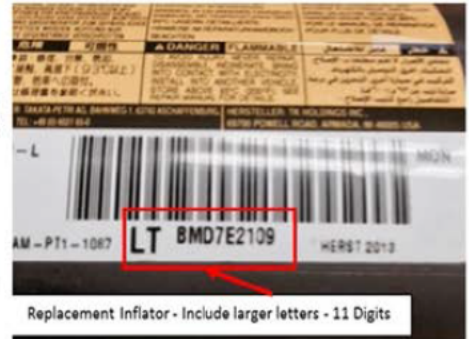
### Replacement Inflator

The first two characters of the Replacement Inflator Serial code will be either 'LT' or 'LR'.

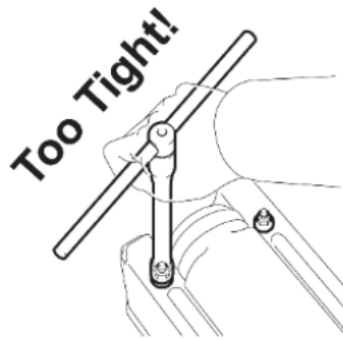
**NG**

**Too Tight!**

**These tools cause overtightening !**

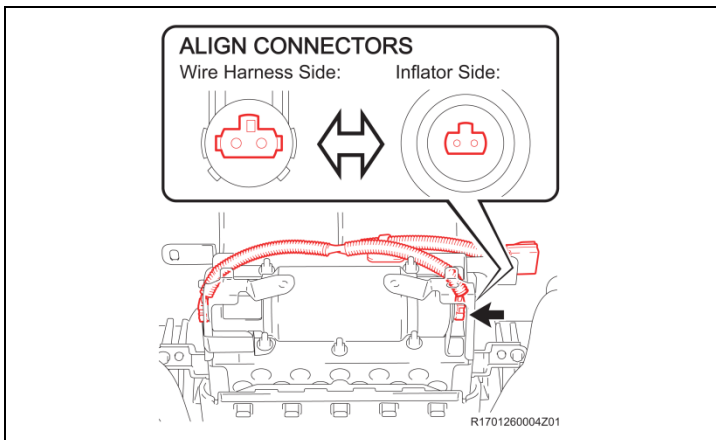
- k) Engage the 2 clamps for the new wire harness.

- l) Connect the connector and the secondary lock.

**NOTE: Ensure that the connector is securely connected.**
