TECHNICAL INSTRUCTIONS FOR SAFETY RECALL G0R FRONT PASSENGER AIRBAG INFLATOR MODULE CERTAIN 2010 MY 4RUNNER

UPDATE 7-17-18

The subject vehicles are equipped with front passenger airbag inflators produced by Takata. According to Takata, the propellant in these inflators may degrade after prolonged exposure to high absolute humidity and fluctuating high temperatures. Degraded propellant can cause inflator rupture during airbag deployment. In the event of an inflator rupture, metal fragments could pass through the airbag cushion material, striking the vehicle occupants, and result in serious injury or death.

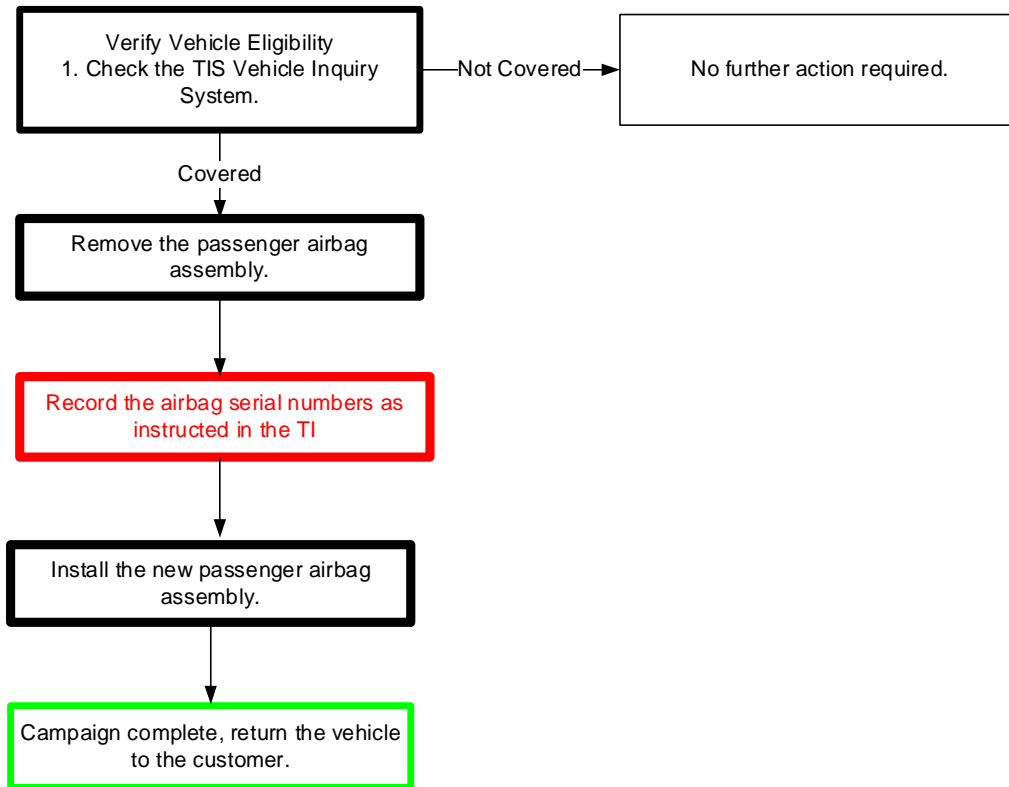
I. OPERATION FLOW CHART

The flow chart is for reference only. **DO NOT** use it in place of the full technical instructions. Follow **ALL** steps as outlined in the full technical instructions to confirm the campaign is completed correctly.

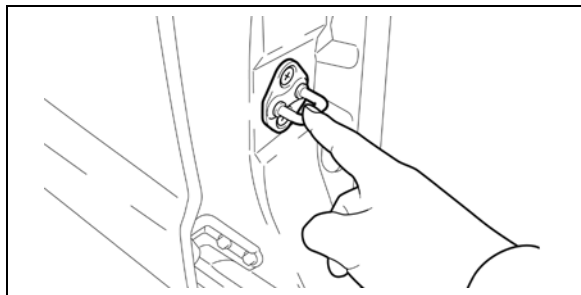
1. ELIMINATE STATIC ELECTRICITY

- Before starting work and periodically while working on the vehicle, touch a metallic part of the vehicle to discharge static electricity in the body.

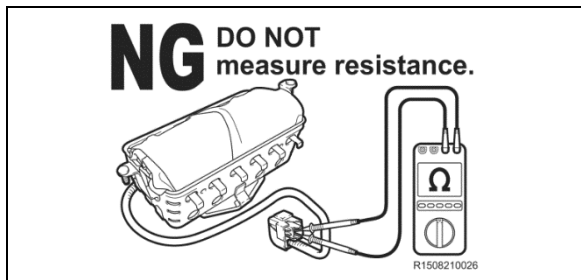
2. DO NOT MEASURE RESISTANCE

- DO NOT** measure resistance of airbag components, this may cause accidental activation.

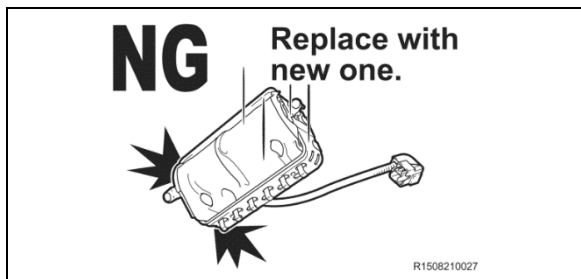
3. HANDLE THE AIRBAG CAREFULLY

- If an airbag is dropped, replace it with a **NEW** one.

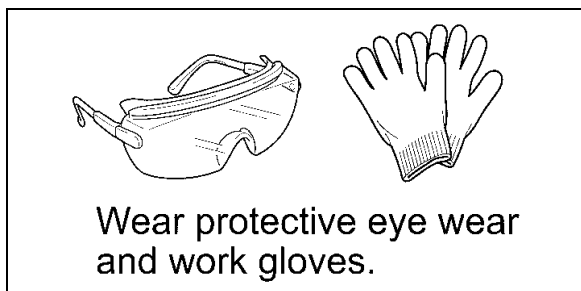
4. WEAR PROTECTIVE EQUIPMENT

- Always wear appropriate protective equipment when working on the SRS.

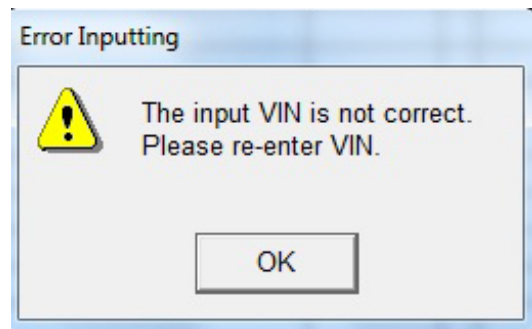
- After the health check has completed, run a diagnostic report by clicking on the link on the health check screen.

NOTE: If the VIN was not entered in ALL CAPS when Techstream was launched, an error will be displayed and there will be a prompt to reenter the VIN

- Enter the vehicle mileage and repair order information, then click the 'report' button.

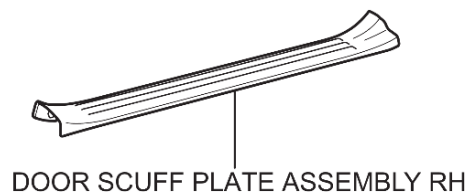
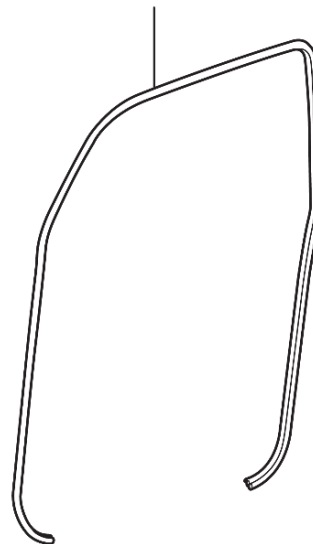
R1703160011

CAUTION-PLASTIC RETAINING CLIPS ARE FRAGILE. REMOVE WITH CARE

N*m (kgf*cm, ft.*lbf) : Specified torque

FRONT PILLAR
GARNISH RH

FRONT DOOR OPENING TRIM
WEATHERSTRIP RH

COWL SIDE TRIM BOARD RH

Part manufactured
before August 2013:

Part manufactured
after August 2013:

● FRONT PILLAR
GARNISH LH

No. 1 FRONT PILLAR
GARNISH COVER LH

FRONT PILLAR
GARNISH LH

FRONT DOOR OPENING TRIM
WEATHERSTRIP LH

COWL SIDE TRIM BOARD LH

DOOR SCUFF PLATE ASSEMBLY LH

● Replacement part

*The left front A-Pillar garnish needs to be replaced on vehicles manufactured prior to August 2013. Only one garnish is required per vehicle depending upon color code. The kit contains the garnish and the non-reusable clip.

NOTE: The left front A-Pillar garnish needs to be replaced on vehicles manufactured prior to August 2013. Only one garnish is required per vehicle depending upon color code. The kit contains the garnish and the non-reusable clip. (see parts information)

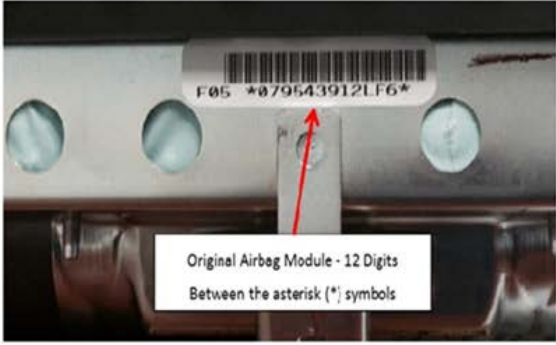
If the airbag serial number and barcode are not legible or are not present, check the box in the application indicating the serial number is not legible.

a) If the airbag serial number cannot be scanned or is not present check the box as shown below.

Check this box if the label is damaged or missing

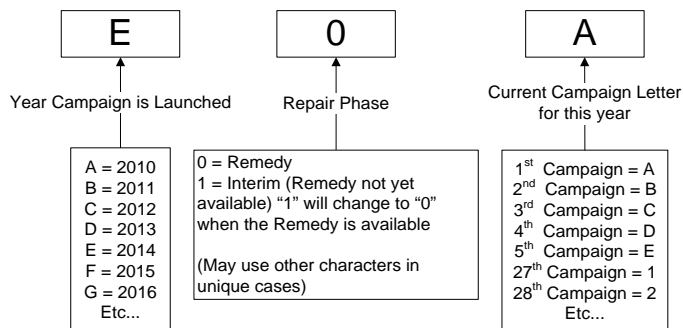
A. CAMPAIGN DESIGNATION DECODER

Examples:

A0D = Launched in 2010, Remedy Phase, 4th Campaign Launched in 2010

B1E = Launched in 2011, Interim Phase, 5th Campaign Launched in 2011

C1C = Launched in 2012, Interim Phase, 3rd Campaign Launched in 2012
