SAFETY RECALL GLG

FRONT PASSENGER AIRBAG INFLATOR REPLACEMENT

CERTAIN 2010-2013 MY IS 250/350 CONVERTIBLE

UPDATED 1-9-2018

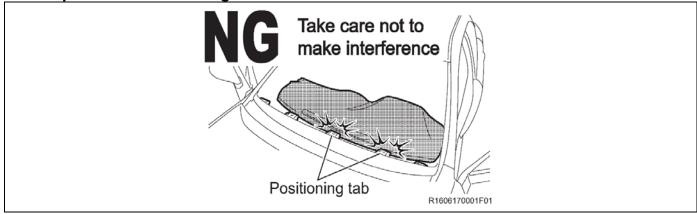
NOTE: DO NOT contact the postioning tabs while removing the instrument panel as the panel could be damaged.

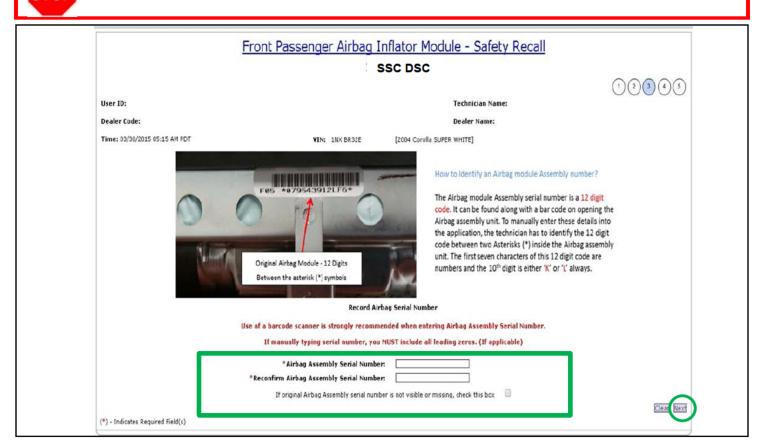
Airbag Serial Number Label Example

- The airbag serial number is *ALWAYS* the 12 *DIGITS* located between the asterisks.
- The 3 digits before the asterisk *ARE NOT* part of the serial number, and *SHOULD NOT* be entered or an inaccurate response may be returned.

The AIRBAG ASSEMBLY serial number MUST be recorded prior to replacement.
