## TECHNICAL INSTRUCTIONS FOR SAFETY RECALL GLG/GLH/HLA FRONT PASSENGER AIRBAG INFLATOR REPLACEMENT CERTAIN 2007 – 2012 MY ES 350

**Updated 01-14-2021**

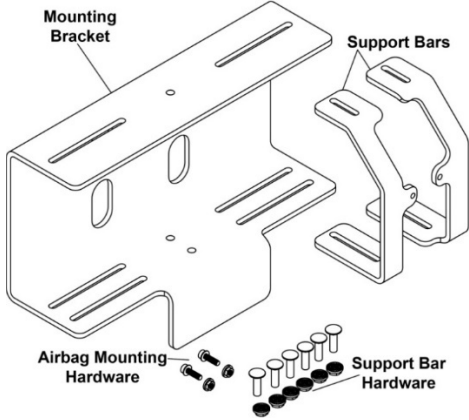
<p>Labels in image: Mounting Bracket, Support Bars, Airbag Mounting Hardware, Support Bar Hardware</p>	Airbag Mounting Bracket & hardware (Provided to the dealership at the launch of SSC DLC)	1

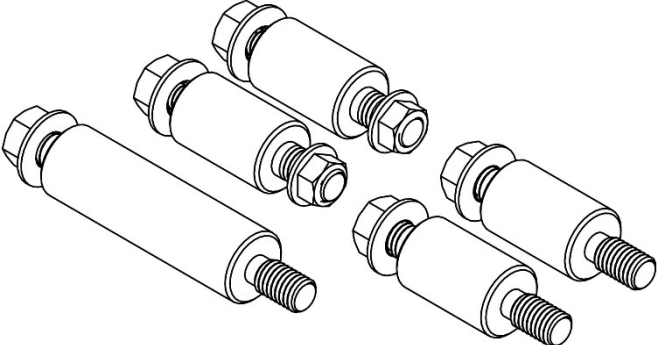
579943 Adaptor set*	1

\*The adaptor set was sent to dealers prior to the start of this campaign.

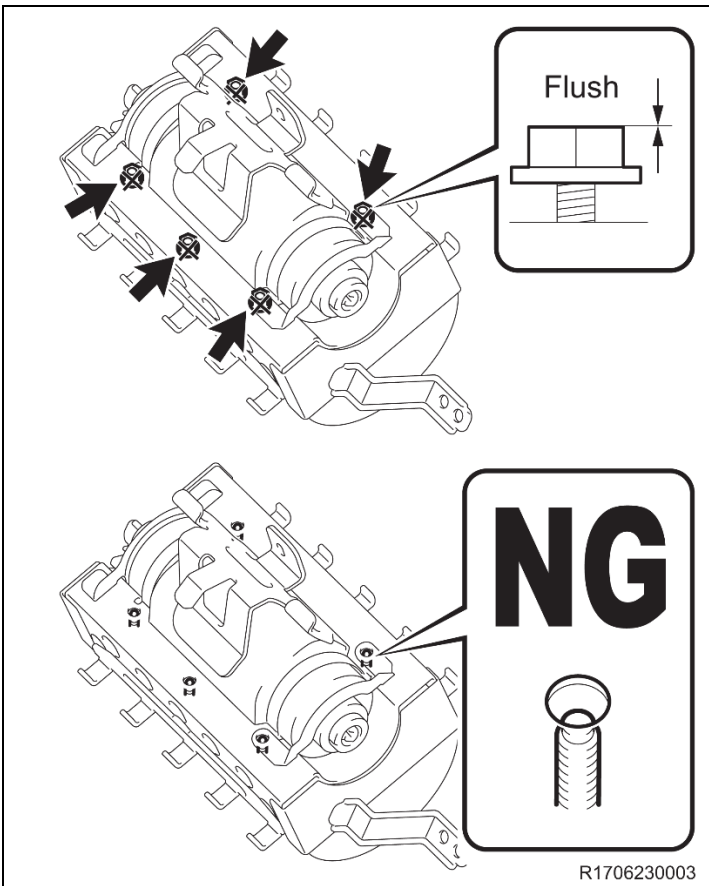
d) Loosen the 5 nuts until each nut is flush with the top of the stud as shown.

**NOTE: You may need to slide the airbag to the left or right to access the middle nut. DO NOT use power tools to remove the nuts.**

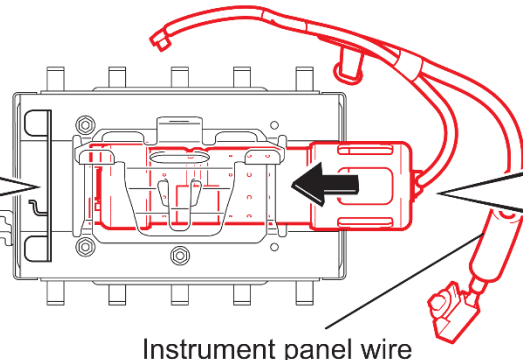
R1707250019A02

a) Install the inflator as shown below and ensure the inflator is oriented in the correct position as shown below.

- Make sure to follow the installation procedure carefully as the instrument panel wire connector cannot be disconnected once connected
- Make sure the inflator is correctly positioned.
- The inflator cannot be fully inserted if it is upside down.

Check orientation

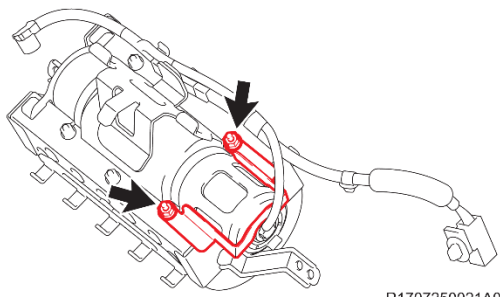
R1707250021A01

**DO NOT** connect the airbag connector yet.

**Install temporarily by hand.**

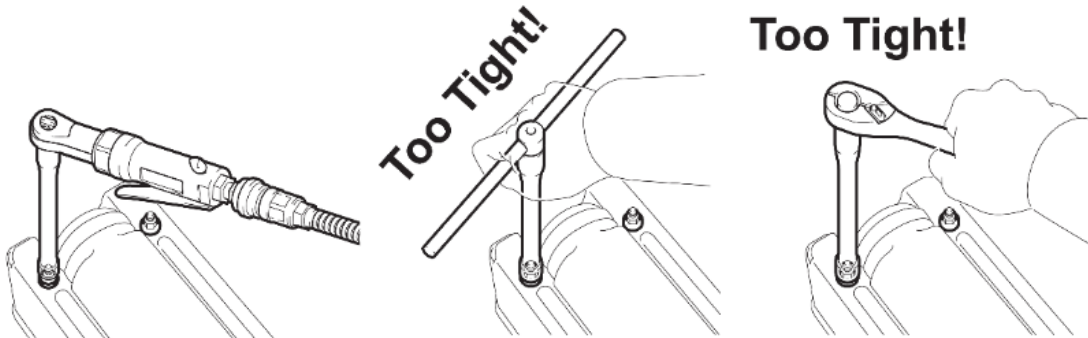
R1701260011Z01

f) Tighten the 5 nuts evenly in several increments in the sequence shown. Use a socket driver or torque wrench to tighten the nuts.

Torque: 35 in. lbf (3.9N·m)

- There will be some resistance when tightening the nuts because they are self-locking, confirm the nuts are tightened correctly.
- **DO NOT** use a power tool, T-handle, or ratchet when tightening the nuts to avoid over torquing and deforming the studs.
- You may need to slide the airbag to the left or right with in the mounting bracket to access the center nut.

## These tools cause overtightening !
