## TECHNICAL INSTRUCTIONS

### SAFETY RECALL GLG/GLH and HLA

### FRONT PASSENGER AIRBAG MODULE

**CERTAIN 2006 – 2013 MY IS 250/350 and 2008 – 2013 MY IS F**

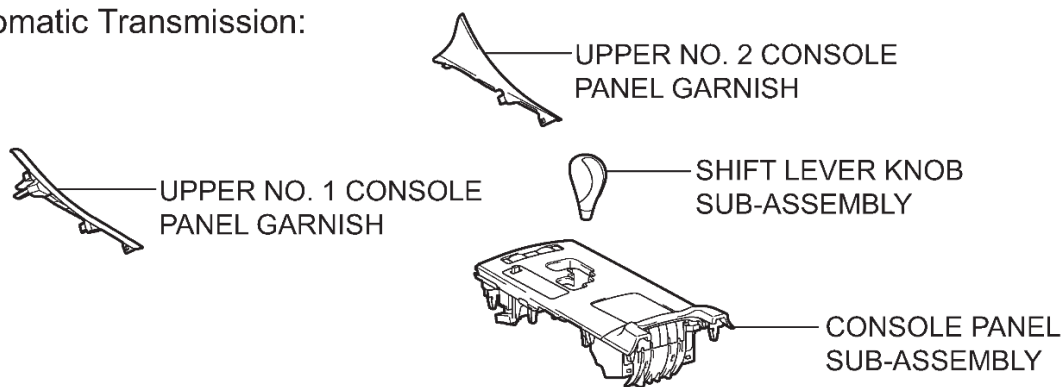
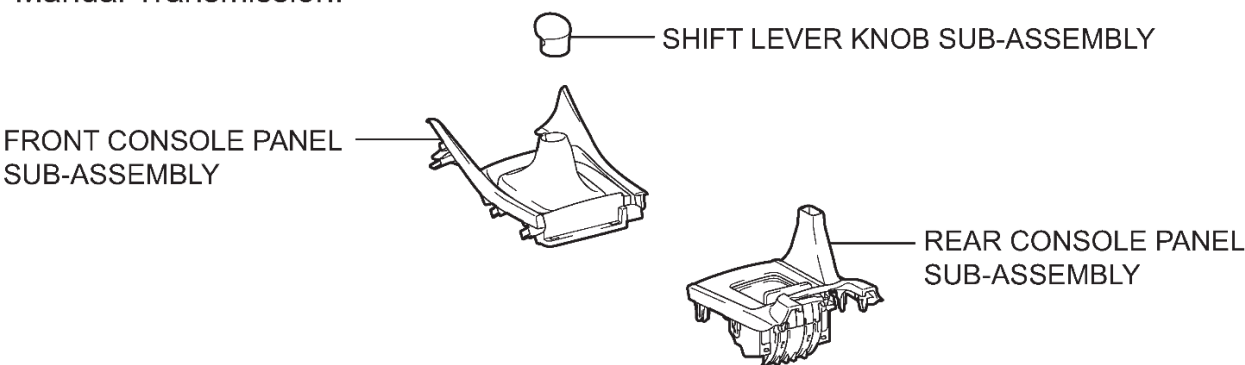
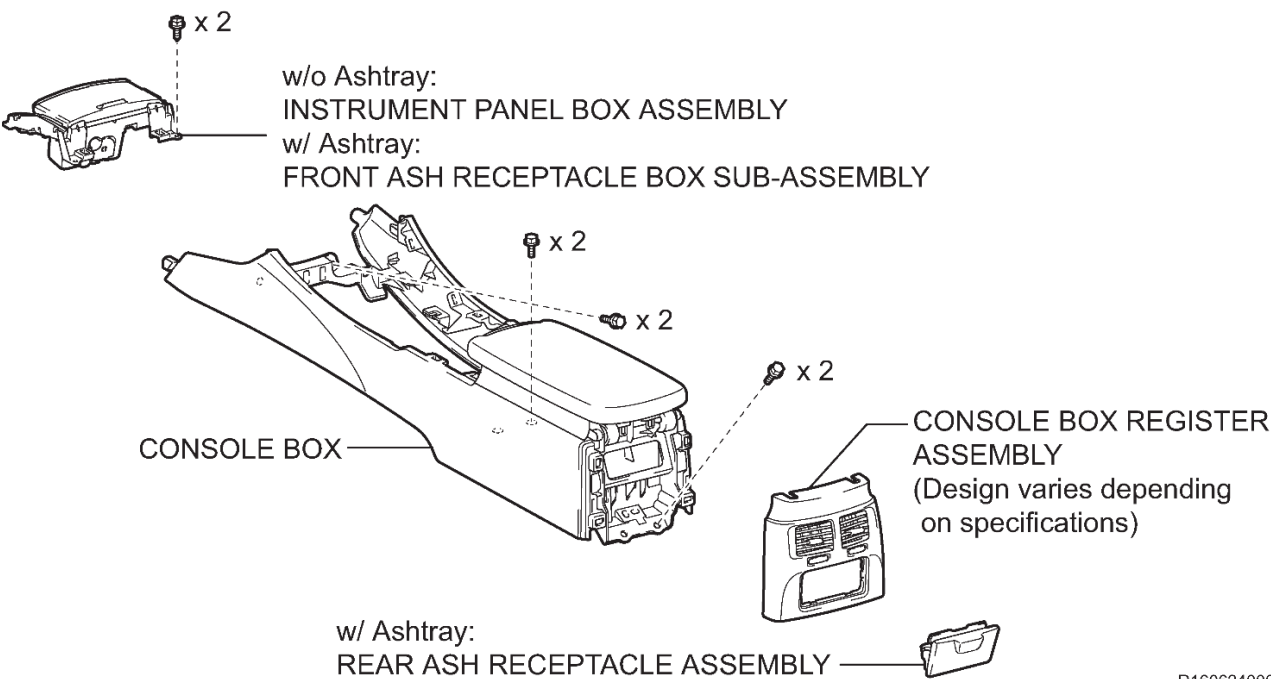
**VII. FRONT PASSENGER AIRBAG REMOVAL**  
**COMPONENTS**

for Automatic Transmission:

for Manual Transmission:

20 (204, 15) 【New bolt : Shorter than old bolt】

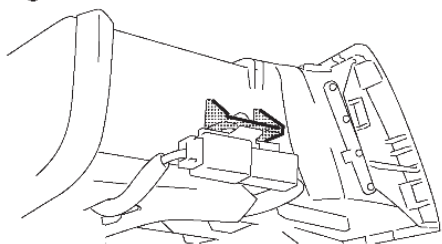
Back side of the part manufactured  
after August 2008:

○ : Claw

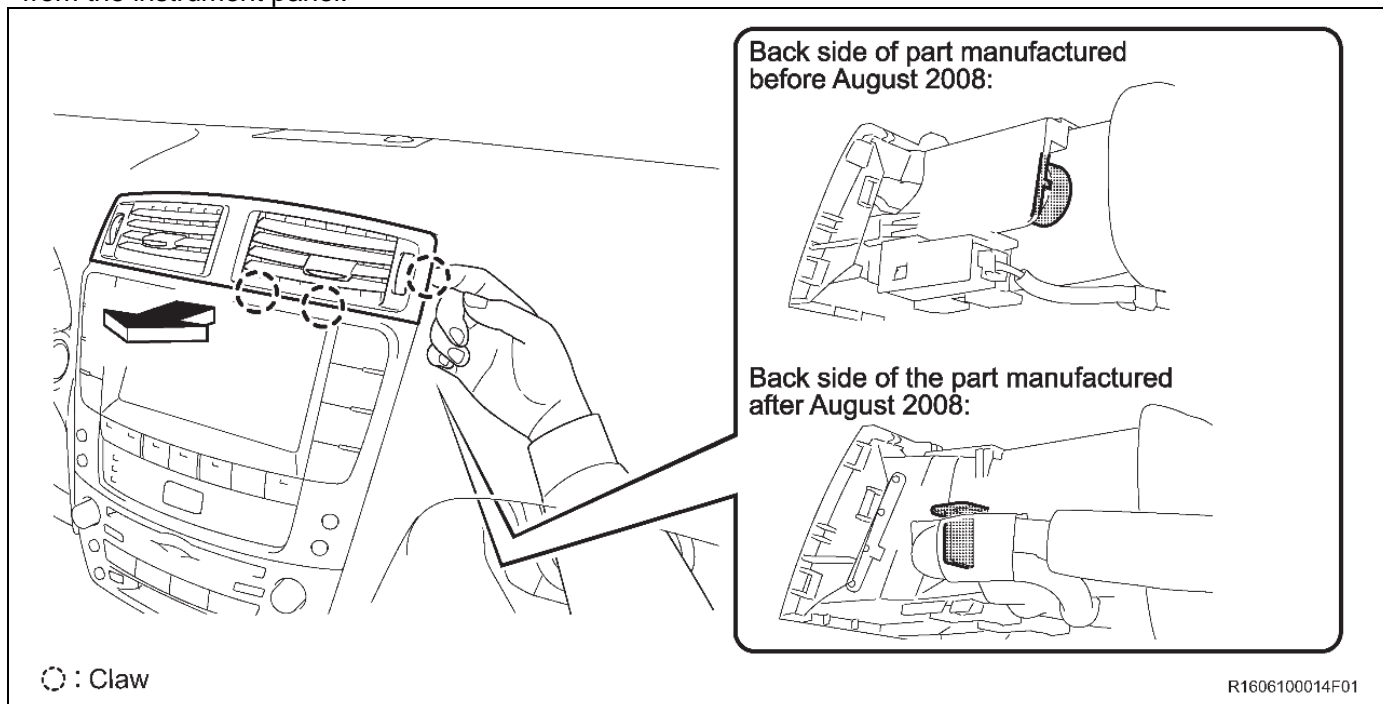
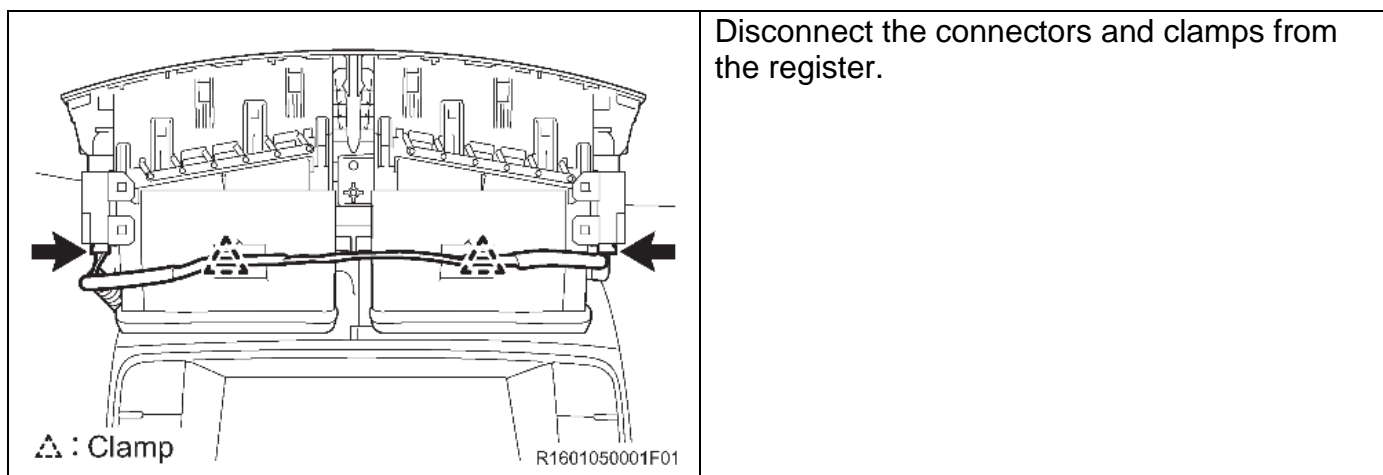
Using your finger on the right side push out at the point shown to disengage the 3 claws and remove the register from the instrument panel.

**NOTE: DO NOT** contact the positioning tabs while removing the instrument panel as the panel could be damaged.
