# TECHNICAL INSTRUCTIONS FOR SAFETY RECALL G0P/G0R/H0A FRONT PASSENGER AIRBAG INFLATOR MODULE CERTAIN 2011-2014 MODEL YEAR SIENNA

**Updated 1-9-2019**

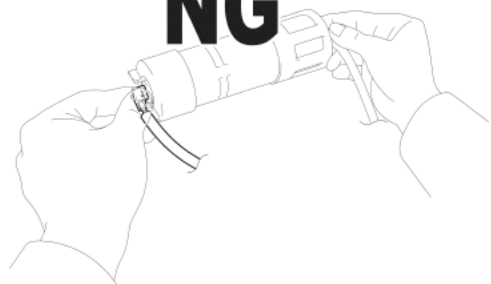
- DO NOT** connect the inflator harness at this time. It is **CRITICAL** to first confirm that the inflator is installed in the correct position before connecting the harness.

DO NOT CONNECT PREMATURELY  
CANNOT DISCONNECTED

**NOTE:** Once connected the inflator harness cannot be disconnected without damaging the connector, and would require that the inflator and harness be replaced.
