TECHNICAL INSTRUCTIONS

SAFETY RECALL GLH

FRONT PASSENGER AIRBAG INFLATOR REPLACEMENT

CERTAIN 2010 MY IS 250/350 CONVERTIBLE

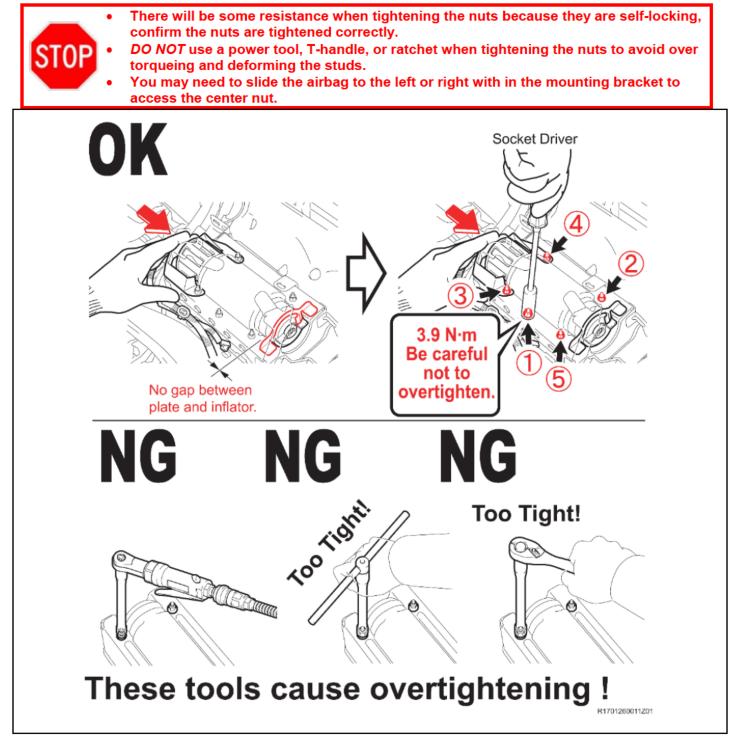
k) Tighten the 5 nuts evenly in several increments in the sequence shown. Use a socket driver or torque wrench to tighten the nuts.

Torque: 35 in. lbf (3.9N·m)
