**TECHNICAL INSTRUCTIONS  
FOR  
SAFETY RECALL HLA  
FRONT PASSENGER AIRBAG MODULE  
CERTAIN 2007 – 2009 MY ES 350  
UPDATED 1-9-2018**

Update 1-9-2018

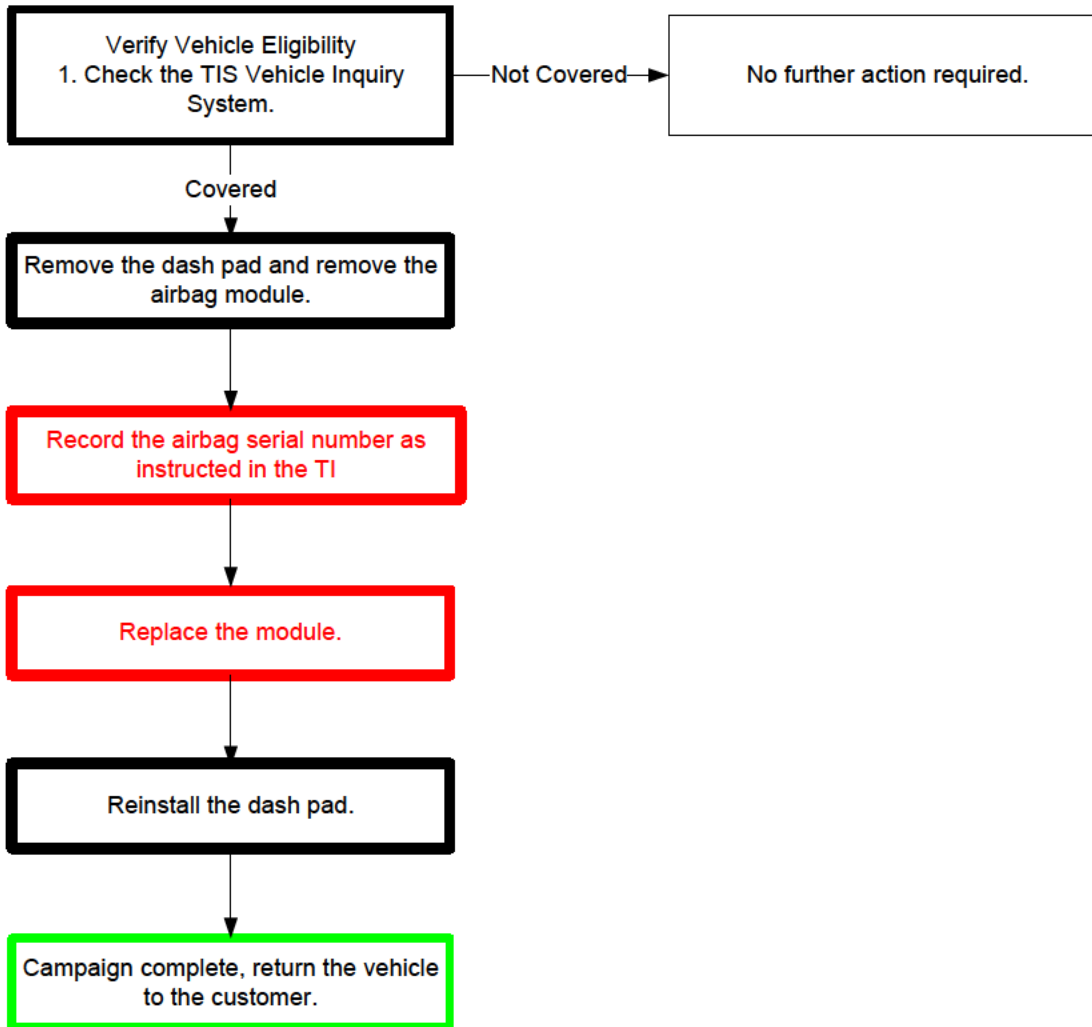
## I. OPERATION FLOW CHART

The flow chart is for reference only. **DO NOT** use it in place of the full technical instructions. Follow **ALL** steps as outlined in the full technical instructions to confirm the campaign is completed correctly.

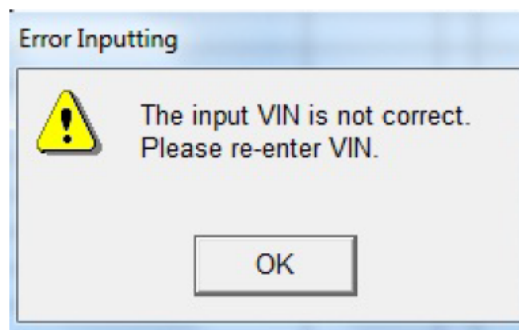
**NOTE:** If the VIN was not entered in ALL CAPS when Techstream was launched, an error will be displayed and there will be a prompt to reenter the VIN

- b) Enter the vehicle mileage and repair order information, then click the 'report' button.

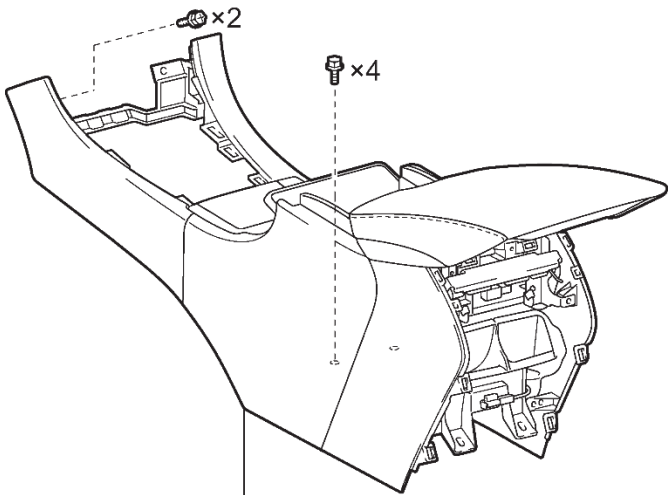
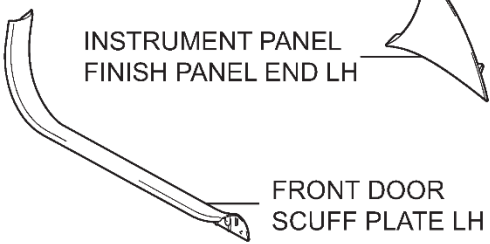
R1701240004

**VII. FRONT PASSENGER AIRBAG REMOVAL**  
**COMPONENTS**

UPPER CONSOLE PANEL ASSEMBLY  
WITH FRONT ASH RECEPTACLE

CONSOLE REAR END PANEL SUB-ASSEMBLY

CONSOLE BOX POCKET  
(Design differ depending on the specification)

CONSOLE BOX CARPET

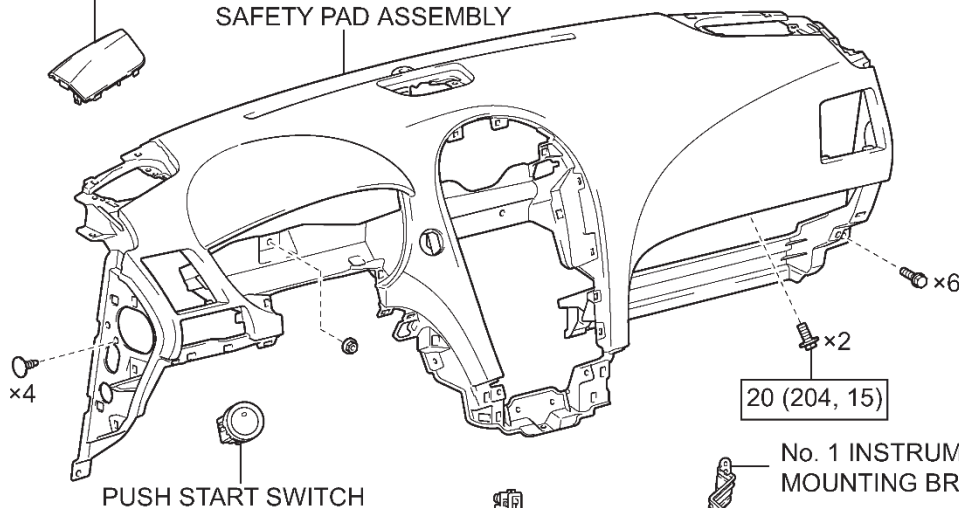
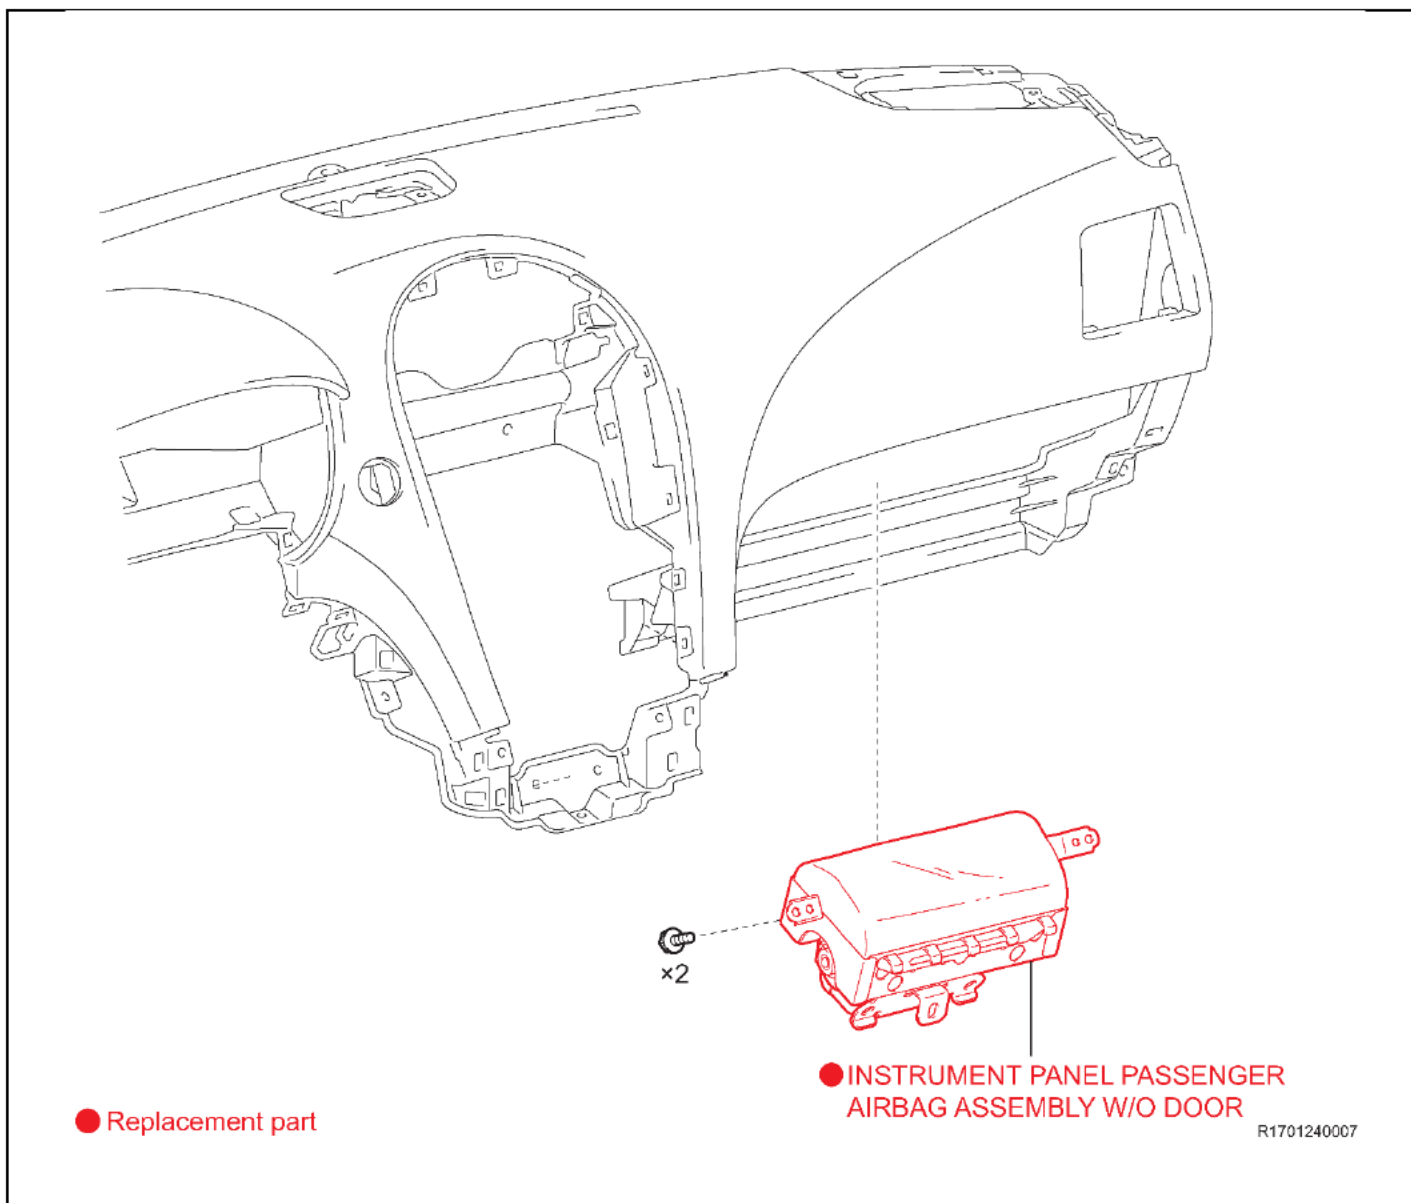
R1701240006

INSTRUMENT PANEL  
SAFETY PAD ASSEMBLY

PUSH START SWITCH

No. 1 INSTRUMENT PANEL  
MOUNTING BRACKET

INTEGRATION CONTROL PANEL or  
MULTI-DISPLAY or  
DISPLAY AND NAVIGATION MODULE DISPLAY  
WITH RADIO RECEIVER ASSEMBLY

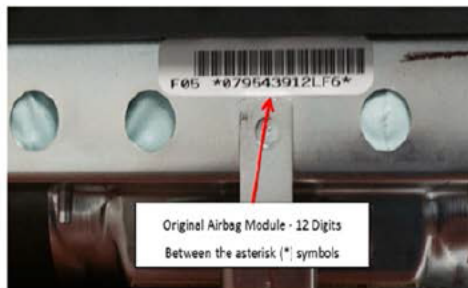
#### Airbag Serial Number Label Example

- The airbag serial number is **ALWAYS** the 12 **DIGITS** located between the asterisks.
- The 3 digits before the asterisk **ARE NOT** part of the serial number, and **SHOULD NOT** be entered or an inaccurate response may be returned.

Original Airbag Module - 12 Digits  
Between the asterisk (\*) symbols

The Airbag module Assembly serial number is a 12 digit code. It can be found along with a bar code on opening the Airbag assembly unit. To manually enter these details into the application, the technician has to identify the 12 digit code between two Asterisks (\*) inside the Airbag assembly unit. The first seven characters of this 12 digit code are numbers and the 10<sup>th</sup> digit is either 'K' or 'L' always.

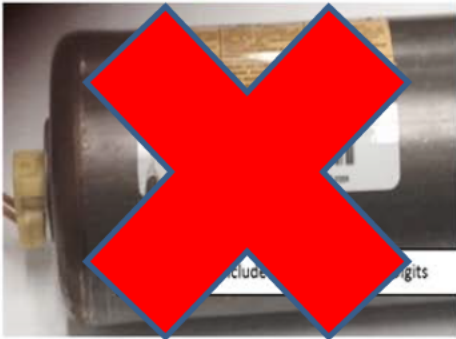
Original Inflator

How to Identify the Inflator serial code on the Original and Replacement Inflator can?

The Inflator serial code is an **11 digit code** on the Inflator can. It can be found with a bar code on removing the Inflator can from the Airbag Assembly unit.

The first two characters of the **Original Inflator Serial code** will be from [AA, AB, AJ, FD or JD].

- c) Check the box that states that the inflator serial number is not visible or missing.  
**(DO NOT SCAN THE INFLATORS)**  
**(this will allow the program to advance to the next screen)**

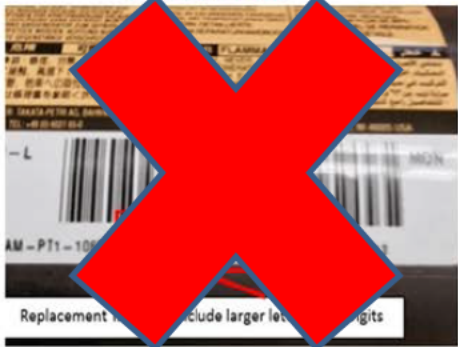
Replacement Inflator

The first two characters of the **Replacement Inflator Serial code** will be either 'LT' or 'LR'.

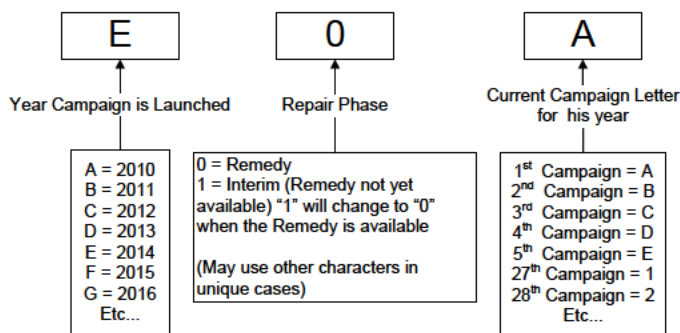
### A. CAMPAIGN DESIGNATION DECODER

Examples:

A0D = Launched in 2010, Remedy Phase, 4<sup>th</sup> Campaign Launched in 2010

B1E = Launched in 2011, Interim Phase, 5<sup>th</sup> Campaign Launched in 2011

C1C = Launched in 2012, Interim Phase, 3<sup>rd</sup> Campaign Launched in 2012
