# IMPORTANT UPDATE

## TECHNICAL INSTRUCTIONS FOR SAFETY RECALL HLA FRONT PASSENGER AIRBAG INFLATOR REPLACEMENT CERTAIN 2007 – 2009 MY ES 350 **UPDATED 1-9-2018**

The subject vehicles are equipped with front passenger airbag inflators produced by Takata. The propellant in these inflators may degrade after prolonged exposure to high absolute humidity and fluctuating high temperatures. Degraded propellant can cause inflator rupture during airbag deployment. In the event of an inflator rupture, metal fragments could pass through the airbag cushion material, striking the vehicle occupants, and result in serious injury or death.

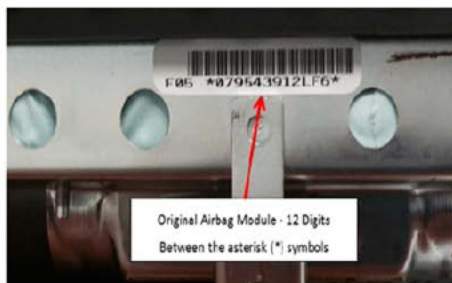
- The airbag serial number is **ALWAYS** the 12 **DIGITS** located between the asterisks.
- The 3 digits before the asterisk **ARE NOT** part of the serial number, and **SHOULD NOT** be entered or an inaccurate response may be returned.

#### Airbag Serial Number Label Example

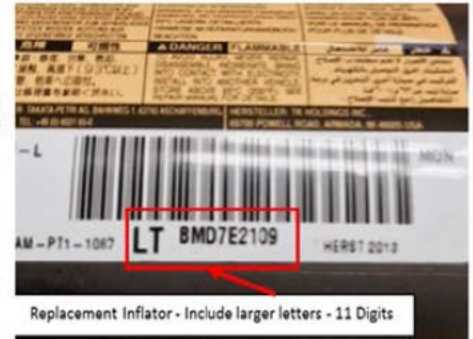
The Inflator serial code is an 11 digit code on the Inflator can. It can be found with a bar code on removing the Inflator can from the Airbag Assembly unit.

The first two characters of the Original Inflator Serial code will be from [AA, AB, AJ, FD or JD].

The first two characters of the Replacement Inflator Serial code will be either 'LT' or 'LR'.

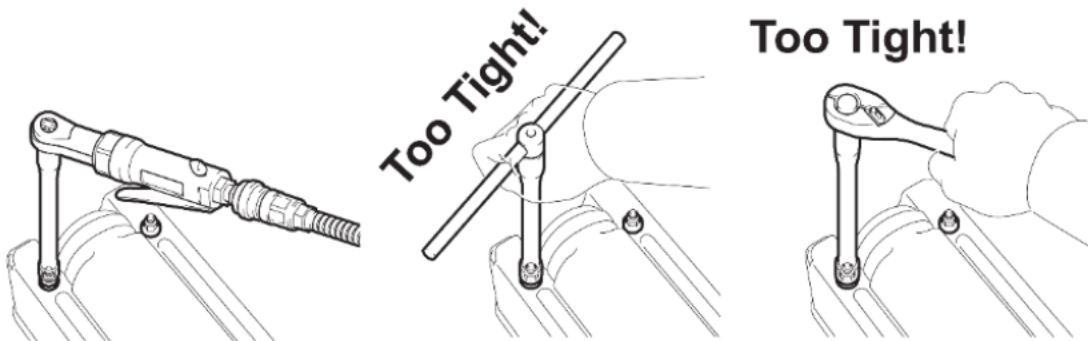
R1701260011Z01

k) Tighten the 5 nuts evenly in several increments in the sequence shown. Use a socket driver or torque wrench to tighten the nuts.

- There will be some resistance when tightening the nuts because they are self-locking, confirm the nuts are tightened correctly.
- **DO NOT** use a power tool, T-handle, or ratchet when tightening the nuts to avoid over torqueing and deforming the studs.
- You may need to slide the airbag to the left or right with in the mounting bracket to access the center nut.

**These tools cause overtightening !**
