TECHNICAL INSTRUCTIONS FOR SAFETY RECALL G0R FRONT PASSENGER AIRBAG INFLATOR MODULE CERTAIN 2009-2010 MODEL YEAR COROLLA

Updated 7-17-18

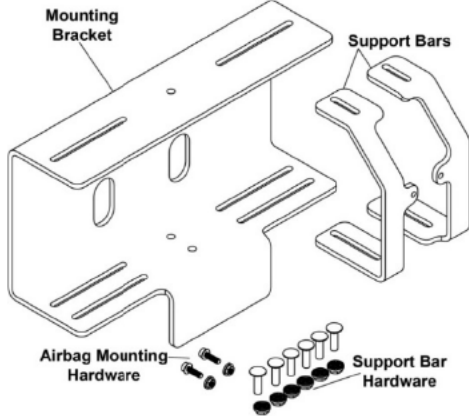
Airbag Mounting Bracket & hardware	1

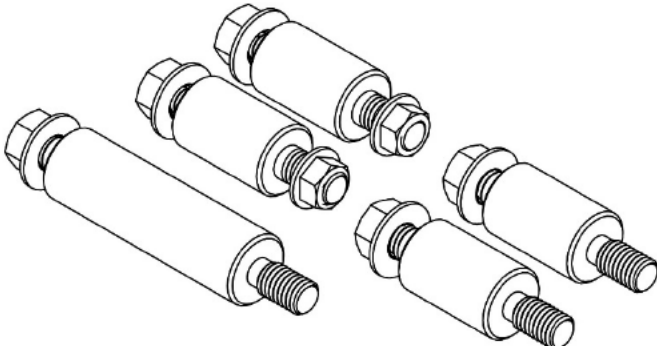
Adaptor set*	1

*The adaptor set was sent to dealers at the start of this campaign.

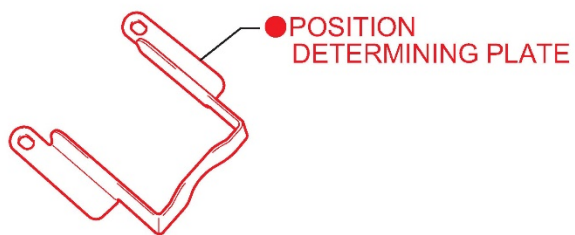
for COROLLA:

● : Replacement part

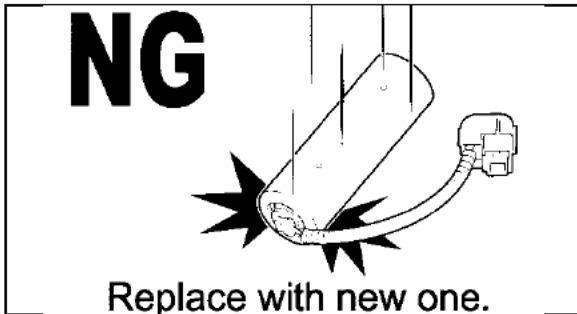
2. DO NOT MEASURE RESISTANCE

- a) **DO NOT** measure resistance of airbag components, this may cause accidental activation.

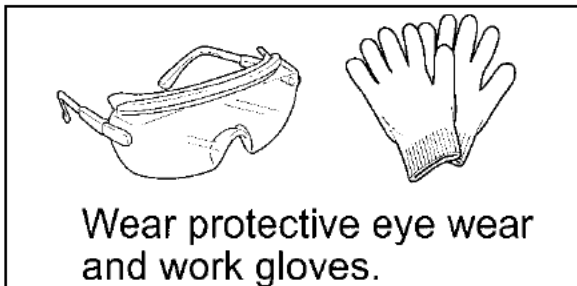
4. DO NOT ALLOW FOREIGN OBJECTS NEAR AIRBAG

- a) Be sure to collect and account for all removed nuts/bolts to prevent them from landing in the airbag assembly.
- b) Any foreign objects in the airbag assembly may cause damage or injury if the airbag is activated.

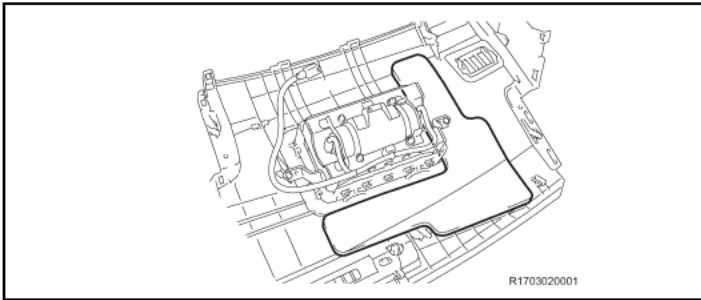
a) Refer to TIS for instructions on airbag removal:

NOTE: For TMC made Corolla only (VIN starts with JT). Do not remove the No. 4 instrument panel cushion.

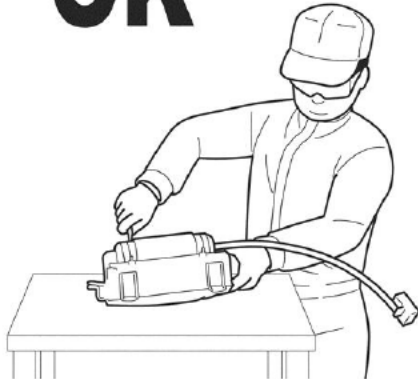
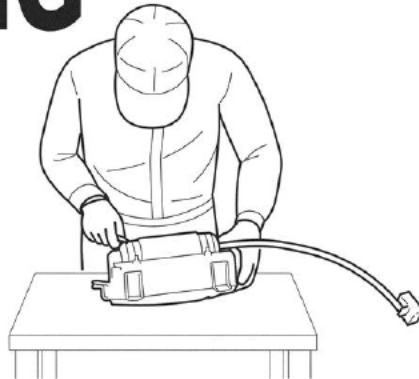
R1301230008E

- Carefully place the airbag on the bench inflator side up.

NOTE: Place clean sheet(s) of paper on the bench to protect the airbag.

- Avoid standing directly over the inflator.

OK

NG

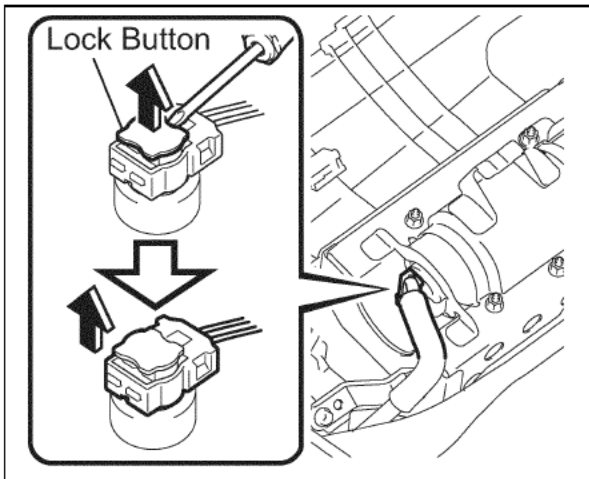
2. AIRBAG PREPARATION

- Use a screwdriver to release the lock button.
- Disconnect the connector.
- Disconnect the wire harness clamps.

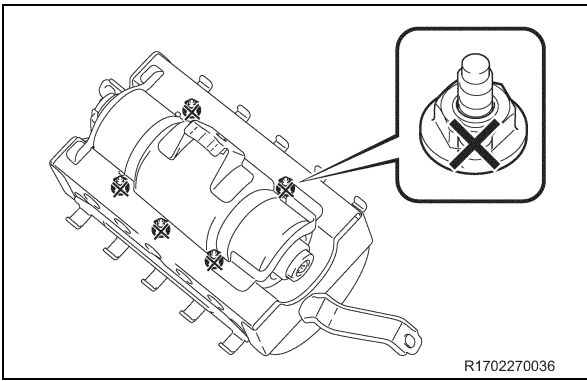
NOTE: Disconnect the connector where the fixed stop plate is located.

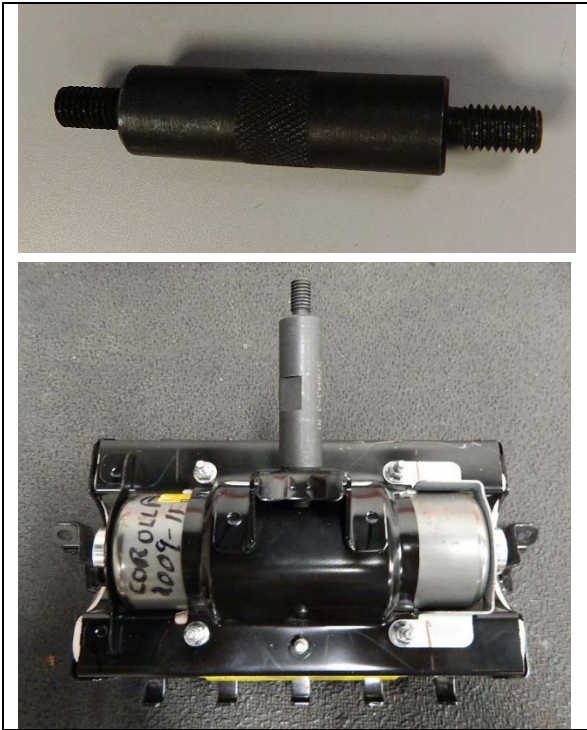
d) Mark all 5 nuts so they will not be reused.

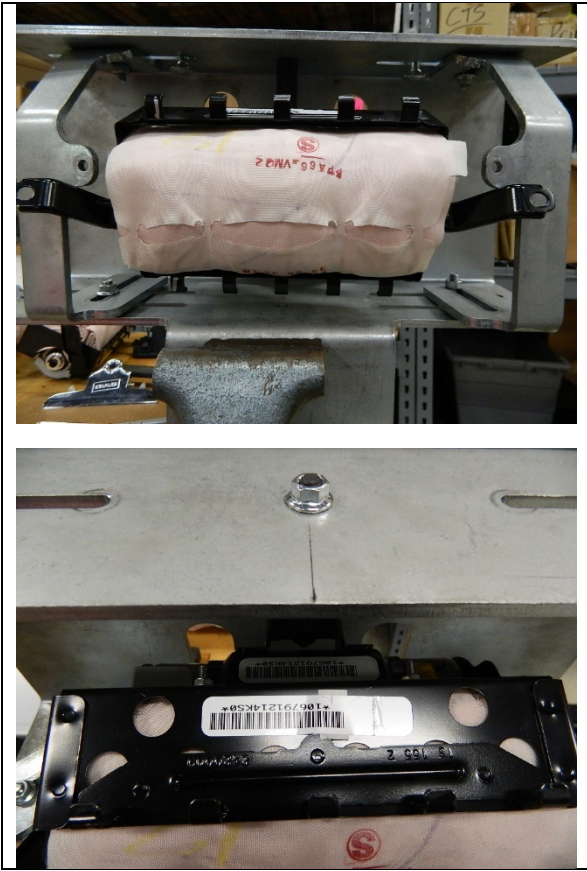
e) Use the long adaptor shown.

f) Thread the adaptor into the airbag as shown.
Note: Use the same mounting nut on the airbag that attaches the airbag to the vehicles cross tube.

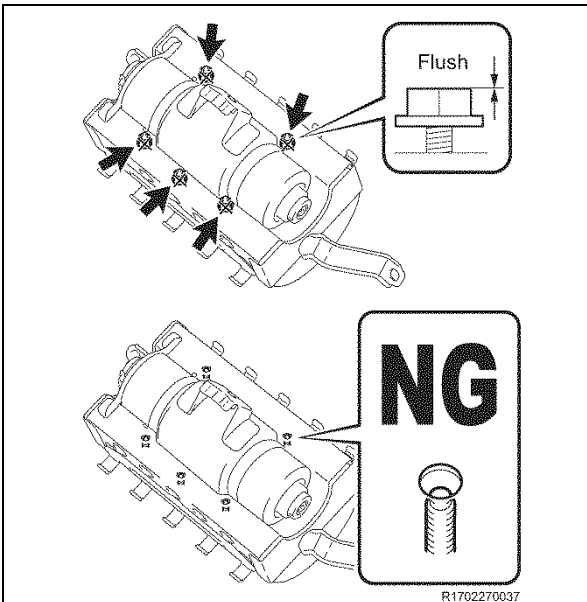
- g) Mount the airbag into the mounting bracket as shown. Pass the stud on the adaptor through the hole, on the top in the middle of the bracket, and secure with the nut.

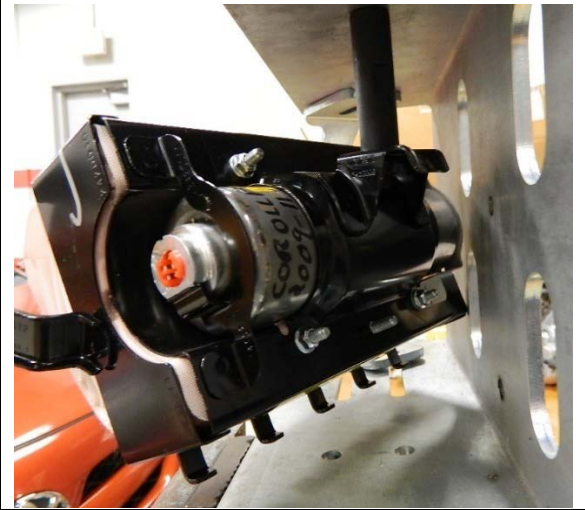
- a) Loosen the 5 nuts until the nuts are at the top of the studs as shown, through the openings in the mounting bracket.

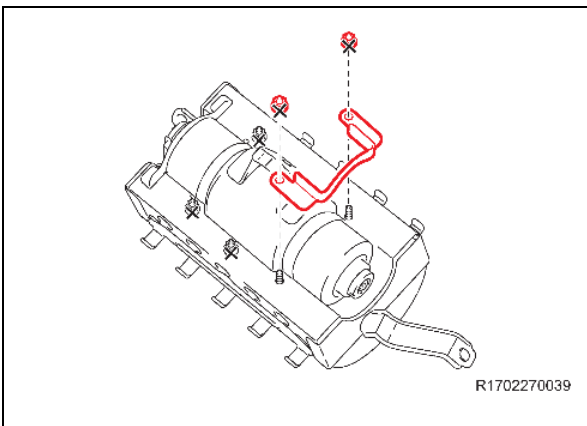
Note: The airbag may need to be turned to the left or right to access the center nut.

- b) Remove the 2 nuts on the end where the bracket is removable.
- c) Remove the bracket and discard.
- d) Reinstall the 2 nuts, until the nut is flush with the top of the stud.

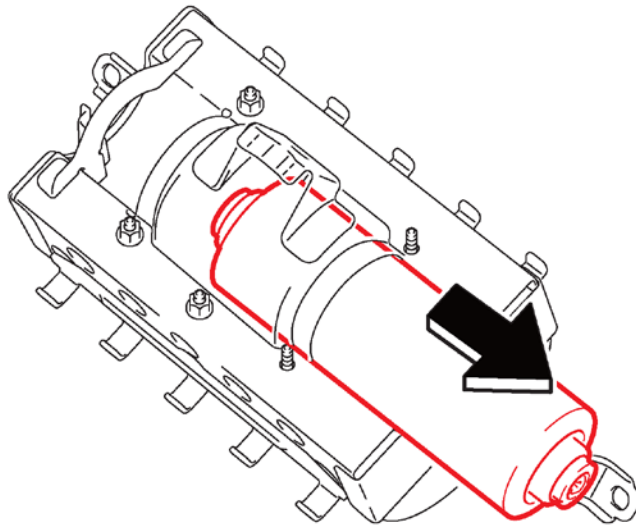
R1702270038

- a) Gently push in the studs until the nuts make contact with the housing to loosen the inflator for removal.

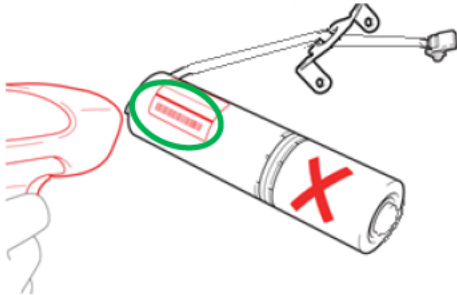
Step a) Old Inflator (bar code)

- Scan the **OLD** inflator bar code.
- Scan the **NEW** inflator QR code.

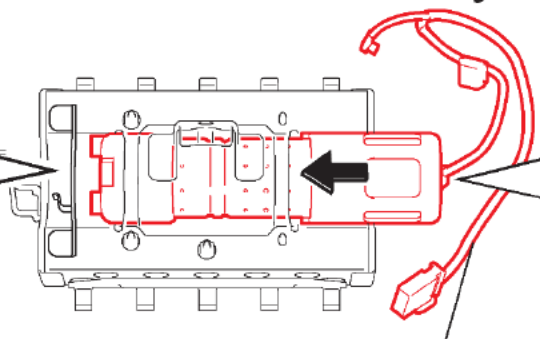
R1702270040

a) Carefully slide the new inflator into the airbag assembly and align as shown.

- DO NOT** connect the inflator harness at this time. It is **CRITICAL** to first confirm that the inflator is installed in the correct position before connecting the harness.

DO NOT insert fully.

Check orientation

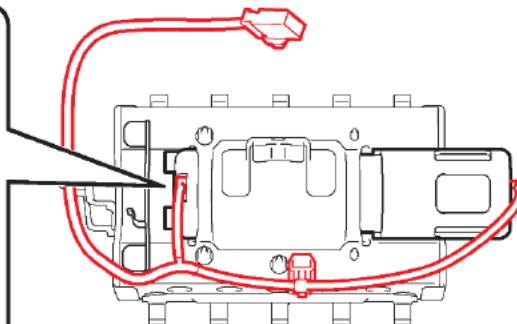
R1702270041

b) Connect the connector to the inflator and ensure that the connector lock is fully engaged as shown.

c) Route and secure the wire harness as shown.

ALIGN CONNECTORS

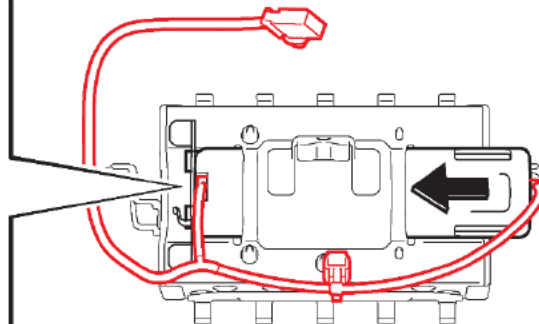
R1702270042

d) Fully insert the inflator and ensure that the inflator is correctly oriented as shown.

NOTE: DO NOT pinch the wiring between the bracket and the inflator.

DO NOT
pinch the wire

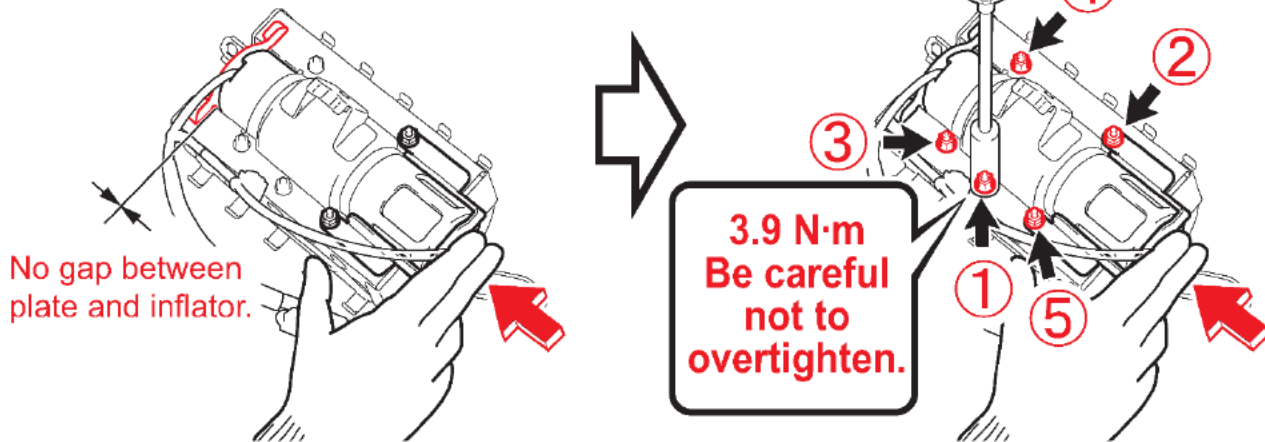
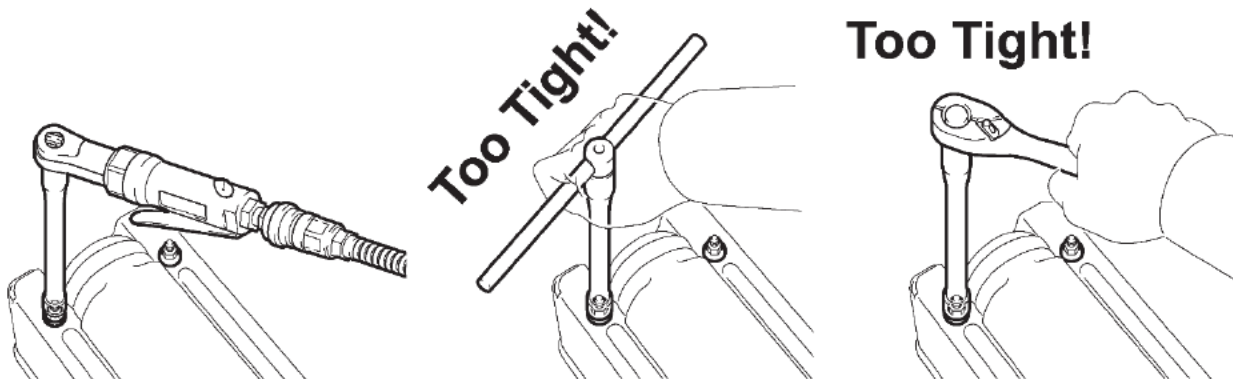
R1702270046

- There will be some resistance when tightening the nuts because they are self-locking, confirm the nuts are tightened correctly.
- **DO NOT** use a power tool, T-handle, or ratchet when tightening the nuts to avoid over torquing and deforming the studs.
- You may need to turn the airbag to the left or right with in the mounting bracket to access the center nut.

These tools cause overtightening !

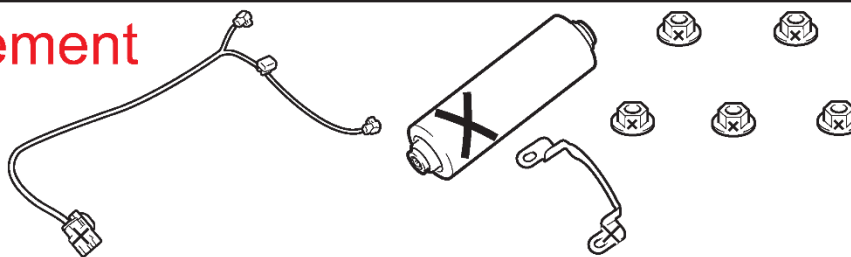
(a) Replacement of parts.

- Confirm the **NEW** inflator and 5 **NEW** nuts have been installed.
- Confirm the position of the inflator and position determining plates are correct.
NOTE: The flats should be aligned and no gaps between the plates and inflator.
- Confirm the routing of the inflator wire harness.
