# IMPORTANT UPDATE

## TECHNICAL INSTRUCTIONS FOR SAFETY RECALL GLG FRONT PASSENGER AIRBAG MODULE CERTAIN 2010-2013 MY GX 460 **UPDATED 4-18-2018**

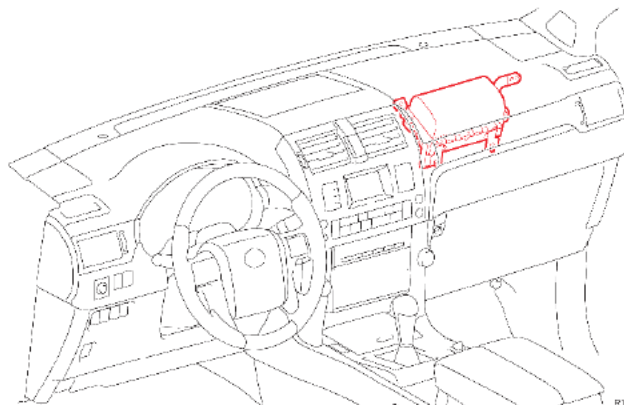
The subject vehicles are equipped with front passenger airbag inflators produced by Takata. The propellant in these inflators may degrade after prolonged exposure to high absolute humidity and fluctuating high temperatures. Degraded propellant can cause inflator rupture during airbag deployment. In the event of an inflator rupture, metal fragments could pass through the airbag cushion material, striking the vehicle occupants, and result in serious injury or death.

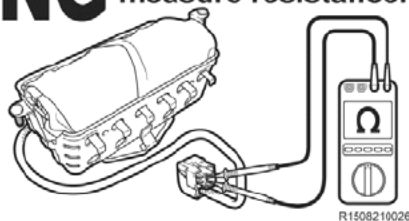
R1508210026

**NG** DO NOT measure resistance.

- a) **NEVER** measure the resistance of an airbag, this may cause accidental activation.

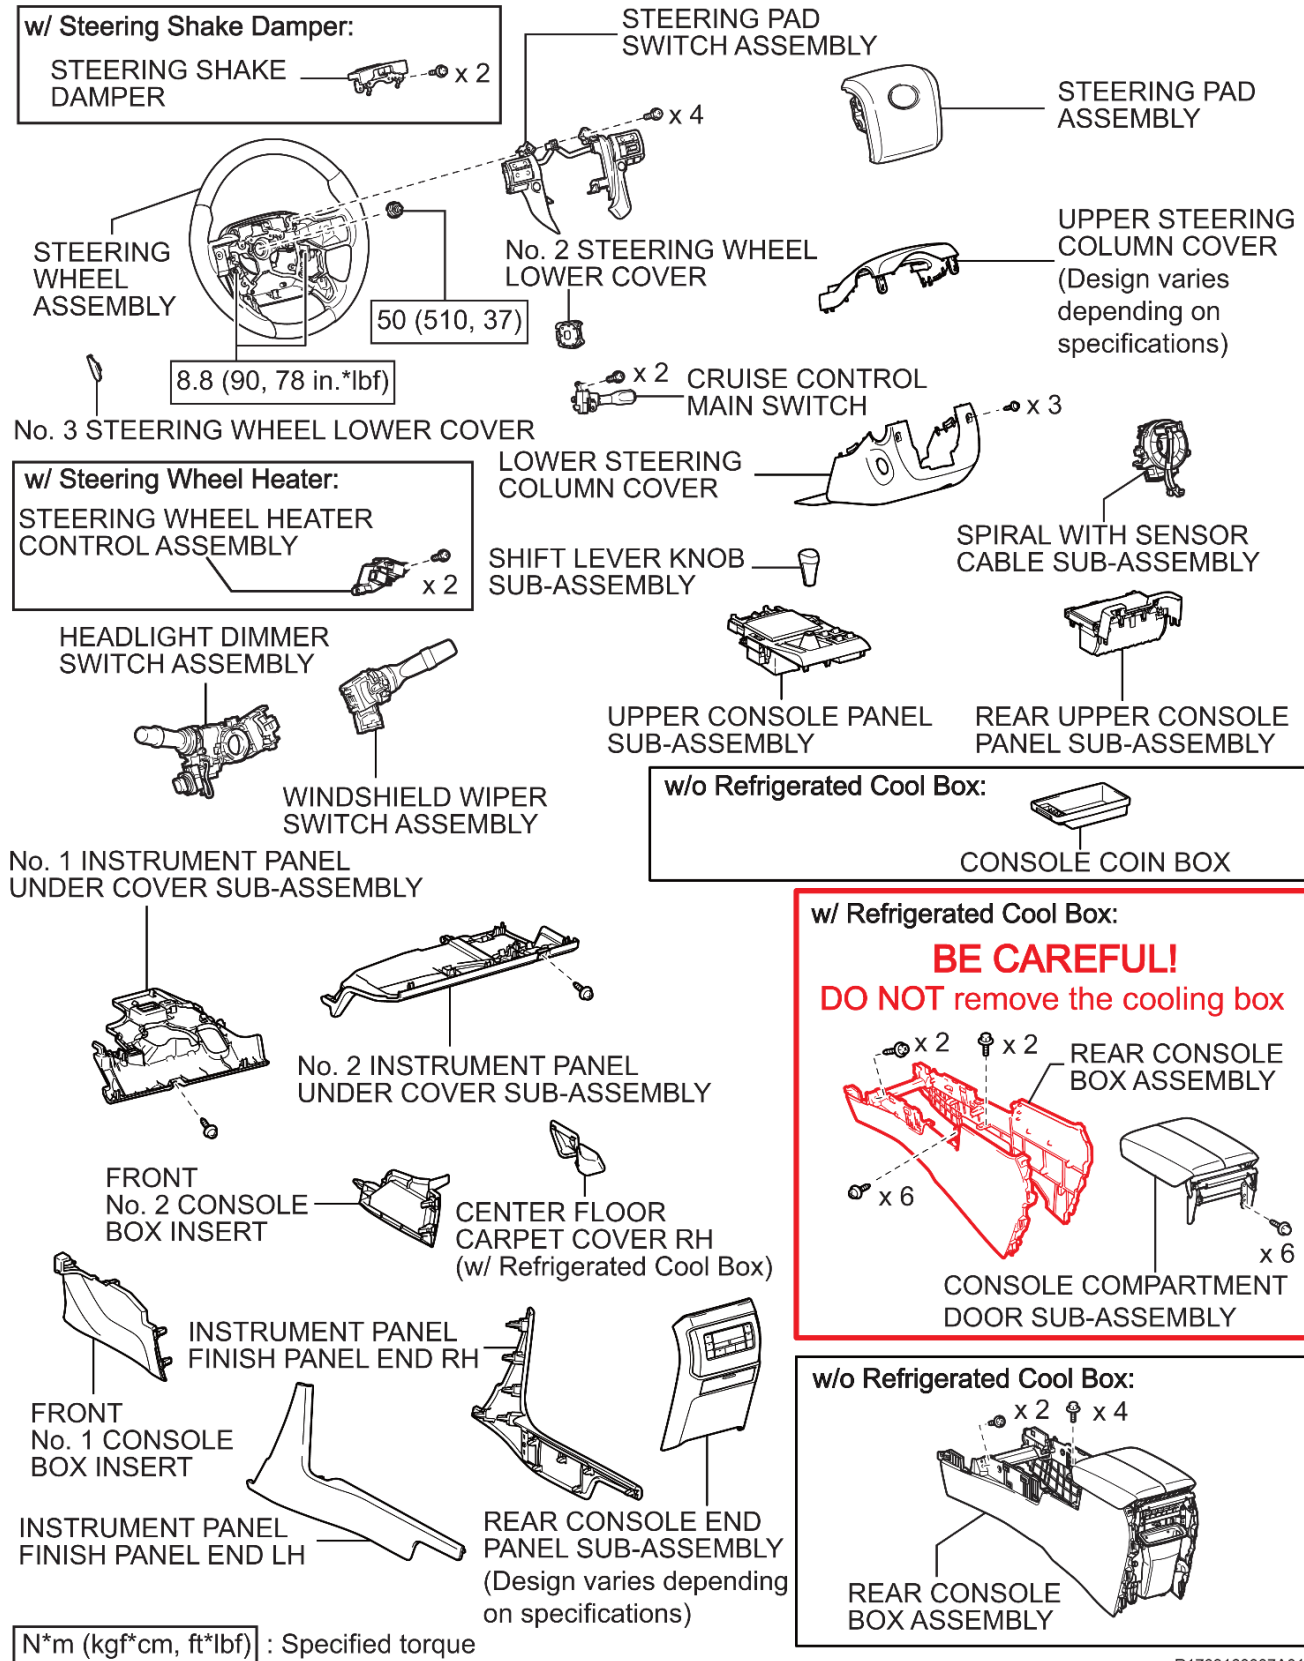
R1703160007A01

## VII. FRONT PASSENGER AIRBAG REMOVAL COMPONENTS

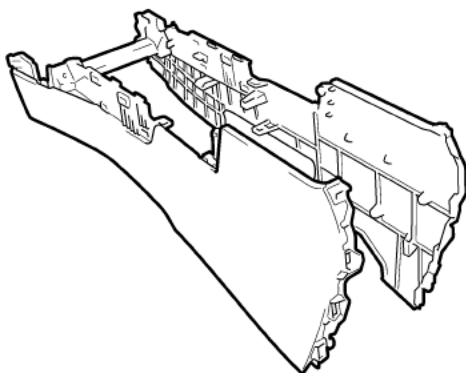
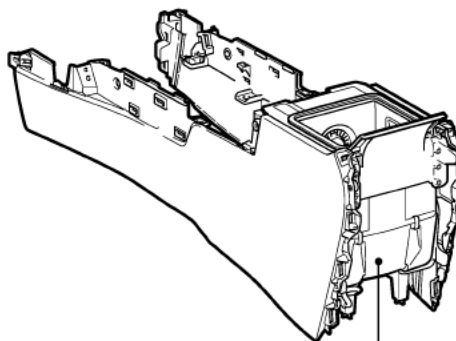
R1703300004

NOTE: The trim around the cool box can be removed and installed without disconnecting the refrigerant lines.

Leave the cooling box on the vehicle.

COOLING BOX

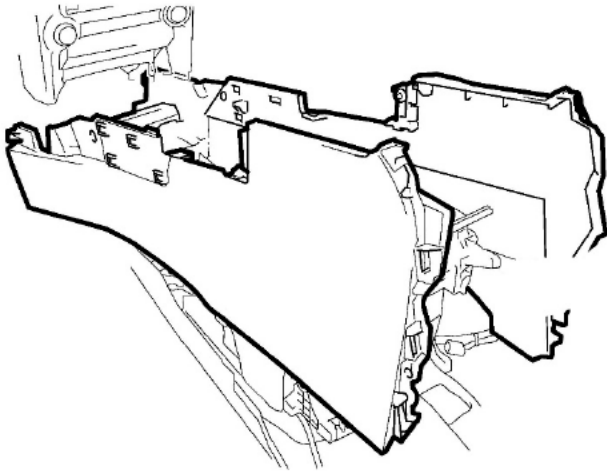
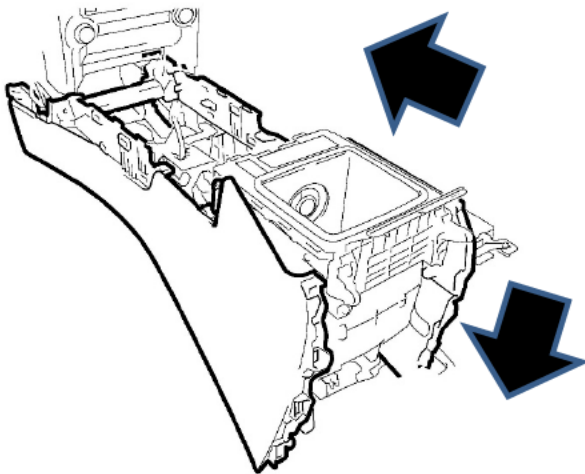
**Do not damage  
surrounding components**

- a) Install the front of the console box with rear section lifted as shown.

- b) Lower the rear of the box and then slide it forward.

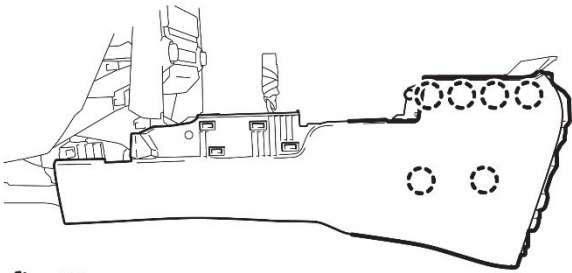
R1703290003

for LH side:

○ : Claw

- c) Reengage the 6 claws on each side of the console as shown.

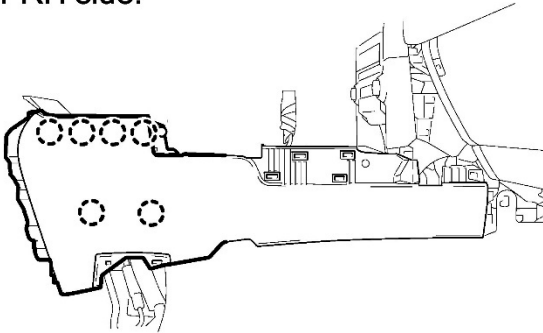
R1703290002

for RH side:

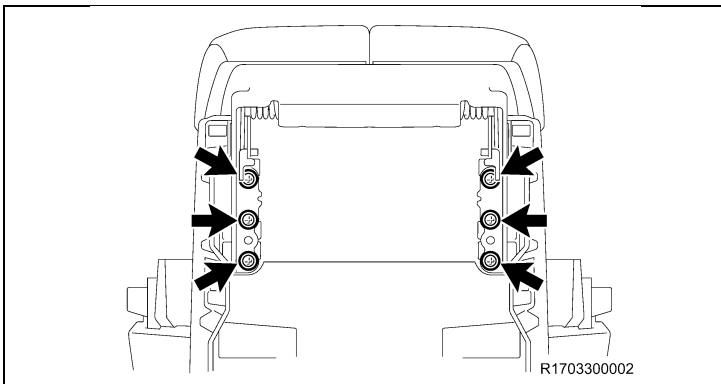
R1703300002

- d) Reinstall the 6 screws.

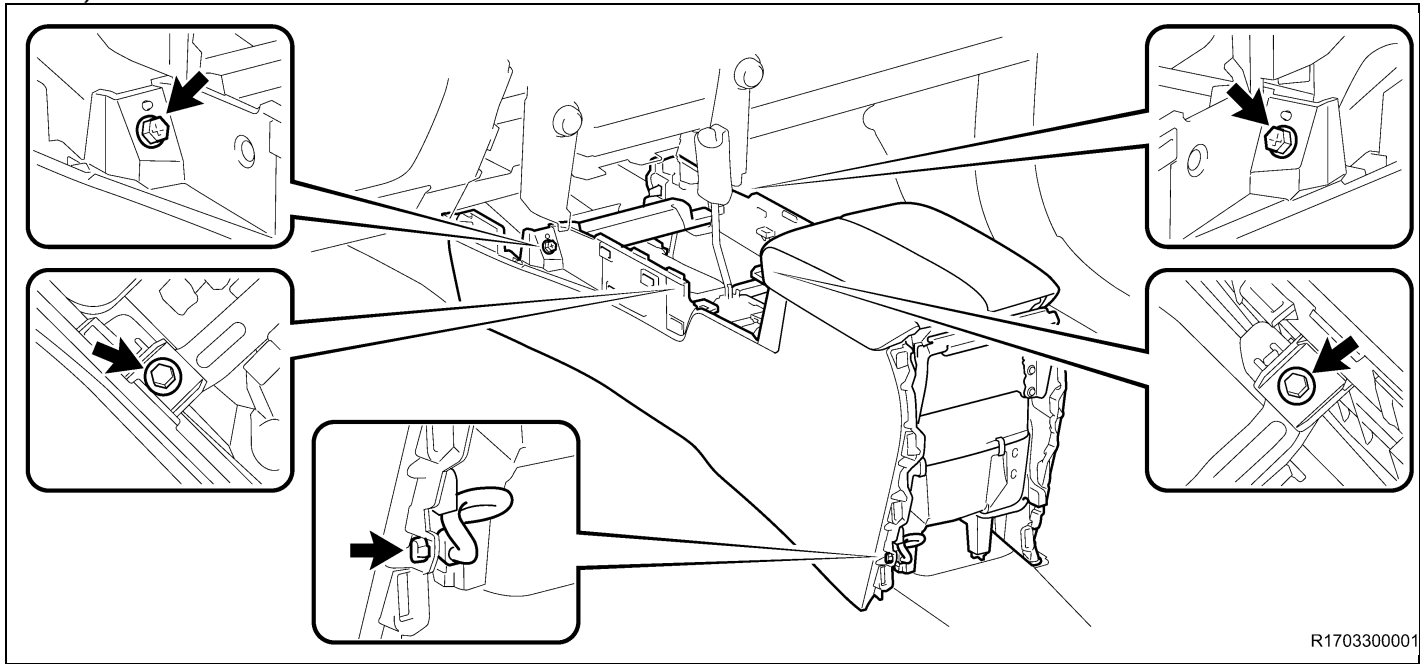
R1703300001

- e) Reinstall the console door.  
f) Reinstall the 6 screws

- g) Reengage the clamp.
- h) Reinstall the 2 bolts and 2 screws.

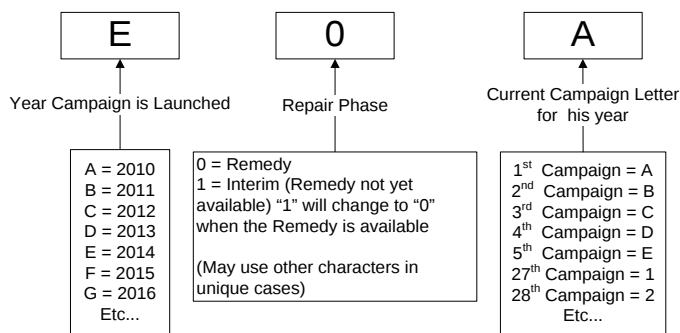
## B. CAMPAIGN DESIGNATION DECODER

Examples:

A0D = Launched in 2010, Remedy Phase, 4<sup>th</sup> Campaign Launched in 2010

B1E = Launched in 2011, Interim Phase, 5<sup>th</sup> Campaign Launched in 2011

C1C = Launched in 2012, Interim Phase, 3<sup>rd</sup> Campaign Launched in 2012
