TECHNICAL INSTRUCTIONS

SAFETY RECALL GOP

FRONT PASSENGER AIRBAG INFLATOR MODULE

CERTAIN 2010-2013 MY 4Runner

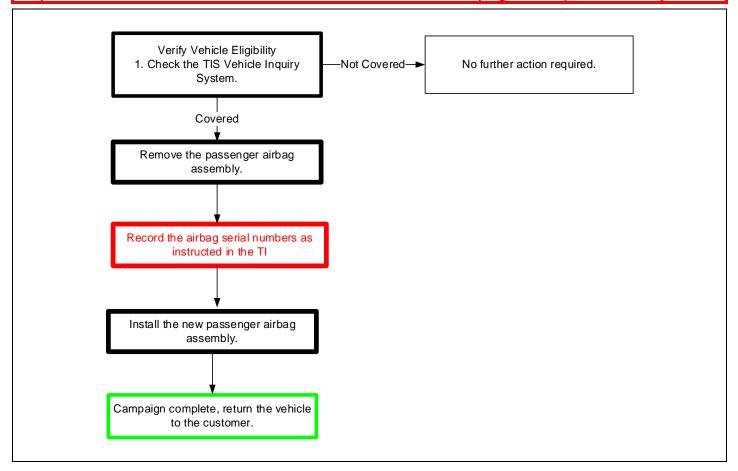
I. OPERATION FLOW CHART

The flow chart is for reference only. *DO NOT* use it in place of the full technical instructions. Follow *ALL* steps as outlined in the full technical instructions to confirm the campaign is completed correctly.

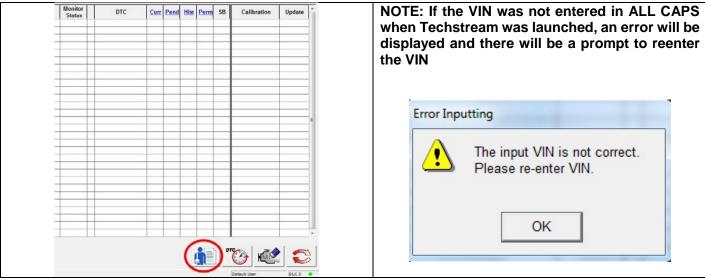
a) After the health check has completed, run a diagnostic report by clicking on the link on the health check screen.

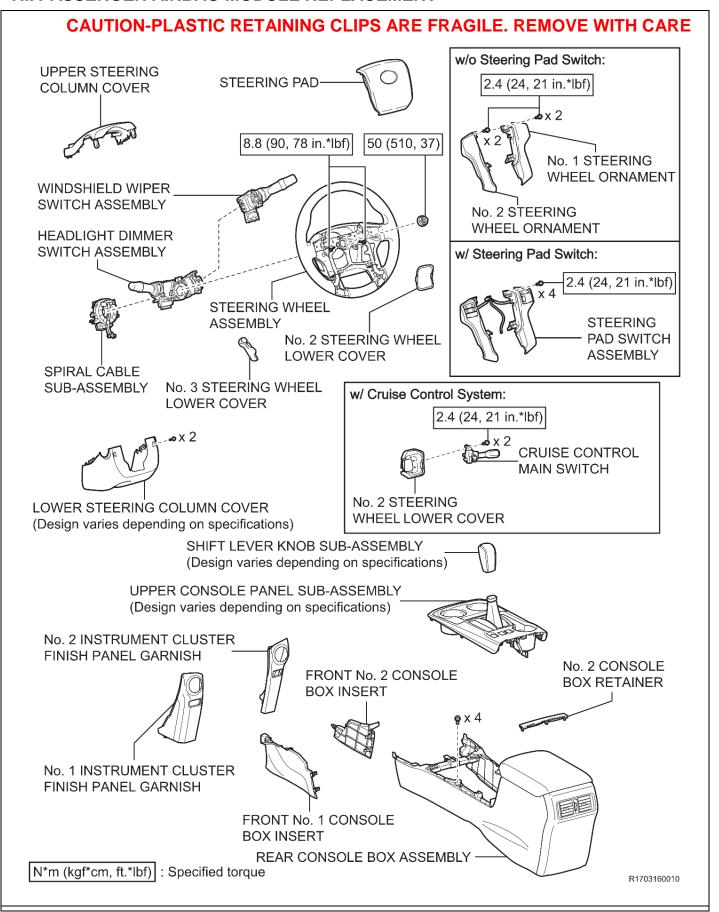
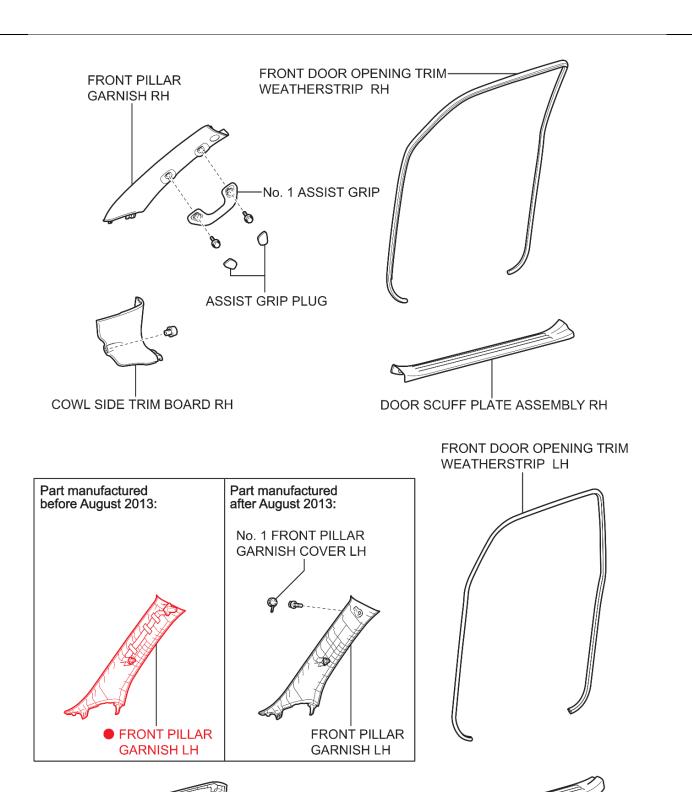
No. 2 INSTRUMENT PANEL No. 1 INSTRUMENT PANEL SPEAKER PANEL SUB-ASSEMBLY SPEAKER PANEL SUB-ASSEMBLY ₽x 2 FRONT No. 2 SPEAKER ASSEMBLY FRONT No. 2 SPEAKER **ASSEMBLY** ⊕x 2 **INSTRUMENT PANEL** SUB-ASSEMBLY No. 2 INSTRUMENT PANEL REGISTER ASSEMBLY 20 (204, 15) 12 (122, 9) x 6 MULTI-MEDIA INTERFACE ECU No. 1 INSTRUMENT PANEL REGISTER ASSEMBLY DCM (TELEMATICS TRANSCEIVER) 12 (122, 9) LOWER INSTRUMENT 13 (127, 9) PANEL SUB-ASSEMBLY 4 WHEEL DRIVE CONTROL ECU (for 4WD) No. 2 SWITCH HOLE BASE **INSTRUMENT PANEL** LOWER INSTRUMENT PANEL **BOX DOOR COVER** 13 (127, 9) FINISH PANEL ASSEMBLY (Design varies depending on specifications) LOWER INSTRUMENT **COVER LH COMBINATION METER** RADIO RECEIVER **ASSEMBLY ASSEMBLY** % x 3 10 (102, 7) LOWER No. 2 INSTRUMENT PANEL AIRBAG ASSEMBLY INSTRUMENT CLUSTER FINISH PANEL SUB-ASSEMBLY 2.5 (25, 22 in.*lbf) LOWER No. 1 INSTRUMENT No. 2 INSTRUMENT PANEL PANEL AIRBAG ASSEMBLY UNDER COVER SUB-ASSEMBLY x 4 10 (102, 7) HEATER CONTROL ASSEMBLY **∞**x 2 %x2 LOWER INSTRUMENT PANEL FINISH PANEL SUB-ASSEMBLY LOWER CENTER INSTRUMENT CLUSTER FINISH PANEL SUB-ASSEMBLY N*m (kgf*cm, ft.*lbf): Specified torque R1703160012

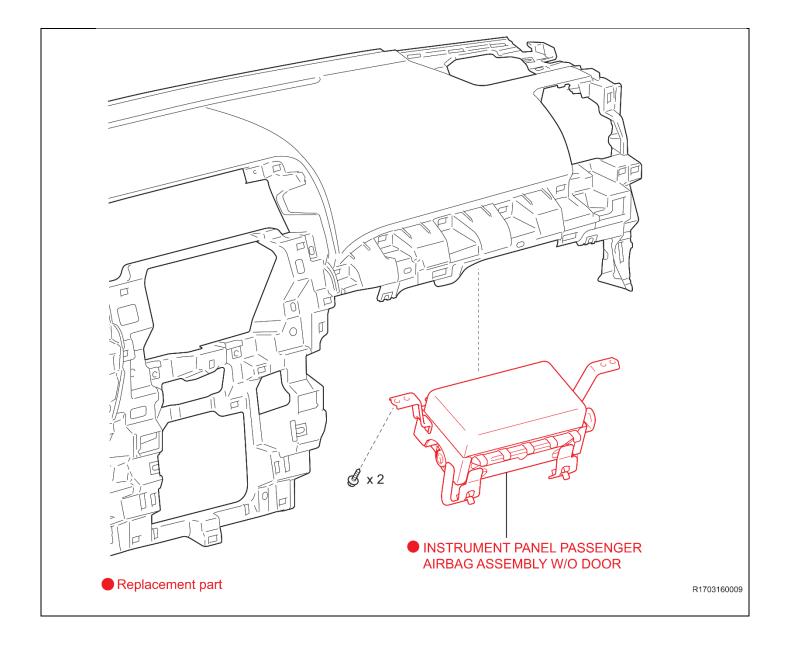
CAUTION-PLASTIC RETAINING CLIPS ARE FRAGILE. REMOVE WITH CARE

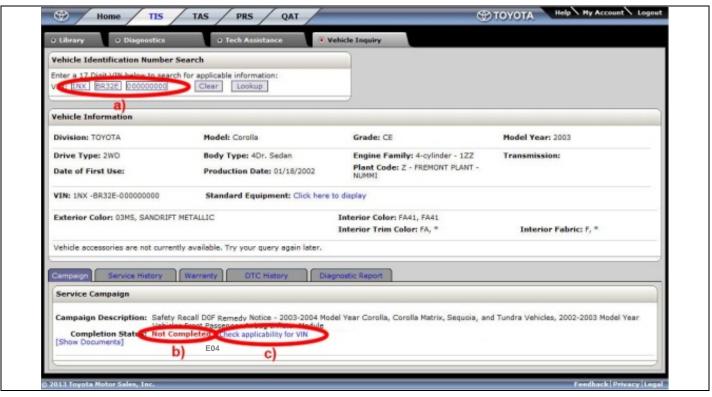
Note: The Serial Number Recording Application is the same as the previous application, so the screens will still indicate an older campaign.

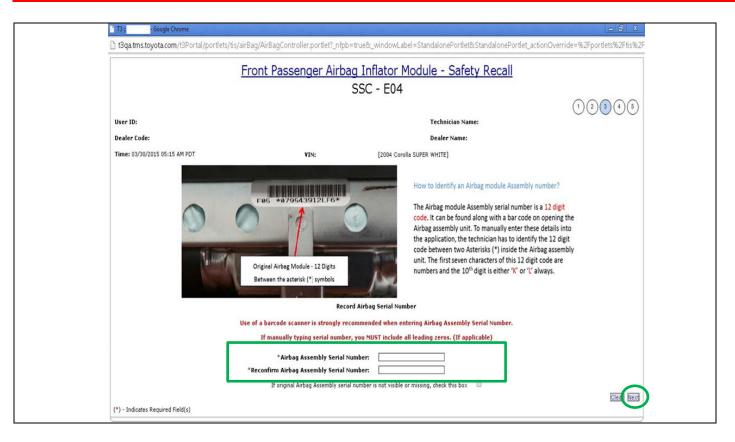
Airbag Serial Number Label Example

- The airbag serial number is *ALWAYS* the 12 *DIGITS* located between the asterisks.
- The 3 digits before the asterisk ARE NOT part of the serial number, and SHOULD NOT be entered or an inaccurate response may be returned.

The AIRBAG serial number MUST be recorded prior to replacement.

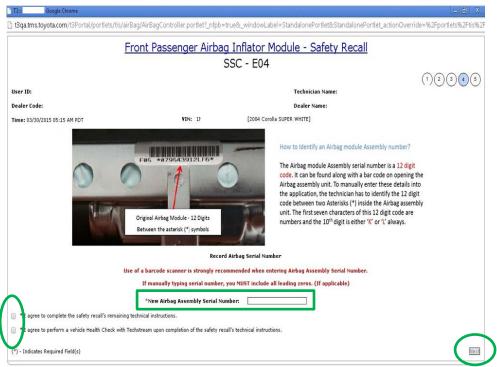
e) Scan the NEW airbag barcode in the Serial Number Recording Application.

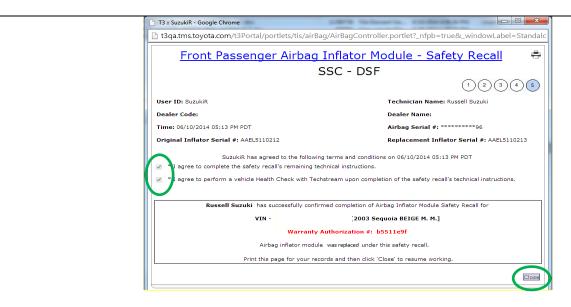
- f) Verify the statements and click the two boxes.
- g) Click next.

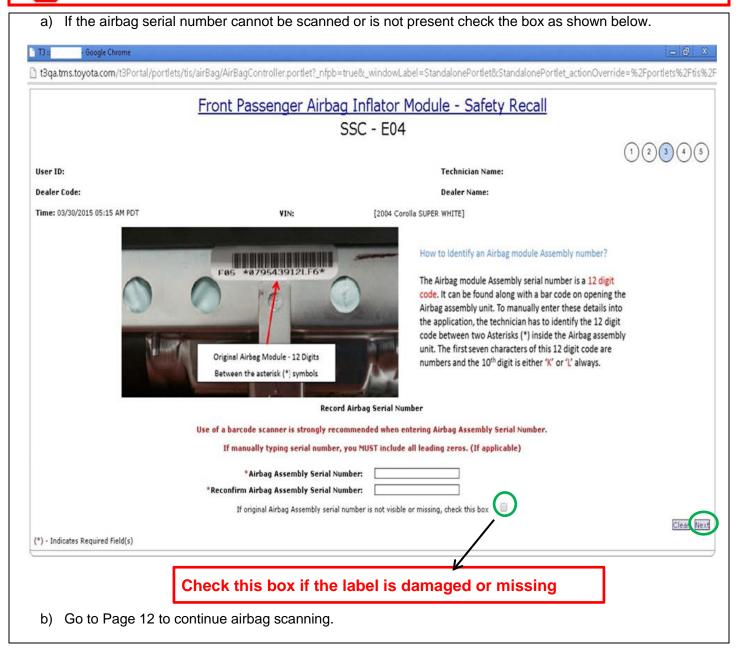
AIRBAG SERIAL NUMBER IS MISSING OR IS UNREADABLE

If the airbag serial number and barcode are not legible or are not present, check the box in the application indicating the serial number is not legible.
