IMPORTANT UPDATE

TECHNICAL INSTRUCTIONS FOR SAFETY RECALL GLG/GLH/HLA FRONT PASSENGER AIRBAG MODULE CERTAIN 2010-2017 MY GX 460 **UPDATED 1-15-2019**

II. BACKGROUND

The subject vehicles are equipped with front passenger airbag inflators produced by Takata. The propellant in these inflators may degrade after prolonged exposure to high absolute humidity and fluctuating high temperatures. Degraded propellant can cause inflator rupture during airbag deployment. In the event of an inflator rupture, metal fragments could pass through the airbag cushion material, striking the vehicle occupants, and result in serious injury or death.

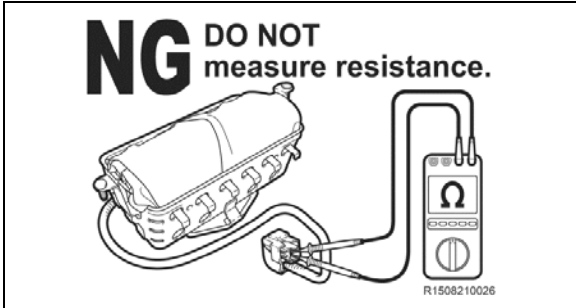
2. DO NOT MEASURE RESISTANCE

- a) **NEVER** measure the resistance of an airbag, this may cause accidental activation.
