TECHNICAL INSTRUCTIONS FOR SAFETY RECALL G0P FRONT PASSENGER AIRBAG INFLATOR MODULE CERTAIN 2011-2013 MODEL YEAR SIENNA

Updated 7-17-18

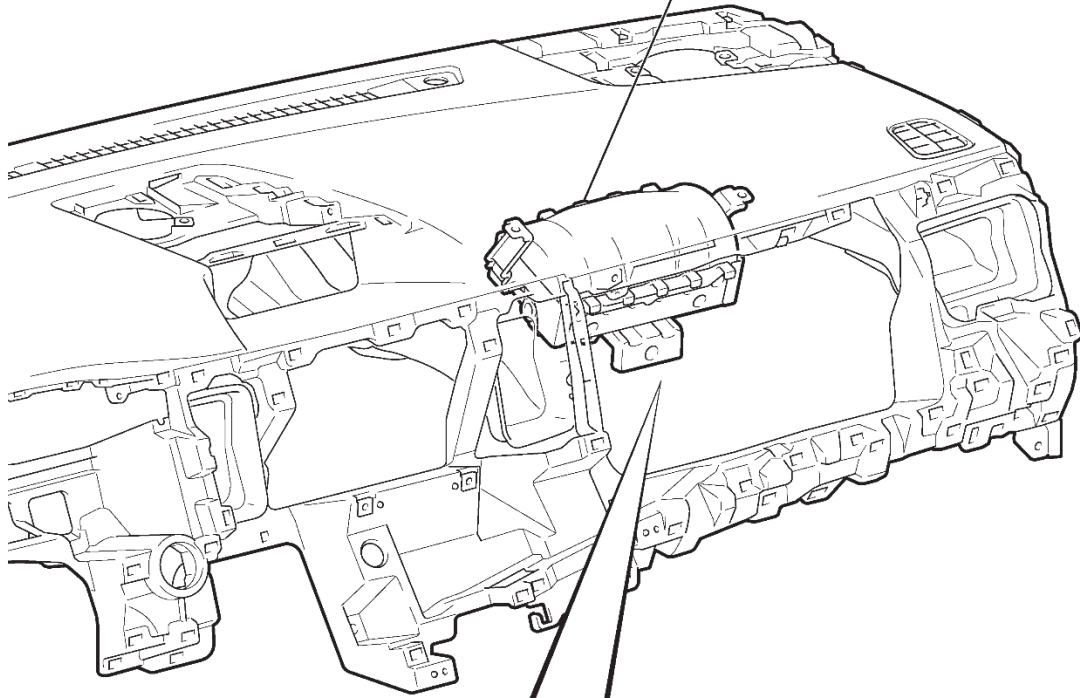
3.9 N·m (40, 35 in.*lbf)
Be careful not to
overtighten.

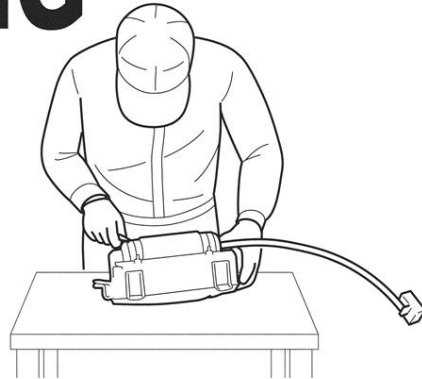
- Carefully place the airbag on the bench inflator side up.

NOTE: Place clean sheet(s) of paper on the bench to protect the airbag.

- Avoid standing directly over the inflator.

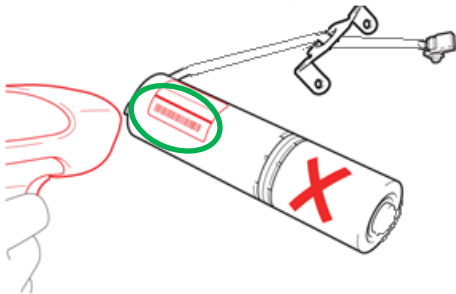
Step a) Old Inflator (bar code)

- Scan the **OLD** inflator bar code.
- Scan the **NEW** inflator QR code.

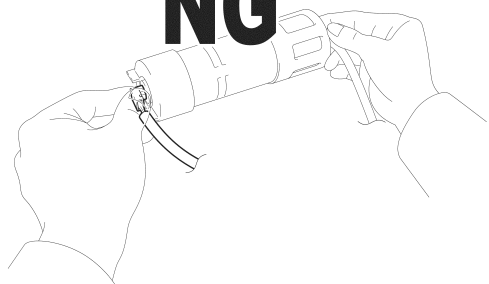
- DO NOT** connect the inflator harness at this time. It is **CRITICAL** to first confirm that the inflator is installed in the correct position before connecting the harness.

DO NOT CONNECT PREMATURELY
CANNOT DISCONNECTED

NOTE: Once connected the inflator harness cannot be disconnected without damaging the connector, and would require that the inflator and harness be replaced.

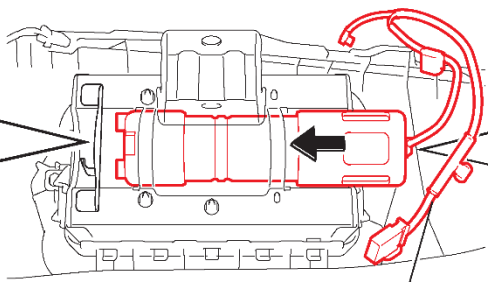
- a) Carefully slide the new inflator half way into the airbag assembly and align as shown.

DO NOT insert fully.

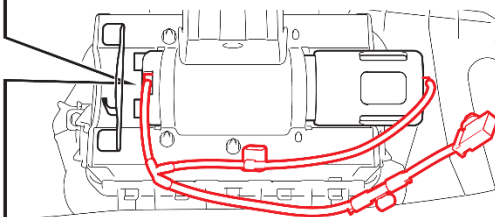
- b) Connect the connector to the inflator and ensure that the connector lock is fully engaged as shown.

ALIGN CONNECTORS

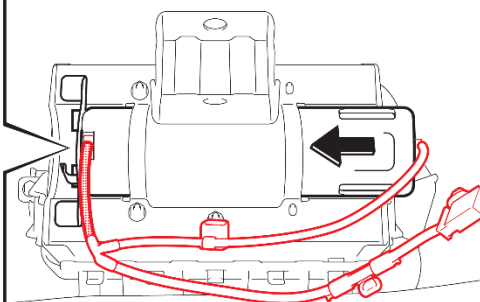
- a) Fully insert the inflator and ensure that the inflator is correctly oriented as shown.

NOTE: DO NOT pinch the wiring between the bracket and the inflator.

DO NOT
pinch the wire

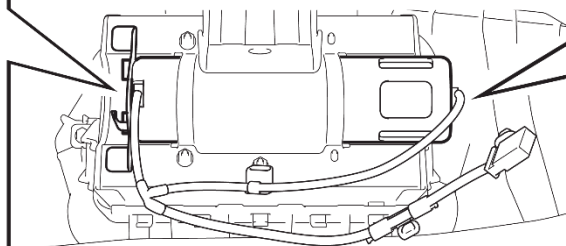
NOTE: Ensure the inflator is correctly oriented.

Check orientation

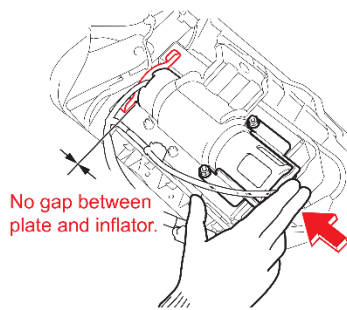
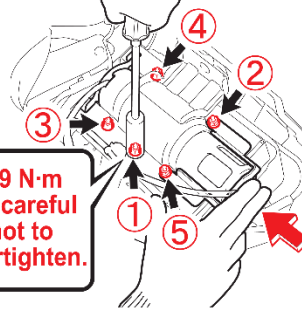
- a) Tighten the 5 nuts evenly in several increments in the sequence shown. Use a socket driver or torque wrench to tighten the nuts.

Torque: 35in. lbf (40 kgf.cm, 3.9N·m)

- There will be some resistance when tightening the nuts because they are self-locking, confirm the nuts are tightened correctly.
- **DO NOT** use a power tool, T-handle, or ratchet when tightening the nuts to avoid overtorqueing and deforming the studs.
- You may need to turn the airbag to the left or right with in the mounting bracket to access the center nut.

These tools cause overtightening !
