## TECHNICAL INSTRUCTIONS FOR SAFETY RECALL H0A FRONT PASSENGER AIRBAG INFLATOR MODULE CERTAIN 2008 - 2009 MY SCION xB

**UPDATED 4-18-2018**

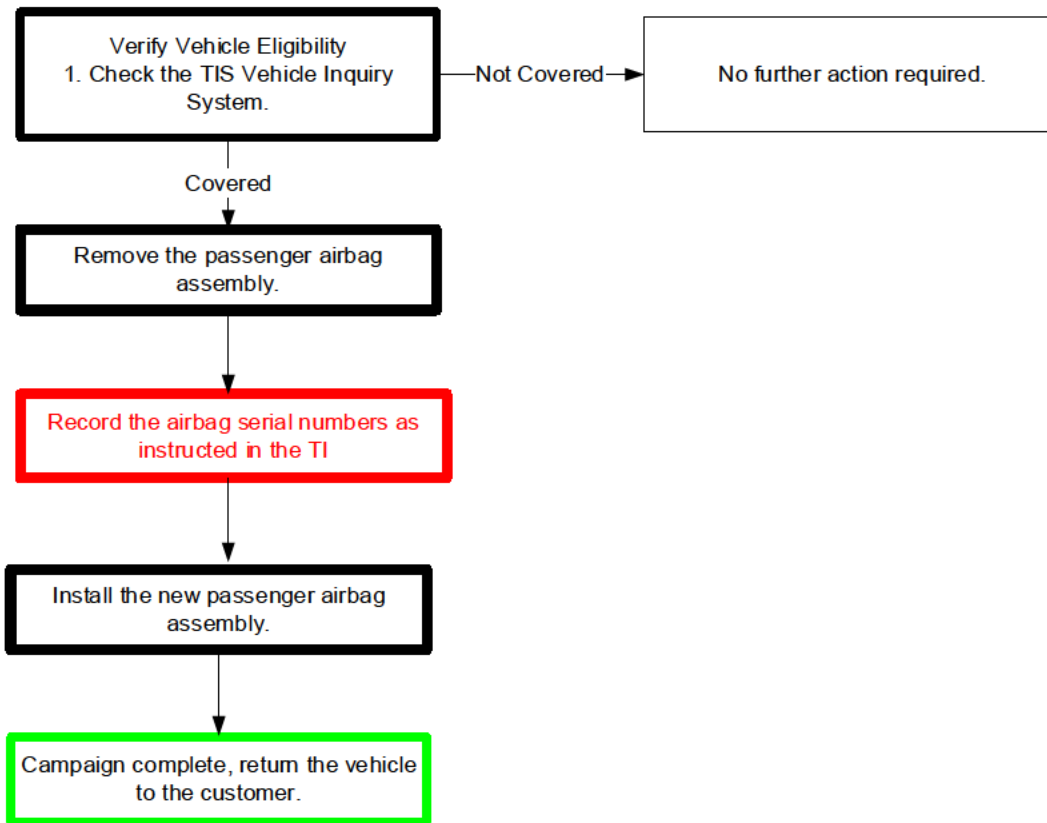
## I. OPERATION FLOW CHART

The flow chart is for reference only. **DO NOT** use it in place of the full technical instructions. Follow **ALL** steps as outlined in the full technical instructions to confirm the campaign is completed correctly.

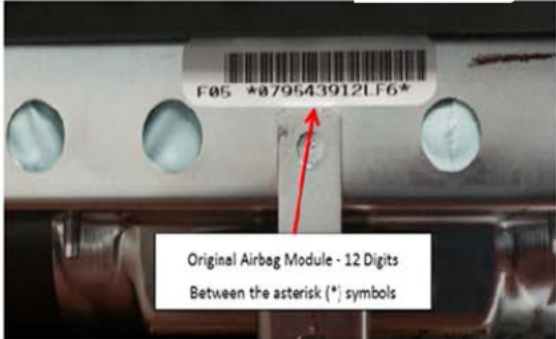
- The airbag serial number is **ALWAYS** the **12 DIGITS** located between the asterisks.
- The 3 digits before the asterisk **ARE NOT** part of the serial number, and **SHOULD NOT** be entered or an inaccurate response may be returned.

Original Airbag Module - 12 Digits  
Between the asterisk (\*) symbols
