# TECHNICAL INSTRUCTIONS FOR SAFETY RECALL G0P/G0R/H0A FRONT PASSENGER AIRBAG INFLATOR MODULE CERTAIN 2009 –2013 MODEL YEAR MATRIX

**Updated 1-9-2019**

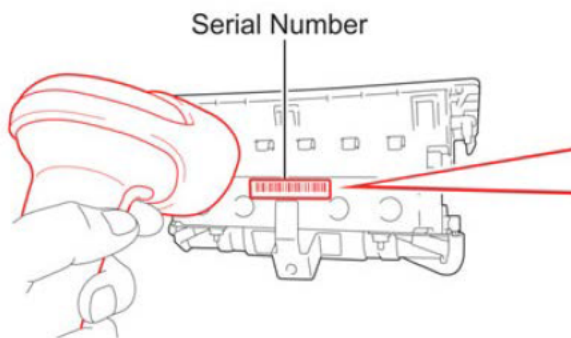
**Airbag Serial Number Label Example**

**AIRBAG SERIAL NUMBER IDENTIFICATION**

- The airbag serial number is **ALWAYS** the 12 **DIGITS** located between the asterisks.
- The 3 digits before the asterisk **ARE NOT** part of the serial number, and **SHOULD NOT** be entered or an inaccurate response may be returned.

The **AIRBAG ASSEMBLY** serial number and the **INFLATOR** serial number are **DIFFERENT**. The **AIRBAG ASSEMBLY** serial number **MUST** be recorded prior to replacement.

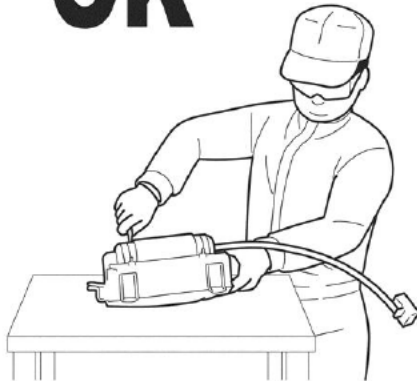
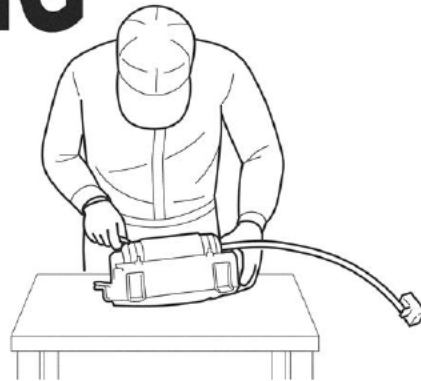
R1301230008E

- Carefully place the airbag on the bench inflator side up.

**NOTE:** Place clean sheet(s) of paper on the bench to protect the airbag.

- Avoid standing directly over the inflator.

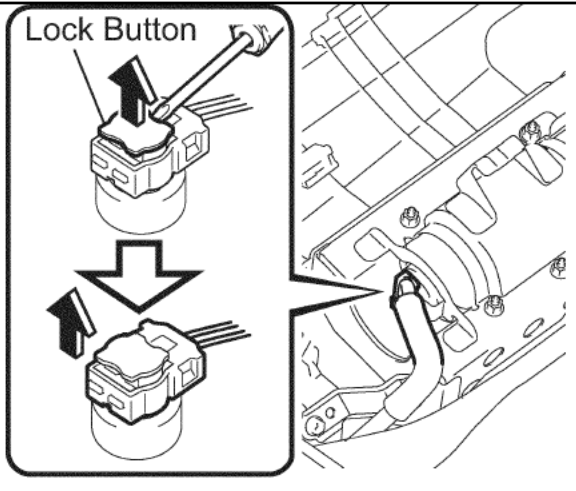
Lock Button

- Use a screwdriver to release the lock button.
- Disconnect the connector.
- Disconnect the wire harness clamps.

**NOTE:** Disconnect the connector where the fixed stop plate is located.

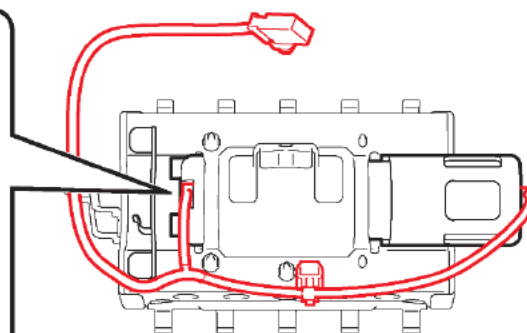
R1702270041

c) Route and secure the wire harness as shown.

**ALIGN CONNECTORS**

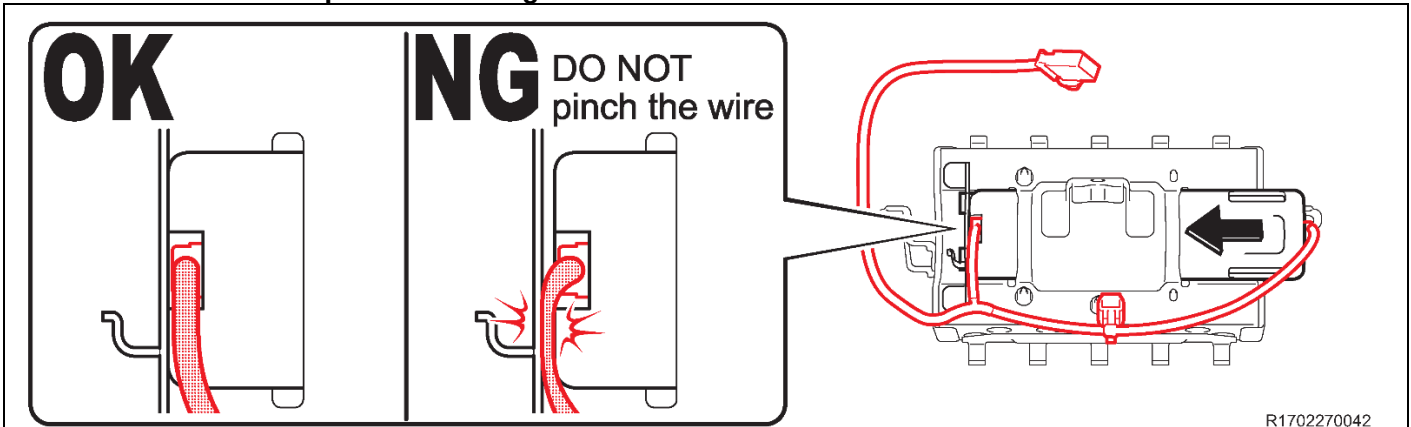
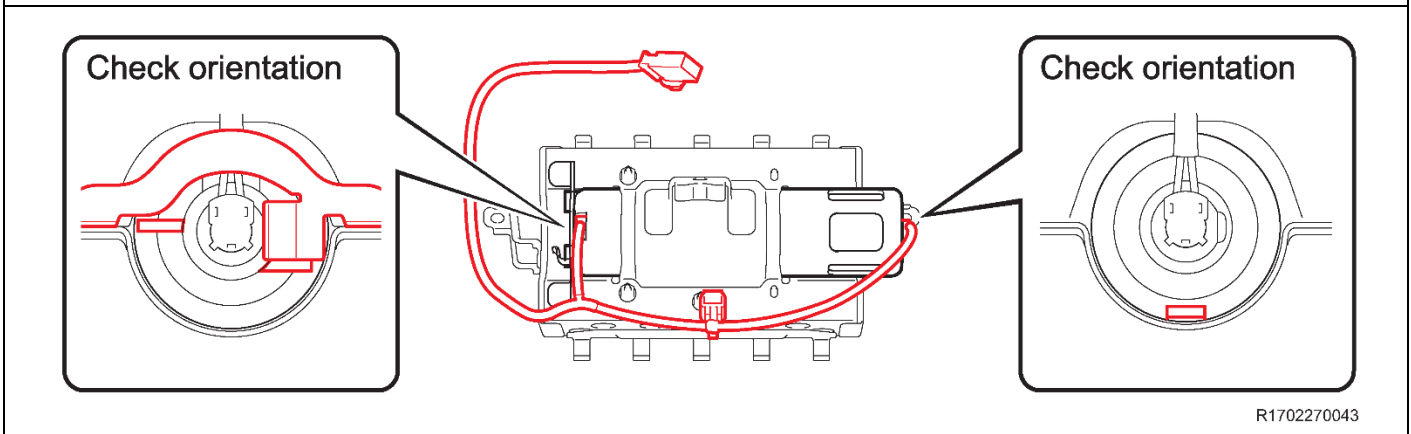
d) Fully insert the inflator and ensure that the inflator is correctly oriented as shown.

**NOTE: DO NOT pinch the wiring between the bracket and the inflator.**
