TECHNICAL INSTRUCTIONS

SAFETY RECALL GLG/GLH and HLA

FRONT PASSENGER AIRBAG MODULE

CERTAIN 2006 – 2013 MY IS 250/350 and 2008 – 2013 MY IS F

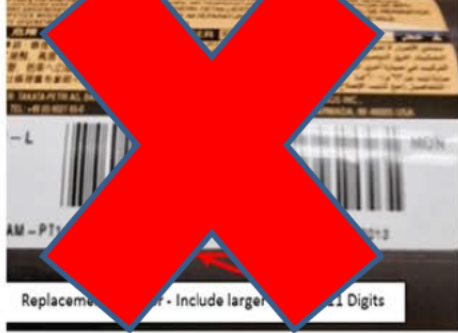
Original Inflator

How to identify the Inflator serial code on the Original and Replacement Inflator can?
The Inflator serial code is an **11 digit code** on the inflator can. It can be found with a bar code on removing the Inflator can from the Airbag Assembly unit.
The first two characters of the **Original Inflator Serial code** will be from [AA, AB, AJ, FD or JD].
The first two characters of the **Replacement Inflator Serial code** will be either 'LT' or 'LR'.

Replacement Inflator
