TECHNICAL INSTRUCTIONS FOR SAFETY RECALL G0R FRONT PASSENGER AIRBAG INFLATOR MODULE CERTAIN 2009-2010 MODEL YEAR MATRIX

Updated 7-17-18

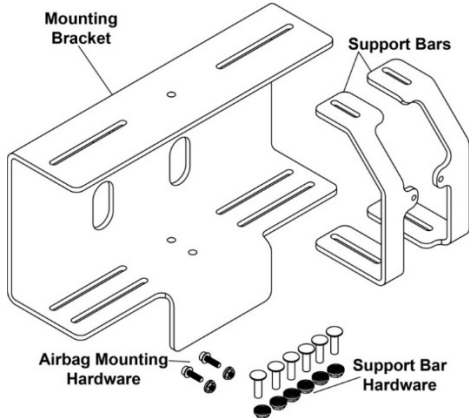
Airbag Mounting Bracket & hardware	1

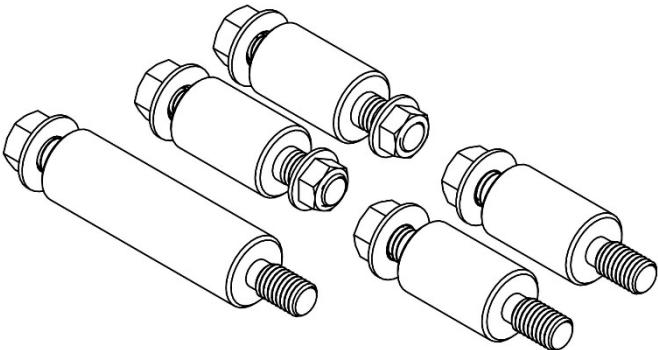
Adaptor set*	1

*The adaptor set was sent to dealers at the start of this campaign.

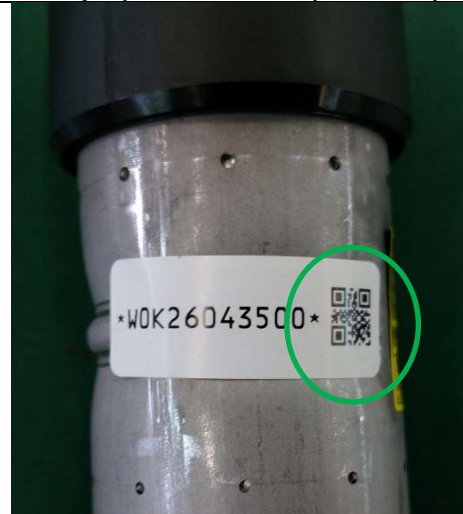
Step b) New Inflator (QR code)
