# IMPORTANT UPDATE

## TECHNICAL INSTRUCTIONS FOR SAFETY RECALL HLA FRONT PASSENGER AIRBAG MODULE CERTAIN 2007 – 2009 MY ES 350 **UPDATED 4-18-2018**

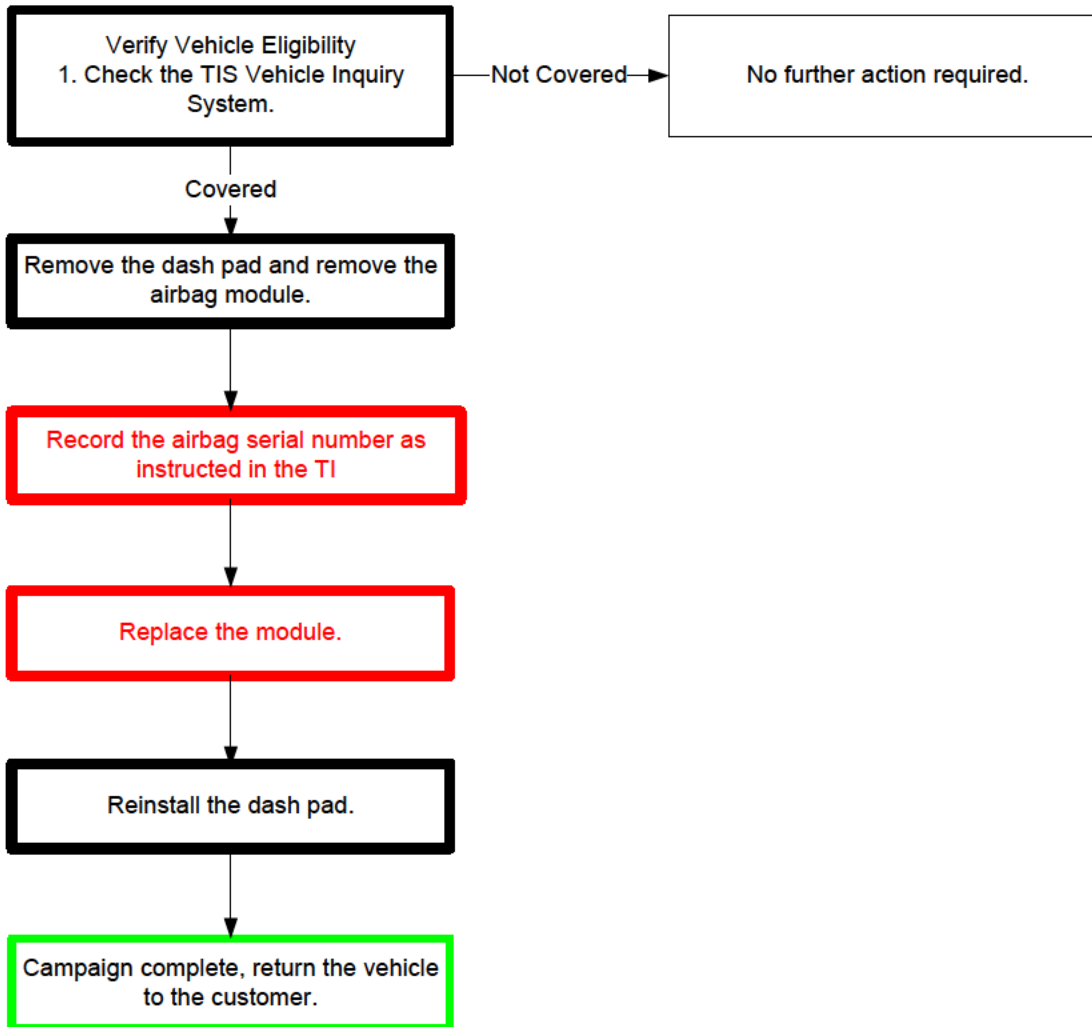
## I. OPERATION FLOW CHART

The flow chart is for reference only. **DO NOT** use it in place of the full technical instructions. Follow **ALL** steps as outlined in the full technical instructions to confirm the campaign is completed correctly.

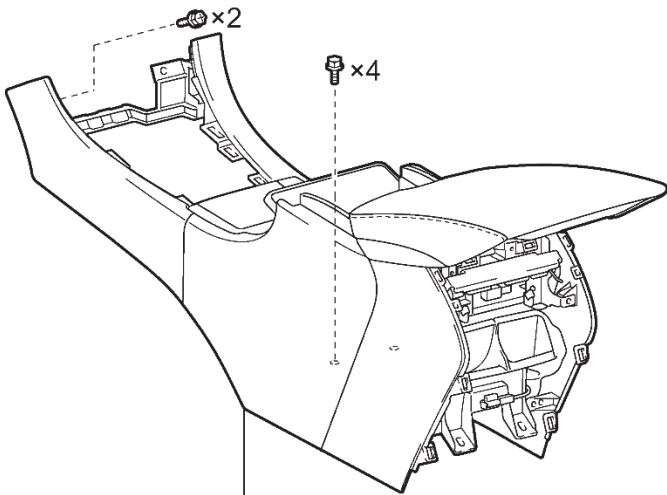
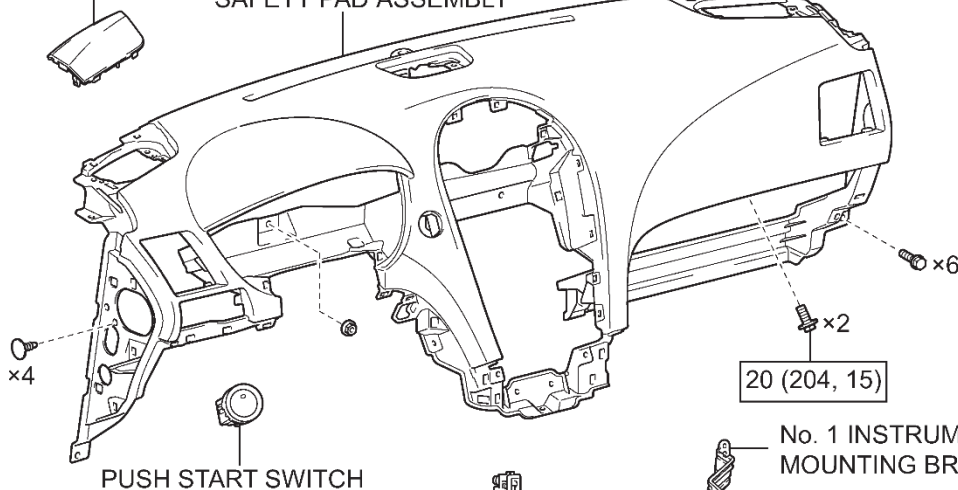
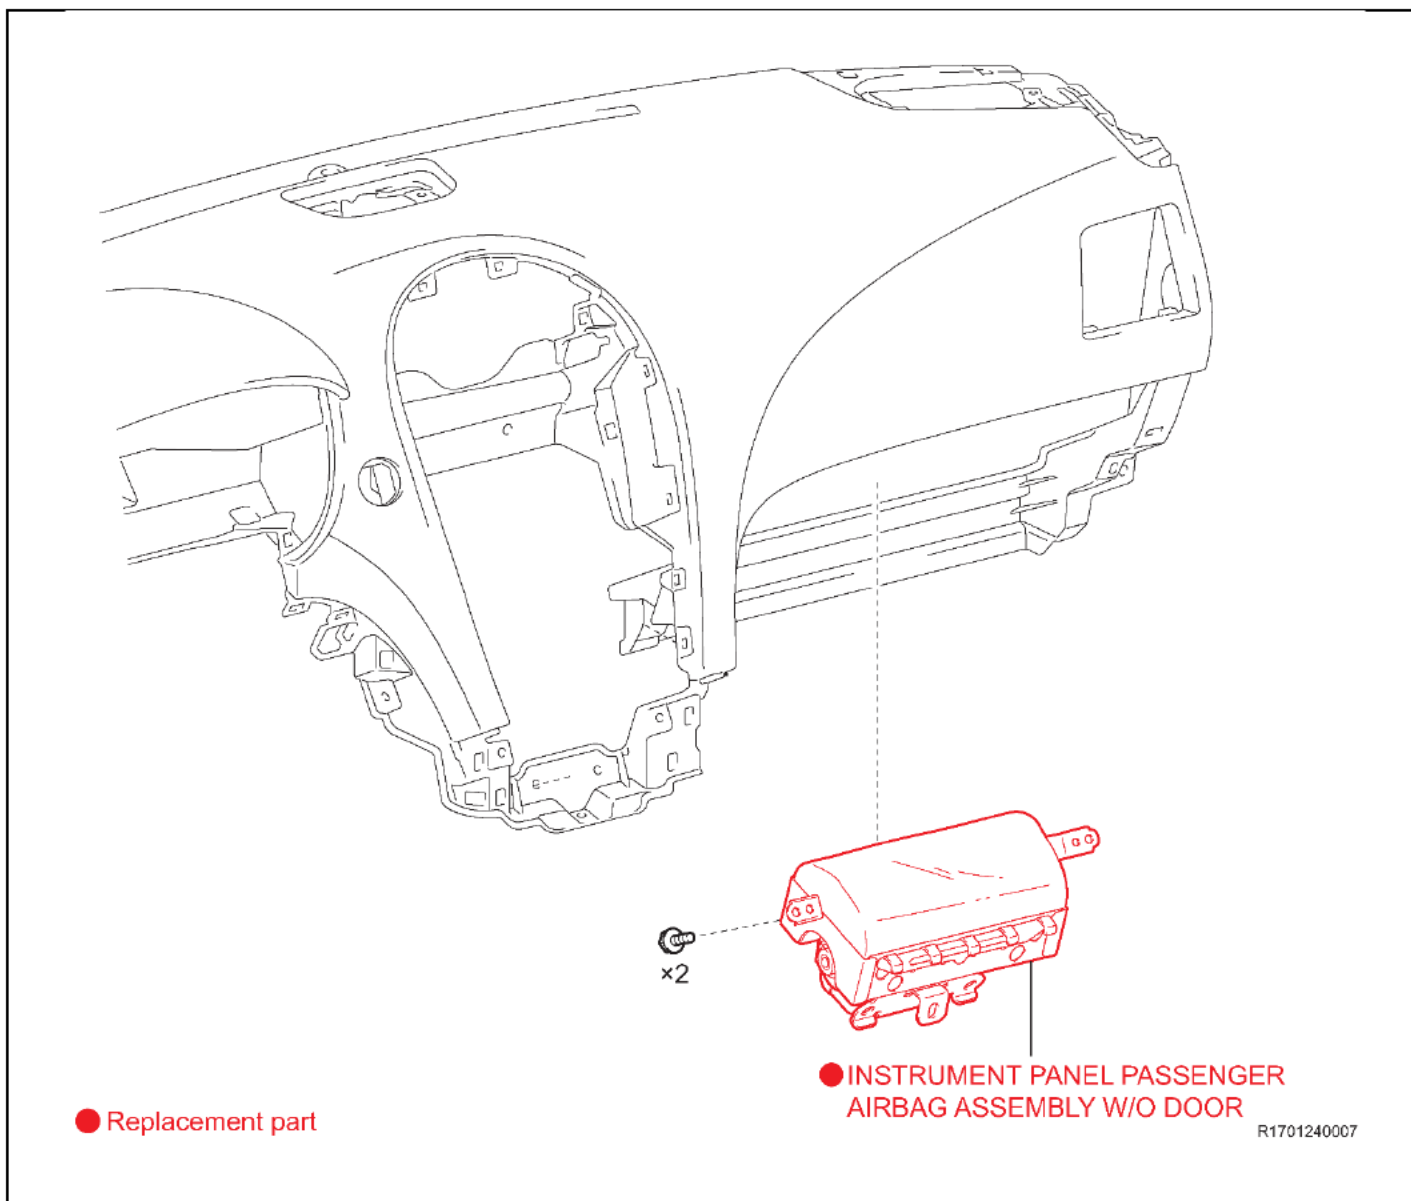
**VII. FRONT PASSENGER AIRBAG REMOVAL  
COMPONENTS**

N\*m (kgf\*cm, ft\*lbf) : Specified torque

N\*m (kgf\*cm, ft\*lb) : Specified torque

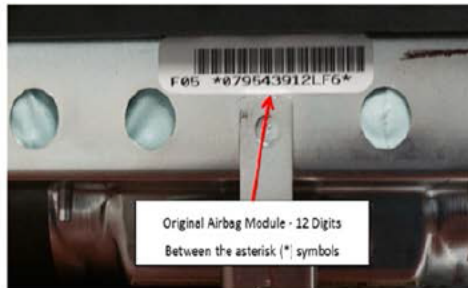
Record Airbag Serial Number

- The airbag serial number is **ALWAYS** the 12 **DIGITS** located between the asterisks.
- The 3 digits before the asterisk **ARE NOT** part of the serial number, and **SHOULD NOT** be entered or an inaccurate response may be returned.

The Airbag module Assembly serial number is a 12 digit code. It can be found along with a bar code on opening the Airbag assembly unit. To manually enter these details into the application, the technician has to identify the 12 digit code between two Asterisks (\*) inside the Airbag assembly unit. The first seven characters of this 12 digit code are numbers and the 10<sup>th</sup> digit is either 'K' or 'L' always.

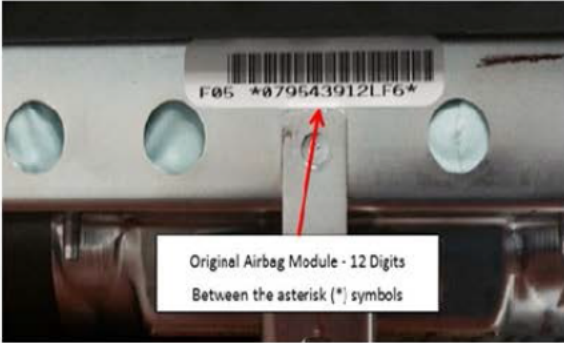
Original Airbag Module - 12 Digits  
Between the asterisk (\*) symbols

The Airbag module Assembly serial number is a **12 digit code**. It can be found along with a bar code on opening the Airbag assembly unit. To manually enter these details into the application, the technician has to identify the 12 digit code between two Asterisks (\*) inside the Airbag assembly unit. The first seven characters of this 12 digit code are numbers and the 10<sup>th</sup> digit is either 'K' or 'L' always.

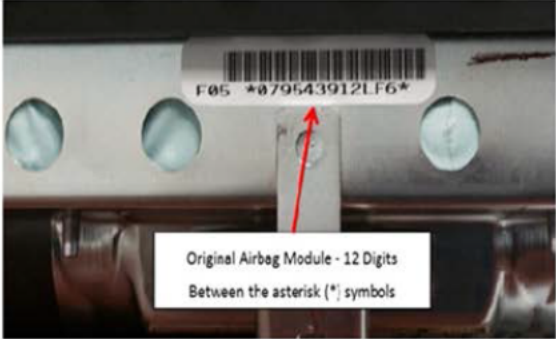
a) If the airbag serial number cannot be scanned or is not present check the box as shown below.

**Check this box if the label is damaged or missing**
