SAFETY RECALL G0P/G0R/H0A

FRONT PASSENGER AIRBAG INFLATOR MODULE

CERTAIN 2010-2016 MY 4Runner

**Updated 01-14-2021**

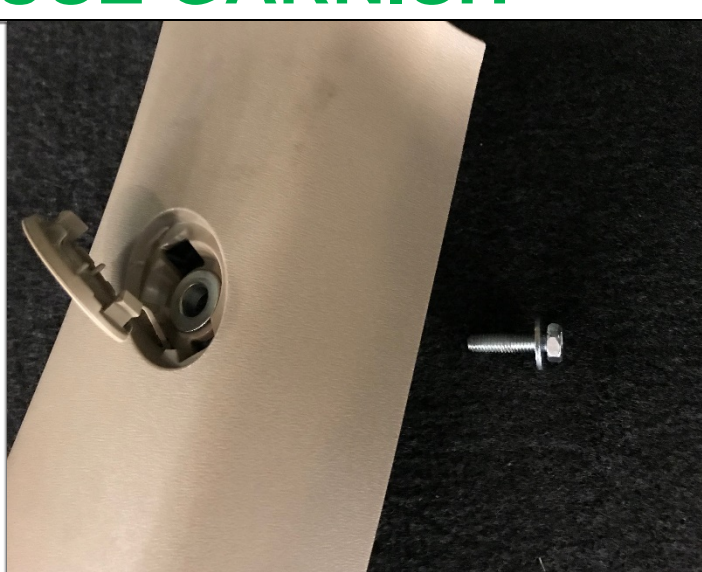
\*\*Only 2010 to Certain 2013 Model Year 4Runner vehicles require A-Pillar garnish replacement. If you have a 2013 – 2016 4Runner that contains an A- Pillar garnish that is bolted in at the top, the A-Pillar **DOES NOT** require replacement. See photos below for reference.

REPLACE	RE-USE GARNISH	
<p>Part manufactured before August 2013:</p>

<p style="color: red; text-align: center;">● FRONT PILLAR GARNISH LH</p>	<p>Part manufactured after August 2013:</p> <p>No. 1 FRONT PILLAR GARNISH COVER LH</p>

<p style="text-align: center;">FRONT PILLAR GARNISH LH</p>

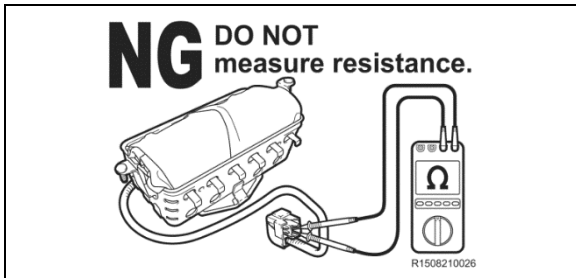
#### 2. DO NOT MEASURE RESISTANCE

- a) **DO NOT** measure resistance of airbag components, this may cause accidental activation.
