## TECHNICAL INSTRUCTIONS FOR SAFETY RECALL H0A FRONT PASSENGER AIRBAG INFLATOR MODULE CERTAIN 2009 MODEL YEAR COROLLA

### UPDATE 4-18-18

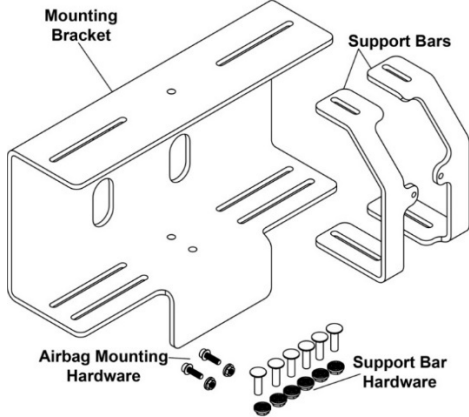
Airbag Mounting Bracket & hardware	1

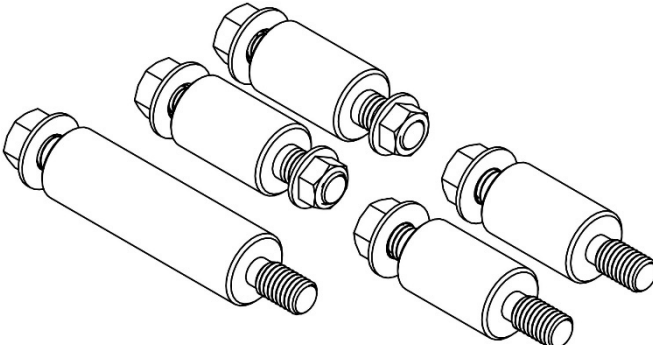
Adaptor set*	1

\*The adapter set was sent to dealers at the start of this campaign.

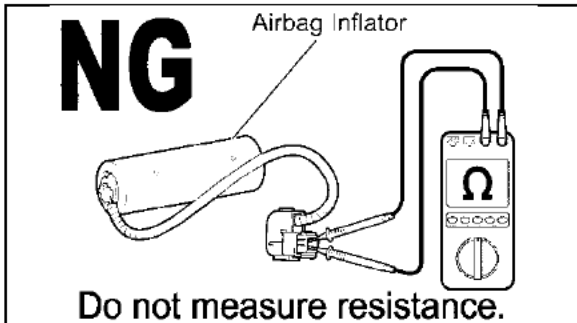
#### 2. DO NOT MEASURE RESISTANCE

- DO NOT** measure resistance of airbag components, this may cause accidental activation.

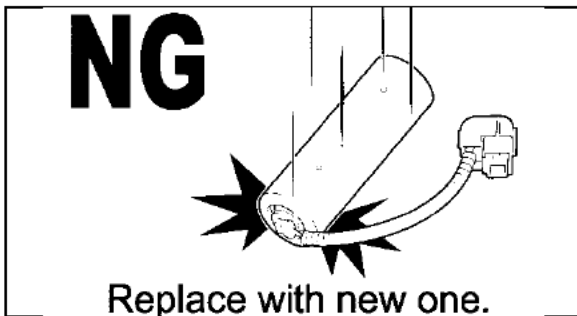
#### 3. HANDLE THE AIRBAG CAREFULLY

- If an inflator is dropped, replace it with a **NEW** inflator.

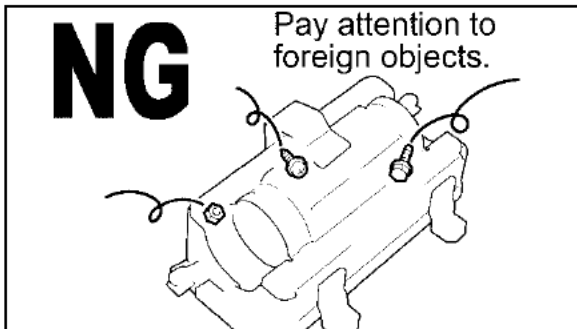
#### 4. DO NOT ALLOW FOREIGN OBJECTS NEAR AIRBAG

- Be sure to collect and account for all removed nuts/bolts to prevent them from landing in the airbag assembly.
- Any foreign objects in the airbag assembly may cause damage or injury if the airbag is activated.

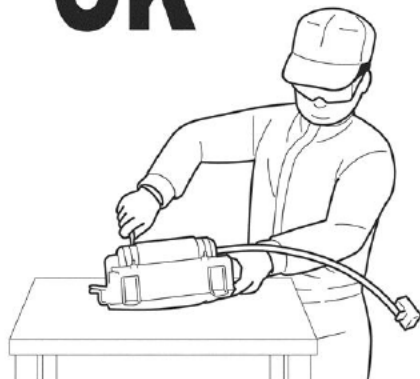
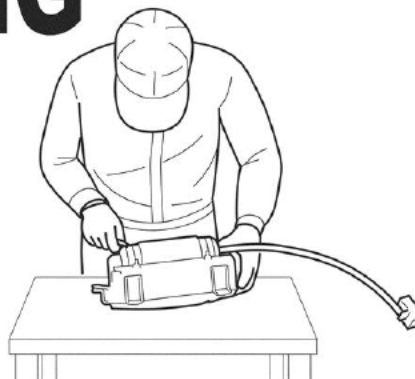
- Carefully place the airbag on the bench inflator side up.

**NOTE:** Place clean sheet(s) of paper on the bench to protect the airbag.

- Avoid standing directly over the inflator.

# OK

# NG

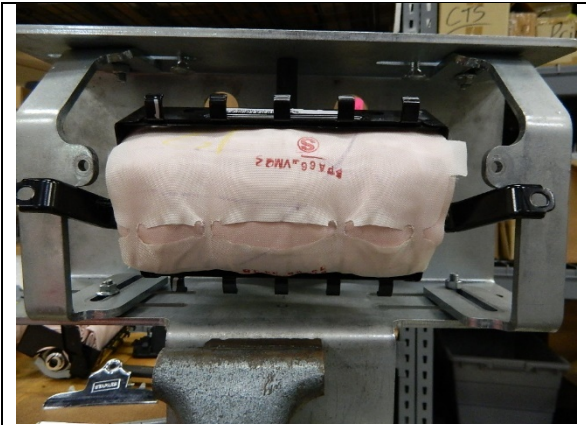
e) Use the long adaptor shown.

f) Thread the adaptor into the airbag as shown.  
**Note: Use the same mounting nut on the airbag that attaches the airbag to the vehicles cross tube.**

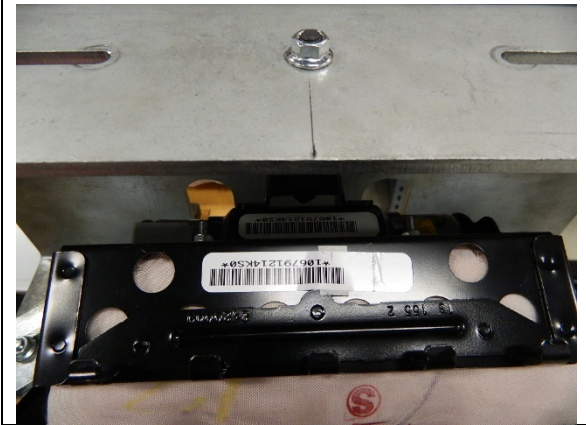
- g) Mount the airbag into the mounting bracket as shown. Pass the stud on the adaptor through the hole, on the top in the middle of the bracket, and secure with the nut.

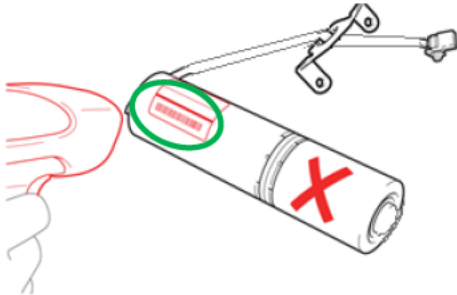
**Step a) Old Inflator (bar code)**

- Scan the **OLD** inflator bar code.
- Scan the **NEW** inflator QR code.

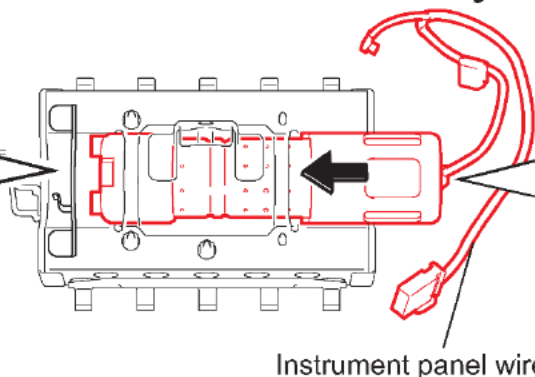
a) Carefully slide the new inflator into the airbag assembly and align as shown.

- DO NOT** connect the inflator harness at this time. It is **CRITICAL** to first confirm that the inflator is installed in the correct position before connecting the harness.

**DO NOT** insert fully.

Check orientation

Upper side

Bottom

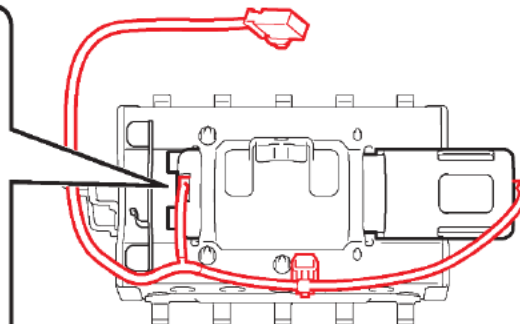
b) Connect the connector to the inflator and ensure that the connector lock is fully engaged as shown.

c) Route and secure the wire harness as shown.

**ALIGN CONNECTORS**

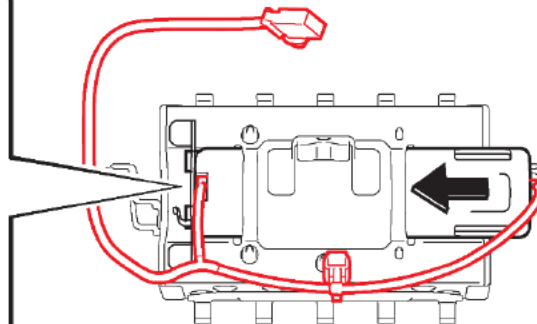
d) Fully insert the inflator and ensure that the inflator is correctly oriented as shown.

**NOTE: DO NOT** pinch the wiring between the bracket and the inflator.

**DO NOT**  
pinch the wire
